Vrynwyn Reserve, Area A – BS 5837: 2012 Arboricultural Report and Impact Assessment

Cura Terrae Land and Nature Limited

Report Title: Vyrnwy Land – Area A – BS 5837:2012 Arboricultural Report,
Impact Assessment and Method Statement

Version: V2.0
Issue Date: January 2025
Report Ref: 22517

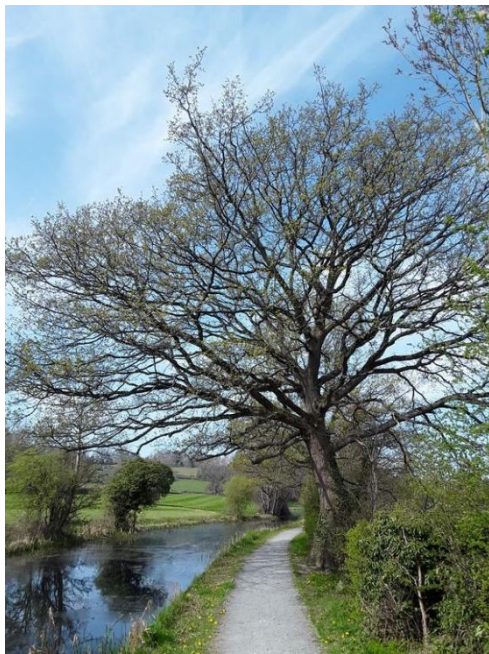
Plate 8: T056

- 3.2.6 There was evidence of some compacted ground and soil erosion along the track in between G047 and T038 by the use of agricultural vehicles.
- 3.2.7 T056 is a high-quality specimen Pedunculate Oak with large diameter stem over 1000mm with no signs of dysfunctional wood or signs of decay. It has a large canopy spread and is a prominent feature on the landscape whilst providing high quality habitat for the local environment. This tree has the capability to have life expectancy that could exceed 40 years. The tree has had 3 bat boxes attached to the main stem, it was unclear if the bat boxes were in use. However, this tree is showing

good habitat potential including potentially protected species as per section 1.4 and an ecological survey is recommended.
