Vyrnwy Land – Area B – BS 5837: 2012 Arboricultural Report and Impact Assessment

Date: 14/01/2025
Prepared by: Andrew Bagshaw
Ref: 24539

Report Title: Vyrnwy Land – Area B – BS 5837:2012 Arboricultural Report,
Impact Assessment and Method Statement

Version: V2.0
Issue Date: January 2025
Report Ref: 24539

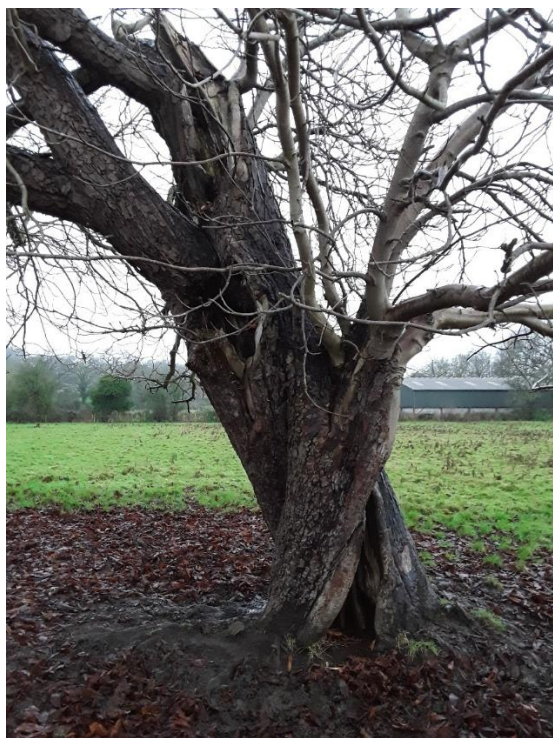
Plate 1: T001

- 3.2.3 The most significant tree was the mature Horse chestnut, T001. This tree is visually prominent and is exhibiting veteran characteristics.
- 3.2.4 Significant vegetation was also present to the north, south and west and consisted mainly of mature hawthorn with occasional oak trees within a network of field boundary hedgerows.
- 3.2.5 There was evidence of some compacted ground and soil erosion around the field boundaries. This is likely to be the result of cattle grazing in this area and may have had a detrimental long-term impact on tree roots.

Tree No.	Species	Height (m)	No. of Stems	Stem Dia. @ 1.5m (mm)	Crown Spreads (m)				Height of Crown Clearance (m)	Age Class	SLE	Overall Condition	Comments	Management	Category	RPA Radius (m)	RPA Area (m ²)
					N	E	S	W									
T001	Horse chestnut (<i>Aesculus hippocastanum</i>)	10	2	1230	5	5	10	8	2	Mature	20+ Years	Fair	Stem/limb decay. Stem hollow, decayed, cracked. Inclusive bark/V union. Fractured limbs - storm damage. Roots at surface. Canopy biased to SW with 2x large diameter (400mm) historic scaffold branch failures. Included union of Codominant stems exhibiting partial failure, although tree located in low footfall area presents very low risk. Tree exhibiting veteran characteristics.	No action required	A1	15	707

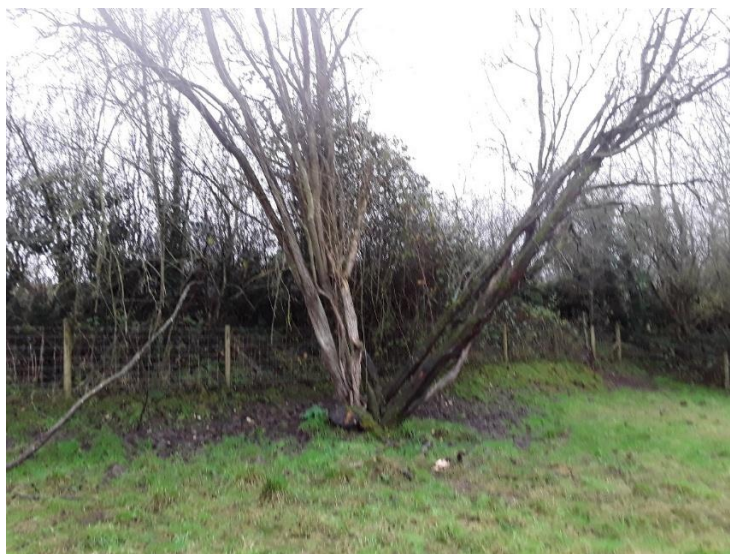
Plate 2: T002

Tree No.	Species	Height (m)	No. of Stems	Stem Dia. @ 1.5m (mm)	Crown Spreads (m)				Height of Crown Clearance (m)	Age Class	SLE	Overall Condition	Comments	Management	Category	RPA Radius (m)	RPA Area (m ²)
					N	E	S	W									
T002#	Common hawthorn (<i>Crataegus monogyna</i>)	10	5	280	5	6	5	7	3	Over Mature	10+ Years	Fair	Historic Codominant stem failure has been cut and removed. Included bark unions of Codominant stems exhibiting partial failure. Mature elder growing adjacent with inter-twined canopy. 2x Codominant stems lean NW and appear to be slowly failing. Acceptable condition at present due to low footfall and low target area.	Remove to facilitate development	C1	7.5	177
T003	Pedunculate oak (<i>Quercus robur</i>)	16	1	500	5	5	6	6	6	Early Mature	40+ Years	Good	Offsite tree located on canal side with northern canopy overhanging into site, currently with 7 metres ground clearance. Located within a low footfall area. Ivy clad stem and crown prevented a detailed inspection.	Remove to facilitate development	A1	6	113

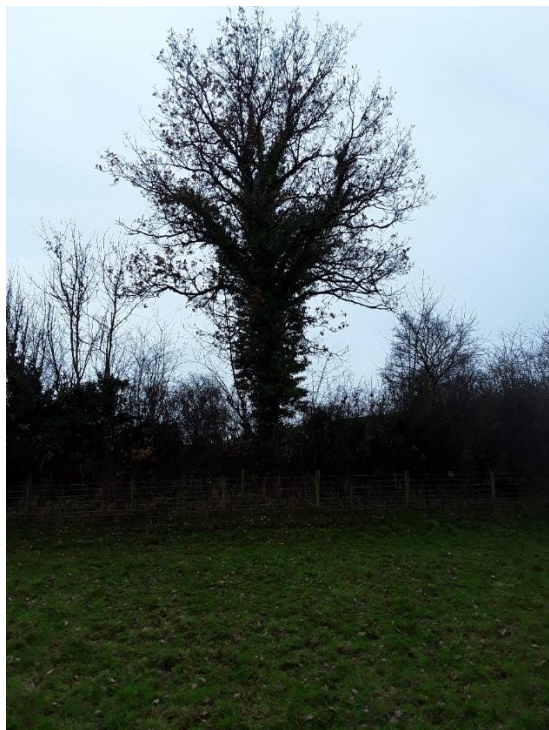
Plate 3: T003

- 4.3.3 T003 has been given a Category A due to its species, age and features. The removal of a Category A should be avoided due to their high amenity value, long life expectancy and contribution to the eco system.

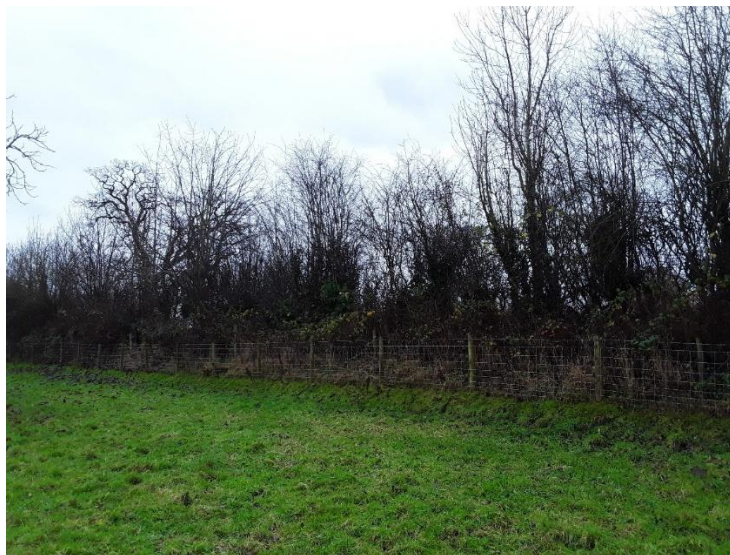
Plate 4: G004

G004#	Oak (<i>Quercus sp.</i>) Hawthorn (<i>Crataegus sp.</i>) Blackthorn (<i>Prunus spinosa</i>) Common holly (<i>Ilex aquifolium</i>) Ash (<i>Fraxinus sp.</i>)	7	1	200 AVG	See plan				0.5	Early Mature	40+ Years	Good	Offsite linear native mixed species hedgerow bordering canal. Providing habitat. Dense bramble understory. The group is outside influencing distance of site and protected by 1 metre post and wire fence.	Remove to facilitate development	B2	–	–

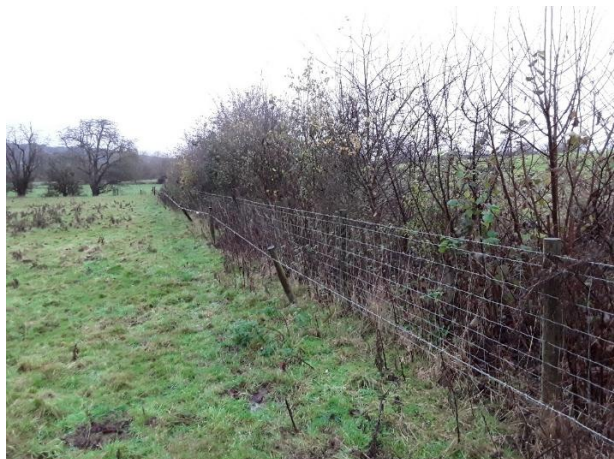
Plate 5: G005

Tree No.	Species	Height (m)	No. of Stems	Stem Dia. @ 1.5m (mm)	Crown Spreads (m)				Height of Crown Clearance (m)	Age Class	SLE	Overall Condition	Comments	Management	Category	RPA Radius (m)	RPA Area (m ²)
					N	E	S	W									
G005#	Willow (<i>Salix sp.</i>) Common hawthorn (<i>Crataegus monogyna</i>) Hazel (<i>Corylus avellana</i>)	4	1	100 AVG	See plan				0.5	Young	10+ Years	Good	Recent planting along field boundary providing potential wildlife habitat. Good future potential.	–	C1,2	–	–
G006#	Common hawthorn (<i>Crataegus monogyna</i>)	8	4	250 AVG	See plan				2.5	Mature	20+ Years	Fair	Lapsed and broken field boundary hedgerow consisting of approximately 15 trees. Evidence of some grazing damage although acceptable condition at present due to current land use (low footfall). Localised dieback to occasional trees presents a low risk.	–	B2	–	–
G007	Common hawthorn (<i>Crataegus monogyna</i>)	8	1	250 AVG	See plan				3	Mature	20+ Years	Good	Lapsed field boundary hedgerow. Evidence of grazing damage although acceptable condition at present due to current land use (low footfall). Providing wildlife habitat and screening from adjacent farm building.	–	B1,2	–	–

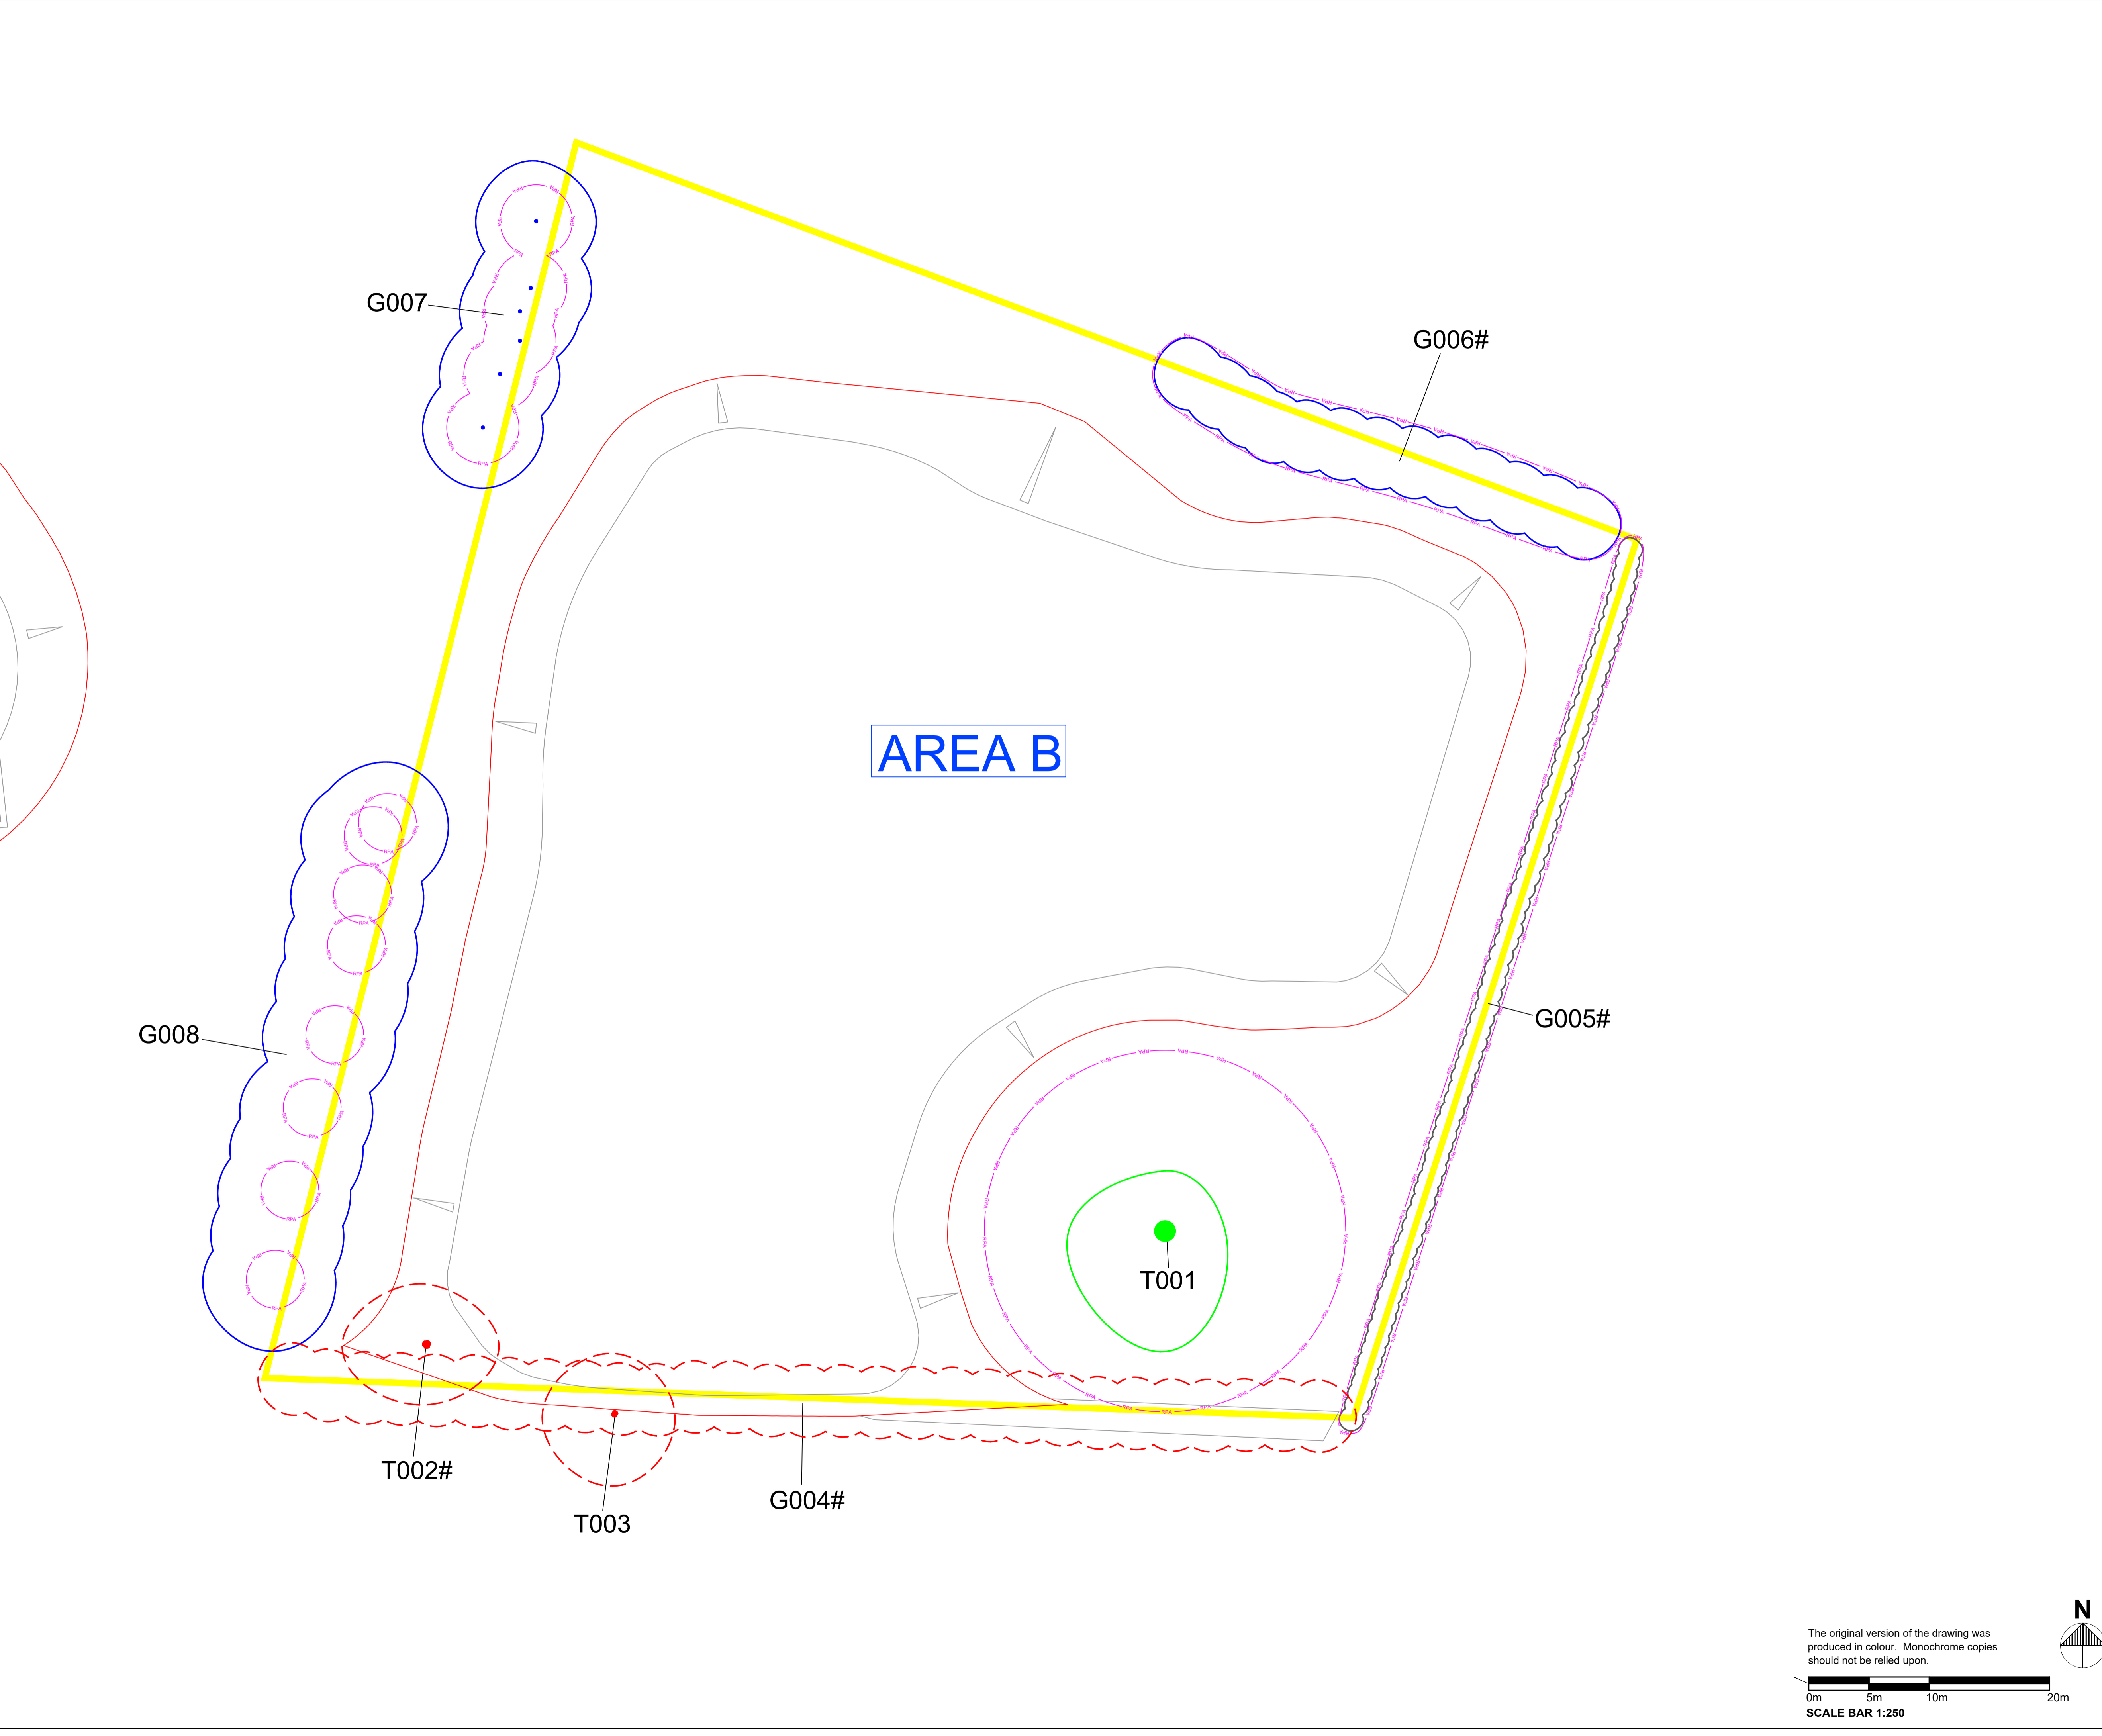
Title
Figure 4 - Tree Impacts Plan

4.3.1 The development proposals indicate that two trees and one group will need to be removed and the retention and protection of all trees within the site boundary is likely to be suitable throughout the development.

- 4.4.1 Where proposed operations encroach beneath the canopy or into the RPA of retained trees there is the potential for damage to occur.
- 4.4.2 Construction of the landscaping bund within Area B is proposed within the RPA of the retained tree T001 as detailed on the Tree Impacts Plan at Appendix 3.
- 4.4.3 In this instance the encroachment is particularly minor, and the tree is unlikely to be significantly affected due to the proposed works being at the edge of the RPA with only approximately 5% of the theoretical Root Protection Area (RPA) being affected.
- 4.4.4 All works within the RPA of retained trees have been detailed as part of the Arboricultural Method Statement at Appendix 3, to ensure that these works are carried out in a manner that eliminates the likelihood of any damage occurring.

- 4.5.1 The retained trees will need protecting from development operations to ensure that they are not negatively impacted during the development. This has been detailed as part of the Arboricultural Method Statement (AMS) at Appendix 3.

- 4.5.3 To compensate for potential root damage and stress caused by construction activities, retained trees onsite should be mulched. The materials that may be used include wood chip, pulverized bark, or leaf mould. The mulched area should extend throughout the open ground within the RPA. The depth of an organic mulch should not be so much as to inhibit aeration of the root system or to cause overheating (Approximately 50 mm to 100 mm).
