# Droitwich Canals

Heritage Survey 2000

Amendments added 2004 (in bold)

## Droitwich Junction Canal/Barge Arm

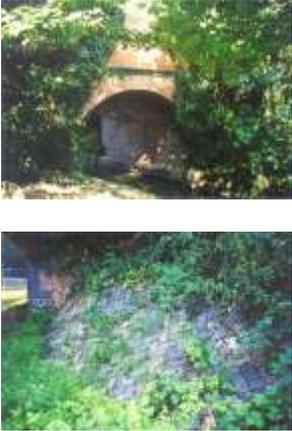
Structure	Location	Construction	Designation	BW grade	Comments	Update 2004	Image
Westfields Farm accommodation bridge	Junction with W & B at Hanbury Wharf	Blue and red brick	Entire corridor in CA	LI	Completely rebuilt parapet

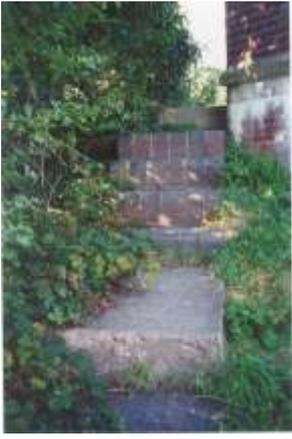
Road bridge	Siding Lane	Modern red brick replacement to original footbridge Blue brick copings to steps from towpath		LI	Replacement for earlier footbridge Steps alongside are earlier	<b>Evidence of former structure below existing bridge</b>
