INITIAL REPORT INTO THE LLANGOLLEN CANAL BREACH AT WHITCHURCH, SHROPSHIRE, ON 22ND DECEMBER 2025

This report presents the initial findings of the ongoing investigation into the Llangollen Canal breach that occurred on 22nd December 2025, at Whitchurch, Shropshire.

¹ This report uses references from the Trust's asset identification scheme. The breach occurred on Whitchurch Embankment 2, asset LA-022-013-L.

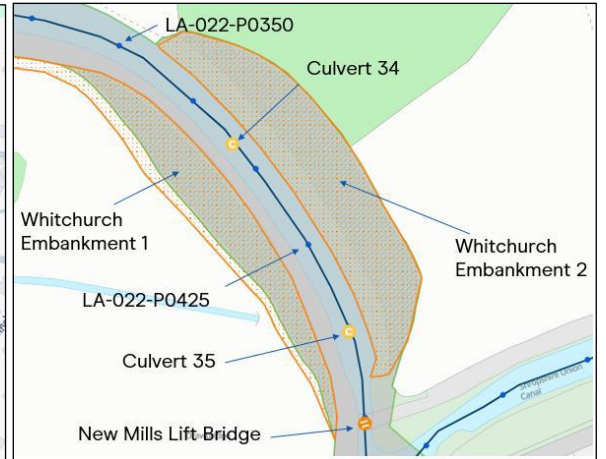
Figure 3: Breach site, Whitchurch Embankment 2

At around 0400-0430 hrs on Monday 22nd December 2025, the Llangollen Canal suffered a major breach at Whitchurch in Shropshire. The breach caused the collapse of a 25m section of embankment and the rapid loss of a large volume of water and debris from the affected section of the canal into surrounding farmland.

The information currently available suggests the most likely cause of the breach was an unusual congruence of multiple factors: specific physical factors in this location (notably a steep, high, sandy embankment), coupled with a suspected slow, low-volume leakage over a number of years that caused piping and internal erosion. Piping can occur if seepage through a soil embankment becomes strong enough to carry soil particles away, forming internal erosion channels. It is possible that the cumulative effect of propeller wash ('prop wash') from engines left in gear on moored boats over time could have contributed to an increase in the rate of leakage.
