Pocklington Canal

Conservation Management Plan

Report Title: Pocklington Canal – Conservation Management Plan

Revision: v1.1
Issue Date: 02/12/15
Report Ref: 5481_PCCMP_v1.1

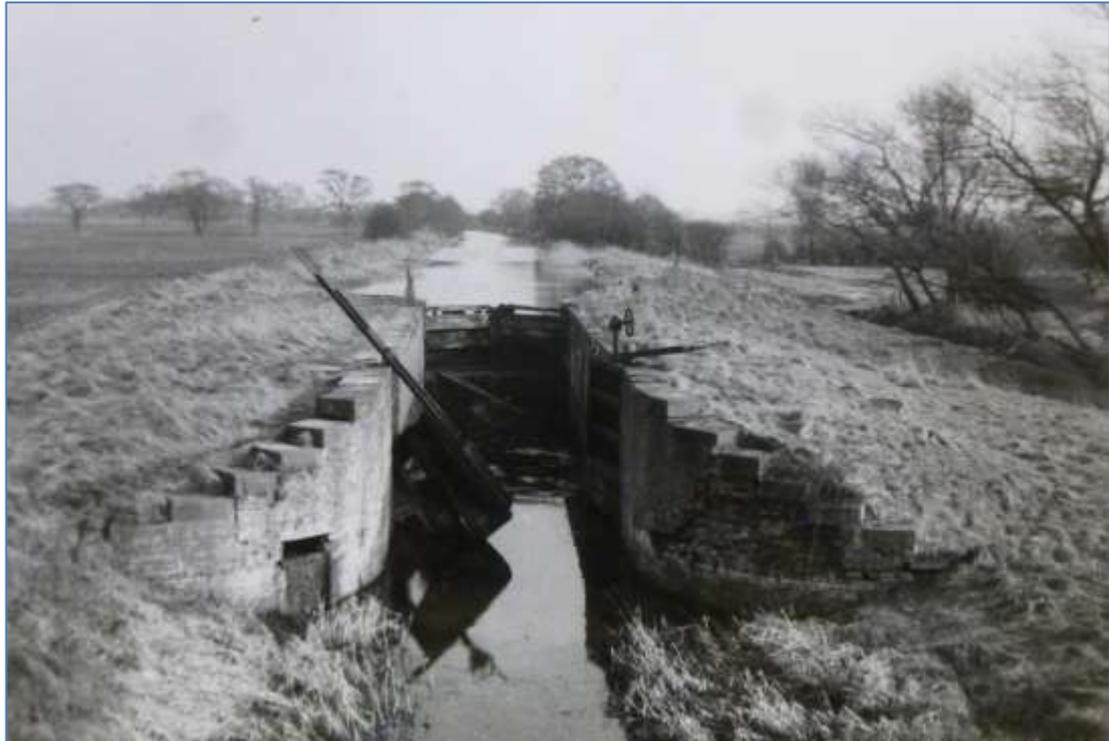
Plate 11: Pocklington Canal in 1959 showing a derelict lock, possibly Walbut (HA 15; © Waterways Museum)

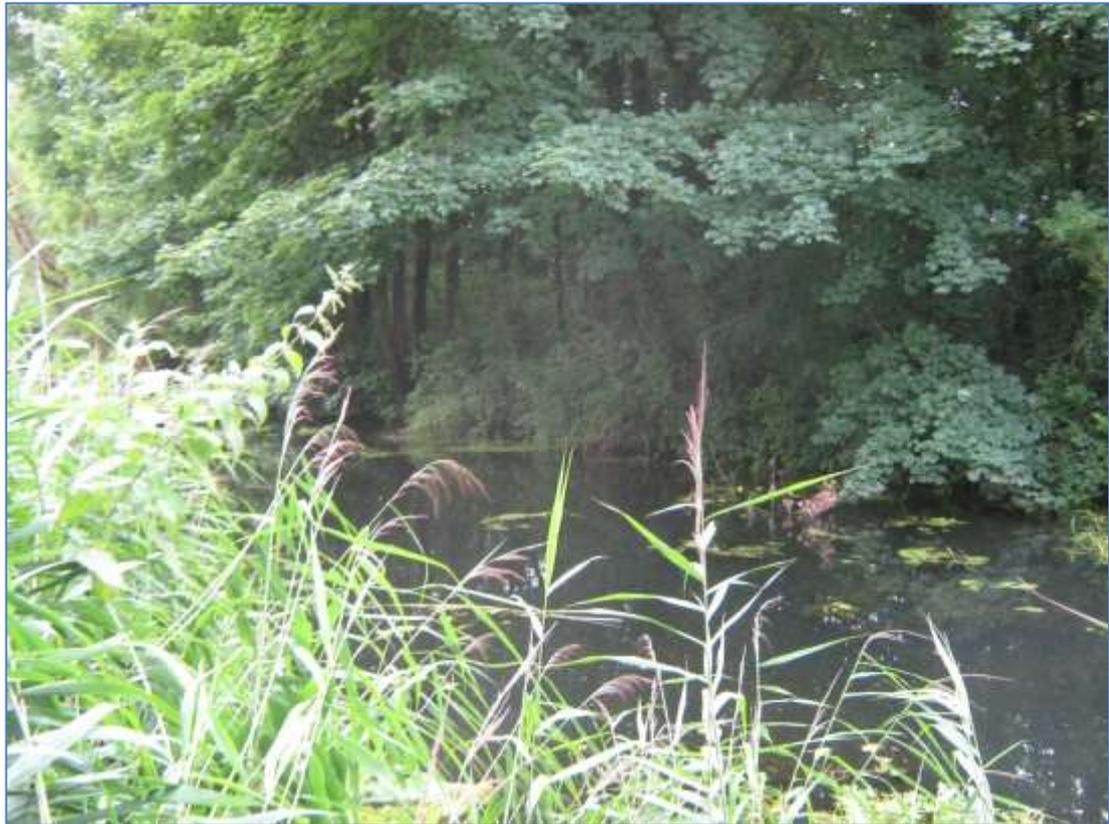
Plate 49: A heavily shaded section of the Canal, note lack of aquatic plants in channel. (S. Christian – Natural England)

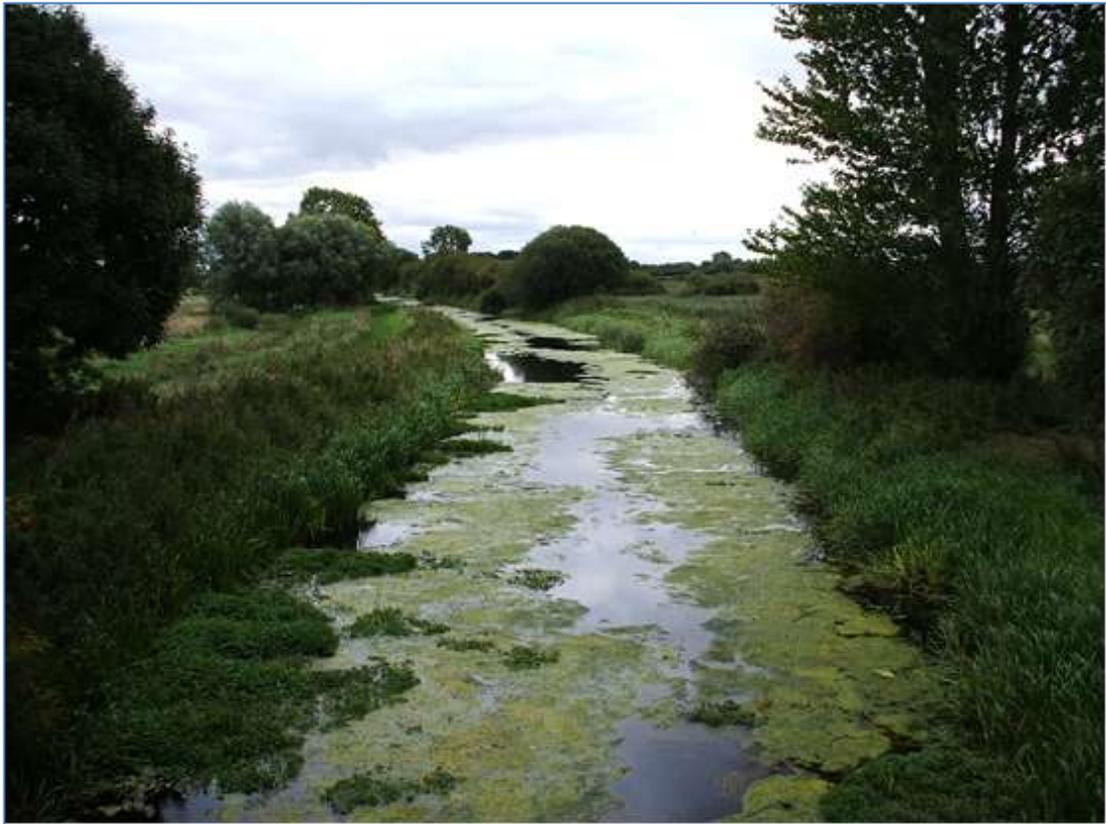
Plate 53: Section of Canal near Melbourne showing excessive growth of filamentous algae (Natural England (Scott Wilson 2007))

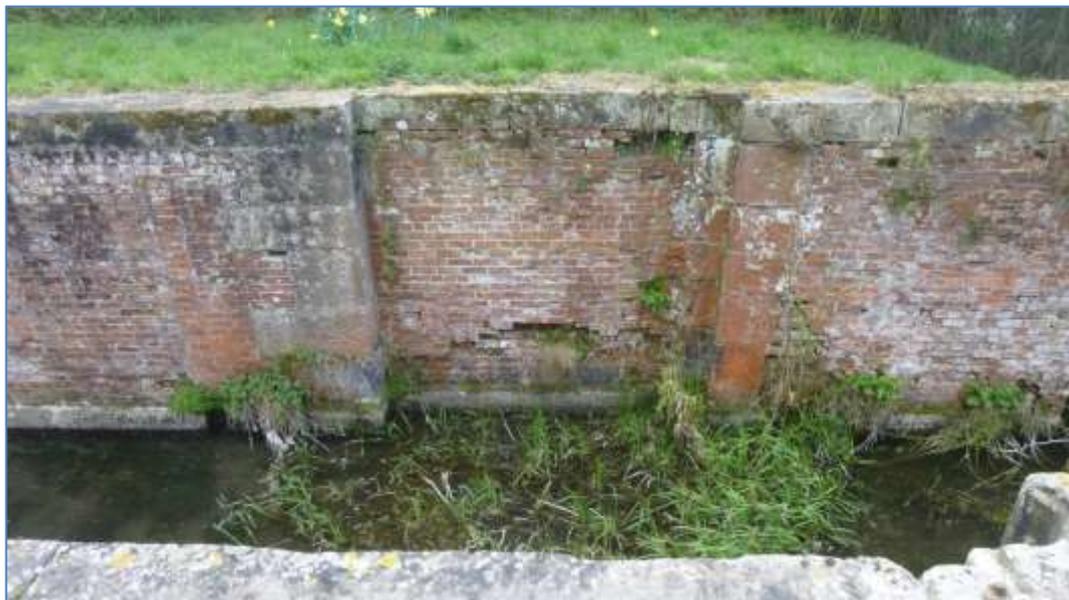
Plate 61: Detail of vegetation damage to Giles Lock (HA 6)

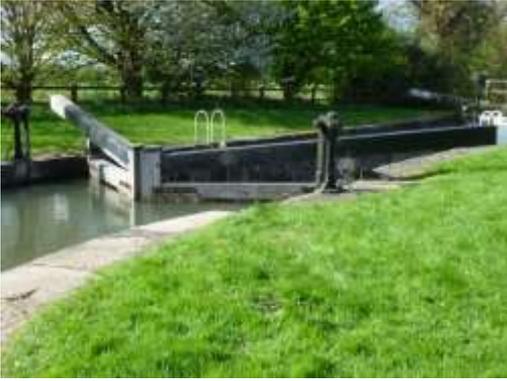
Pocklington Canal: Top Lock No.9		Heritage Asset	4

Statutory Designations:	Grade II Listed Building.	
	Monument Type:	Lock	
	NGR:	479856 447183	
	Location:	South of Lock House.	
<p>Description:</p> <p>Constructed in 1817-1818, and refurbished by PCAS post 1970. The culvert forms joins the Grade II Listed Building of Pocklington Canal Top Lock and Canal Head.</p> <p><i>Element 4.1</i> The top lock is a modern replacement, with square section balance beams. The lock was refurbished in 2002 and a commemorative plaque marks this date. The lock has ground paddle gears comprising cast iron stanchions with rack and pinion gearing. The cast iron anchor collars are a later replacement. The cill was not inspected. The ashlar surrounding the top lock is loose and reeds are growing between joins.</p> <p><i>Element 4.2</i> The Canal chamber is constructed in red brick with ashlar coping stones. The chamber has been partially rebuilt and the coping stones although original have been moved and repositioned. The bricks at water level have suffered some damage. There are full height beam slots built in along the Canal chambers length which would historically have help bumping pieces and a steel ladder set into the Canal chamber wall. The chamber base and wall foundations were not inspected.</p> <p><i>Element 4.3</i> The bottom lock is a later replacement, with square section balance beams, new anchor collars and gate paddle gears. There are two plaques dating to the refurbishment of the lock one dating to 2001 and the second to 2002.</p> <p><i>Element 4.4</i> The entrance to the bywash is located in the ashlar stone coping north of the top lock. It appears to be in working order.</p> <p><i>Element 4.5</i> A bench is situated to the side of the lock which was constructed from old railway tracks which had been used as balance beams on Cottingwith Lock.</p>

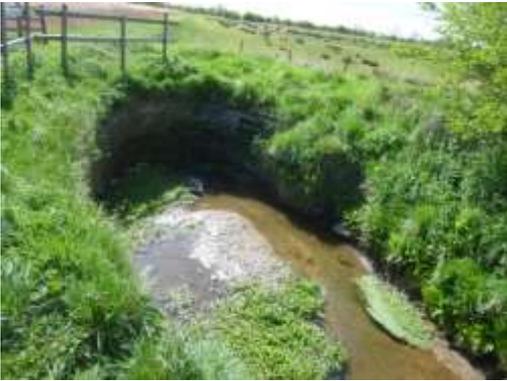
Statutory Designations:	No statutory designations.	
	Monument Type:	Culvert	
	NGR:	478480 444381	
	Location:	East of Thornton Wood.	
Description:	Built 1817-1818. Three brick ring round-arched culvert within curving wing wall built in brick with stone coping. The culvert comprises two-phases and the upper brickwork has been replaced.		
Heritage Value:	The culvert is of local historic and evidential value.		
Survival:	Moderate.		
Condition:	Good - Some of the brick work and masonry is falling loose due to plants establishing themselves between courses.		
Vulnerability:	Deterioration, plant growth, water damage.		
Trend:	Decline.

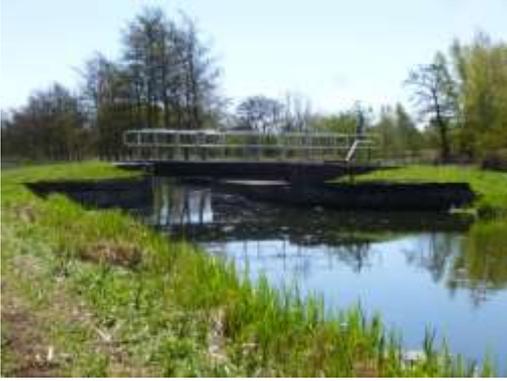
Statutory Designations:	No statutory designations.	
	Monument Type:	Bridge	
	NGR:	474749 444530	
	Location:	North of Deanery Farm, Melbourne.	
Description:	<p>Originally constructed in 1815, likely replaced in the 1930s with a new swing bridge, and replaced with a fixed bridge in the 1960s. The present bridge was installed post-1970.</p> <p>The present bridge is of steel construction and sits on top of curved brick built abutment wall which appears to predate the current bridge structure and has original ashlar coping stones. Concrete and modern brickwork is used extensively to form the foundations and superstructure. The bridge has cobble kickers set into concrete.</p> <p>There are some substantial cracks in the brickwork of the supporting piers.</p>		
Heritage Value:	The swing bridge is of high historic value		
Survival:	Poor

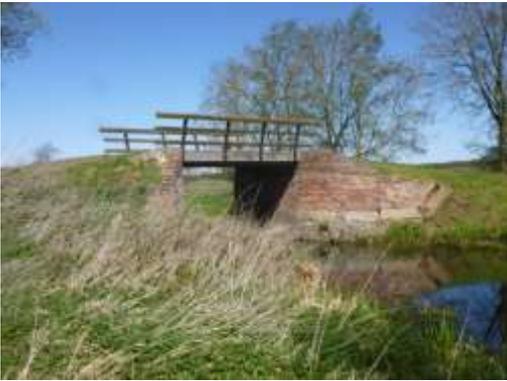
Statutory Designations:	No statutory designations.	
	Monument Type:	Bridge	
	NGR:	473965 444941	
	Location:	South of Melbourne Ings.	
Description:	<p>Swing bridge originally dating to 1815, likely rebuilt in the 1930s then replaced with a level bridge in the 1960s. The bridge was raised by PCAS in the 1970s in order to allow boat passage. The deck was replaced in the 1990s. This bridge was historically also known as Clarks Bridge.</p> <p>The bridge comprises two curving abutments that project into the Canal with fixed timber frame bridge with spayed post and rail fenced parapet. The lower part of the abutments is formed from handmade bricks with ashlar band comprising the coping of the original bridge structure. Above this level the abutments have been raised with later machine made bricks from the Normanton Brick Company. Behind the walls the land has been embanked. The bridge abutments are suffering from collapse.</p>

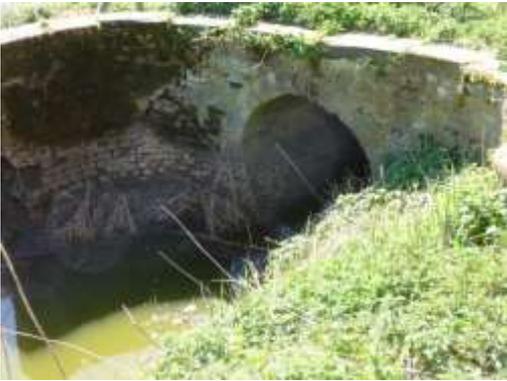
Statutory Designations:	No statutory designations.	
	Monument Type:	Culvert	
	NGR:	473827 445048	
	Location:	North of Westfield Farm.	
Description:	Dates to 1815. Circular culvert with a curved wing walls built in brick with ashlar coping stones. The culvert is in good general condition. The wing wall has been partially rebuilt but is suffering from some collapse and has a number of loose coping stones.		
Heritage Value:	The culvert has local evidential and historic value.		
Survival:	Moderate		
Condition:	Poor - The wing wall of the culvert has been rebuilt but is collapsing. The culvert has a number of loose coping stones.		
Vulnerability:	Deterioration, collapse, plant growth, water damage.		
Trend:	Decline

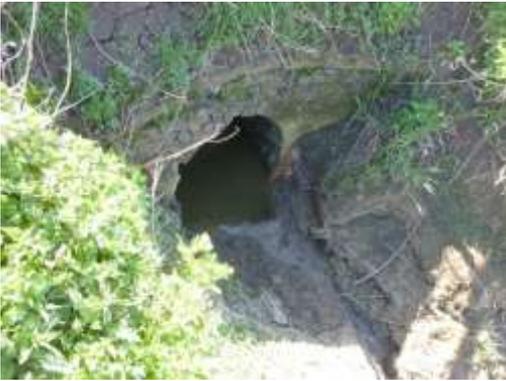
Statutory Designations:	No statutory designations.	
	Monument Type:	Culvert	
	NGR:	470992 444546	
	Location:	The culvert is located north of Storwood.	
Description:	A culvert with a curved brick wing wall with two header brick ring round arched soffit. The culvert is in disrepair with loose brick work threatening its stability.		
Heritage Value:	The culvert has local evidential and historic value.		
Survival:	Good		
Condition:	Very bad - Culvert no.3 is considered to be in generally satisfactory condition with significant localised problems. The culvert is considered to be in declining condition with loose brickwork threatening its overall stability.

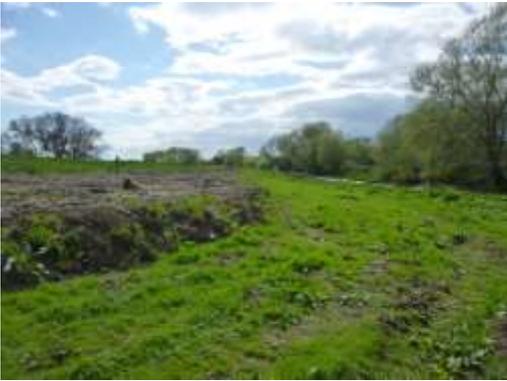
Statutory Designations:	No statutory designations.	
	Monument Type:	Wharf	
	NGR:	469929 442667	
	Location:	Northwest of East Cottingwith on the south bank of canal.	
Description:	A former wharf, located at the Canal terminus at Cottingwith. The wharf now forms the margin of an agricultural field and has since been raised through the deposition of dredged material in this location.		
Heritage Value:	The site is considered to have local historic and evidential value.		
Survival:	Moderate. The wharf remains identifiable, no associated features, were identified.		
Condition:	Fair - Deposition of dredged material is altering the shape and height of the wharf.		
Vulnerability:	Ploughing, deposition of dredged material.		
Trend:	Decline.
