Canal & River Trust

Report on the Nature and Root Cause of the Toddbrook Reservoir Auxiliary Spillway Failure on 1st August 2019

Dr Andy Hughes
February 2020

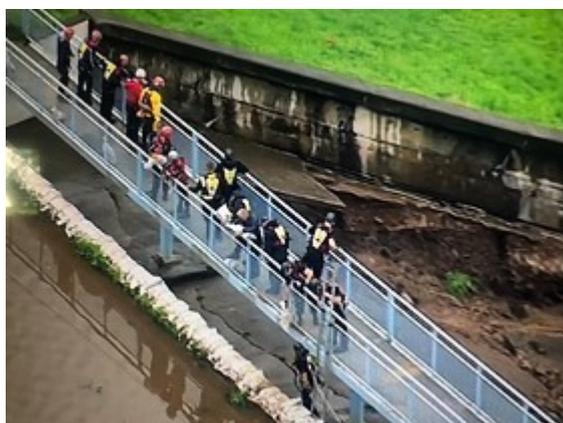
The auxiliary spillway then broke up on the left-hand side (looking downstream) with severe damage to the slabs and removal of large amounts of fill from beneath the slabs in that area.

Damage at left hand end

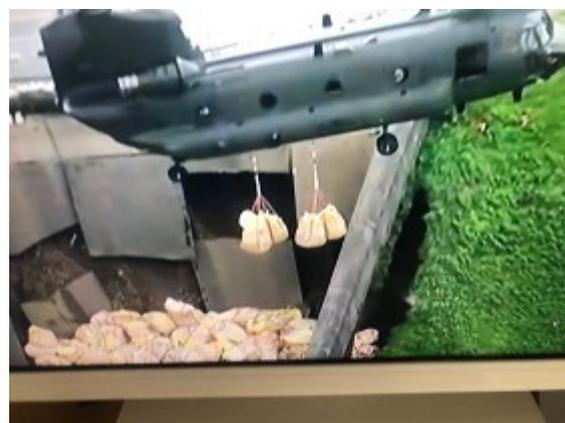
Emergency works (note the void outside the wall)

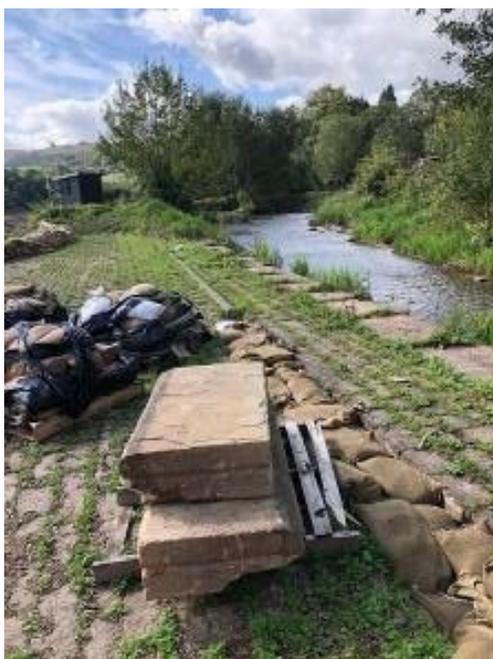
**Main spillway weir and bywash channel
(weir blocks removed during the incident)**

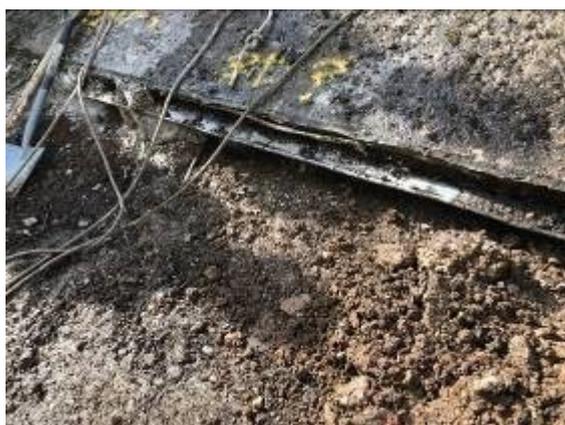
Water bar at joint

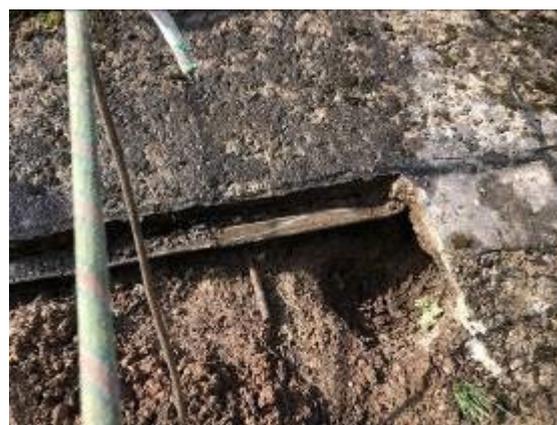
Excavation showing dowels and water bar

The joint detail, the water bar, the transverse ribs, reinforcing steel and dowel bars were all found to be as per the drawings. The reinforcing steel was found to be very small – of the order of 3mm in diameter.

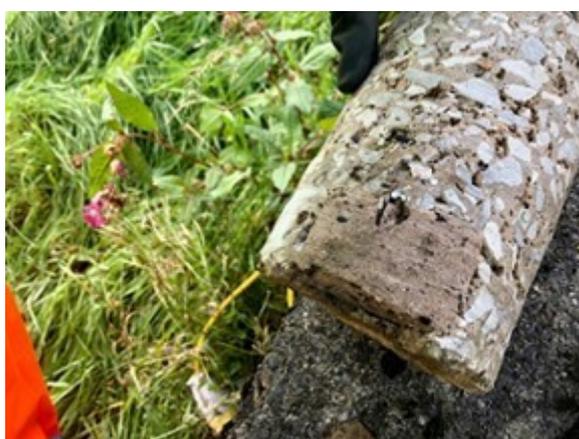
One layer of mesh was used in the spillway slab and mesh used in the ribs was bent to shape. The mesh was found to be very small, about 3 mm diameter.

Small diameter reinforcing bar

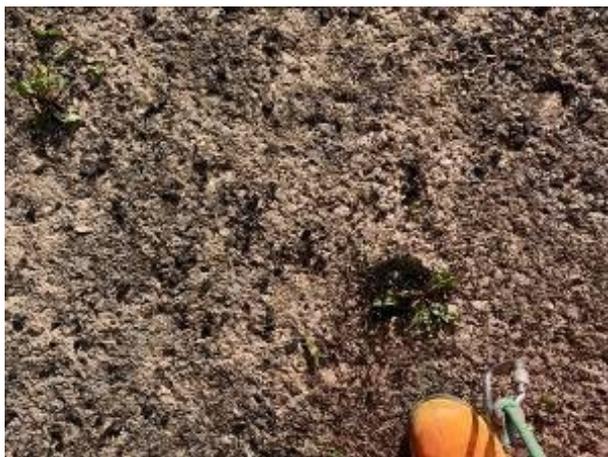
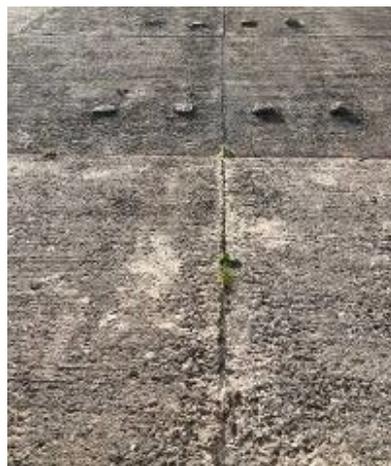
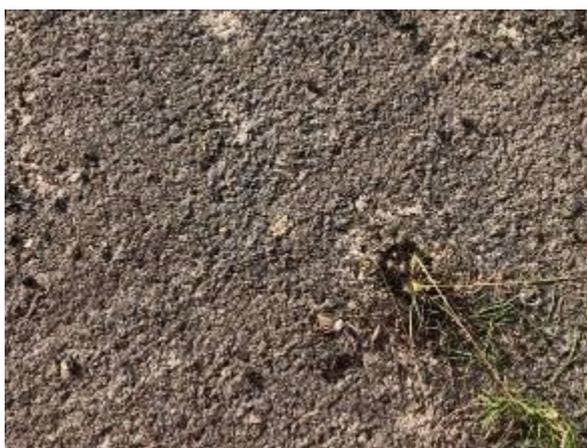
Relief wells were noted in some of the lower slabs. These seem to have been drilled sometime after construction of the spillway. However, these relief wells were seen to be obstructed either by root systems of saplings/coarse vegetation or by stones/ gravel and clearly had not been cleaned for many months/years.

Blocked relief wells

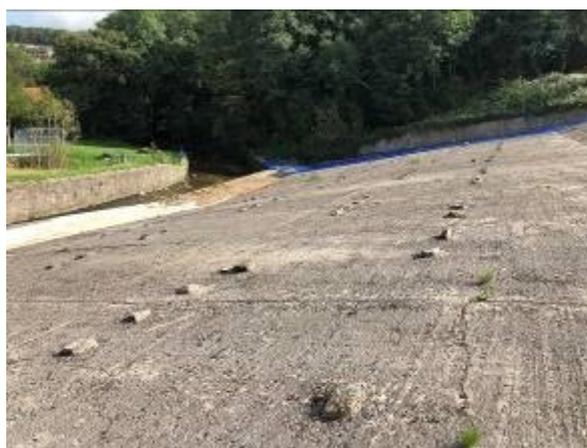
Variation of slope across spillway

The line and level of the slope, outside the area of damage was seen to vary across the slope and particularly in the lower part with the most uniform slope adjacent to the right-hand wall. The variation of slope in the lower part was probably as a result of relaxation of the construction tolerances to accommodate the merging of the spillway channel with the main overflow channel but some may have been due to movement of the slabs over time.

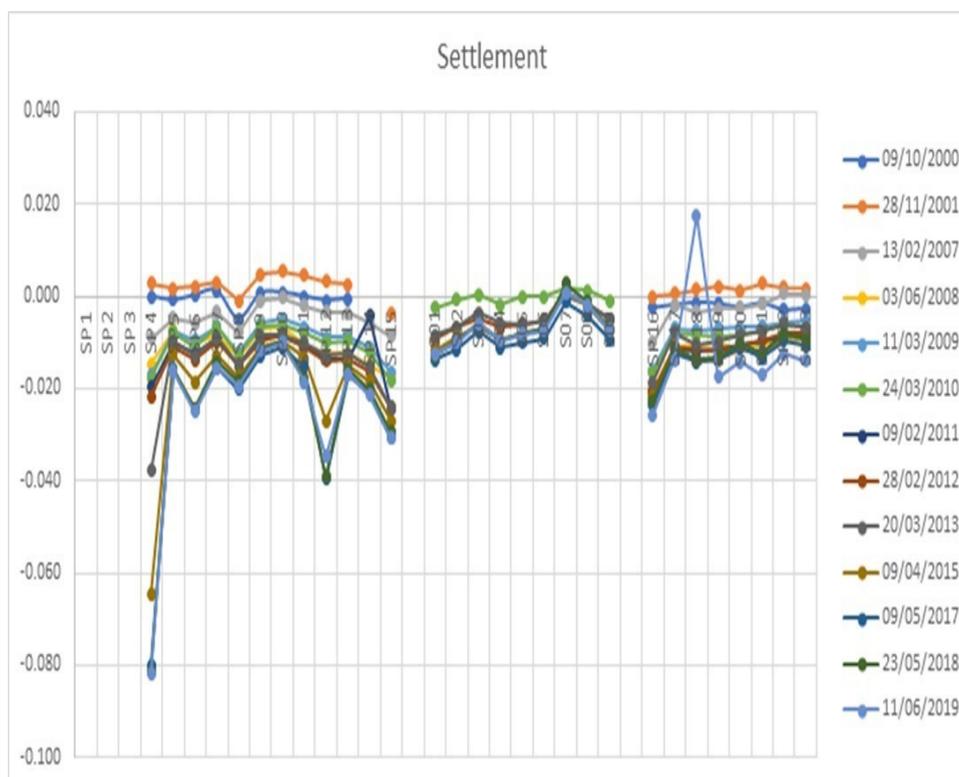
Level pins had been installed on the weir and levelled over the years. The results of the levelling exercise over a period of 19 years shows a settlement profile which confirms the left-hand end of the weir and slab to be some 12 – 13 mm lower than the right-hand end. The points in the middle of the plot below (S01 to S09) are on the auxiliary spillway and show the left-hand end to have settled more than the right-hand end.

Plot of level surveys

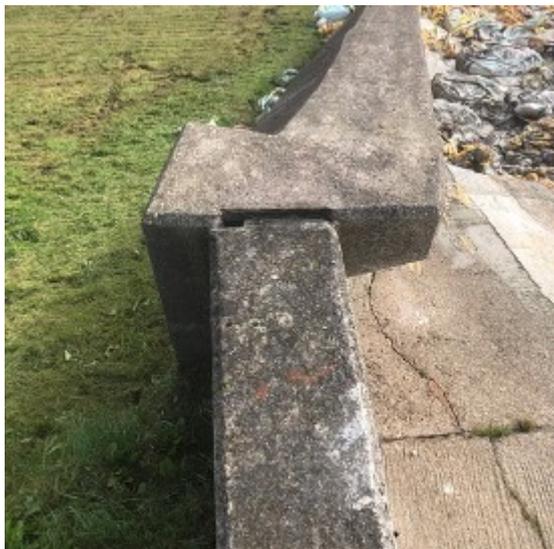
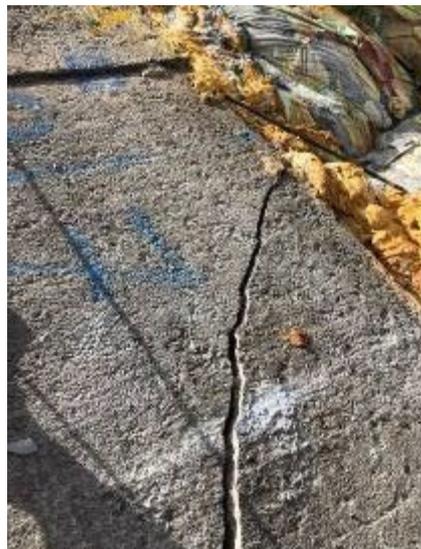
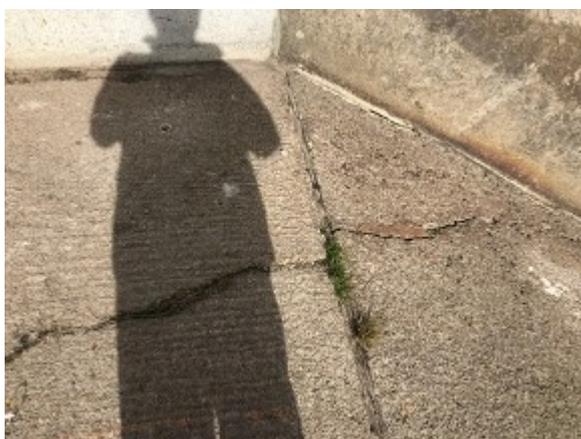
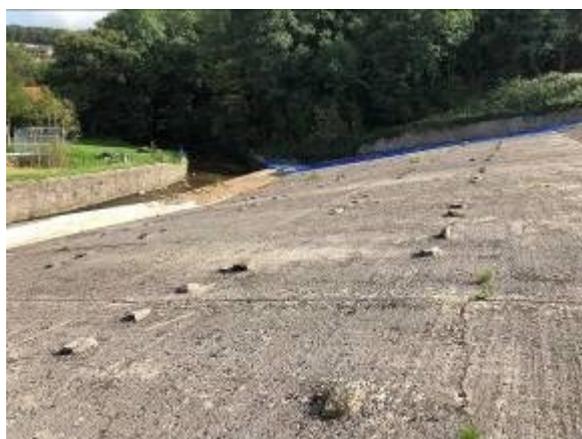
Crack to spillway

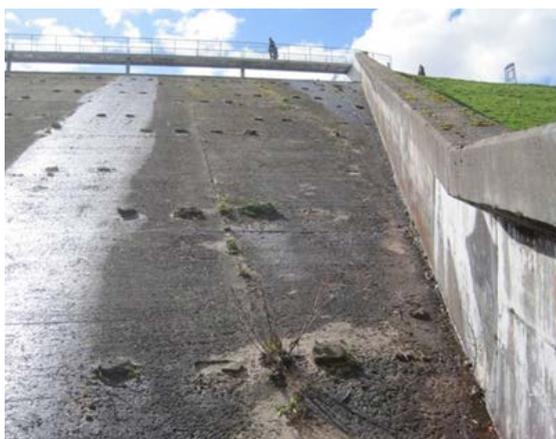
**Flow from the top
of the spillway**

The photographs above were taken in April 2019 by the SE at a time when the reservoir water level was at +0.07m and water was just topping the primary weir, so neither spillway was spilling but a significant amount of water was definitely passing beneath the auxiliary spillway weir slab. It was noted that there is very little vegetation in the joints/cracks. The water accumulating at the bottom is considered to have passed beneath the weir (there is no overflow), come out through a joint, and collected at the

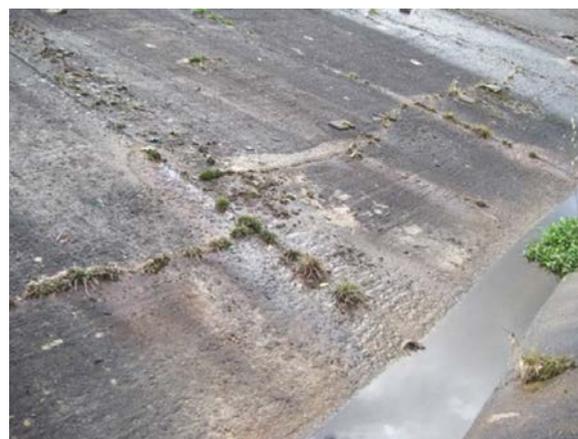
**Accumulated water at the base of the
spillway**

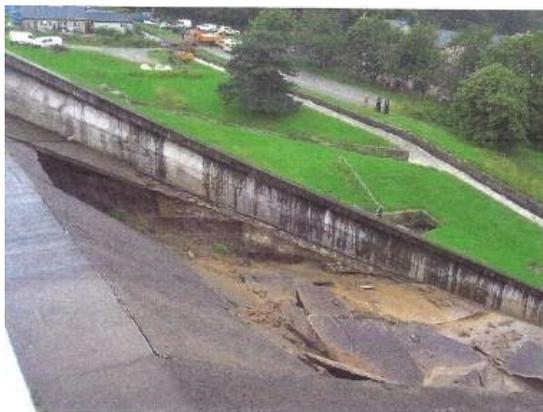
Shallow foundation to the left-hand wall

The shallow or non-existent foundation to the left-hand wall, coupled with the oblique orientation, could have led to a long term 'short-cut' for water that would be able to pass under the wall to emerge on the slope outside the wall.

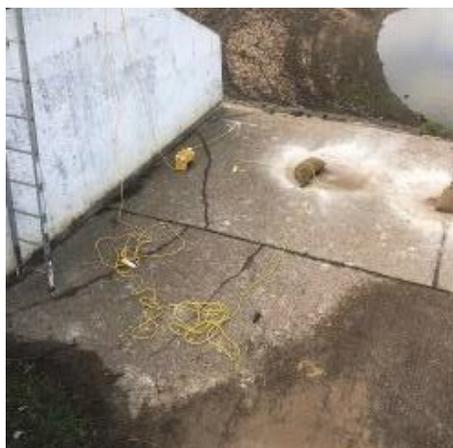
Cracking at extreme left end

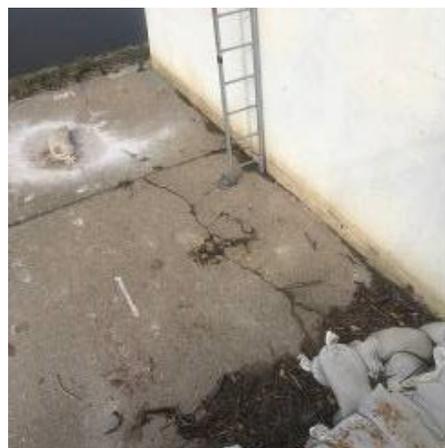
Increased cracking at left end

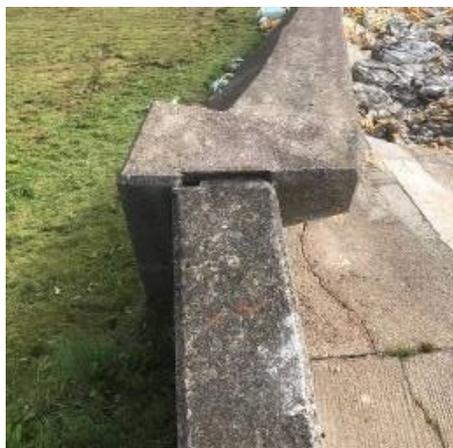
Movement between spillway and wall

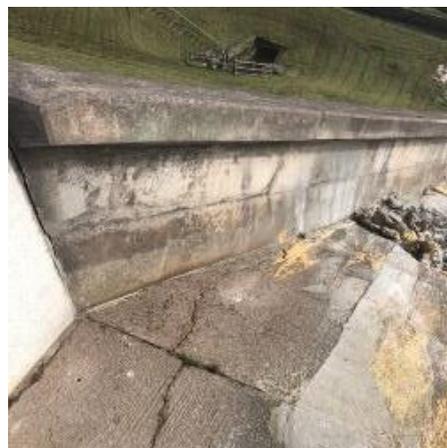
Movement between spillway and wall and cracking

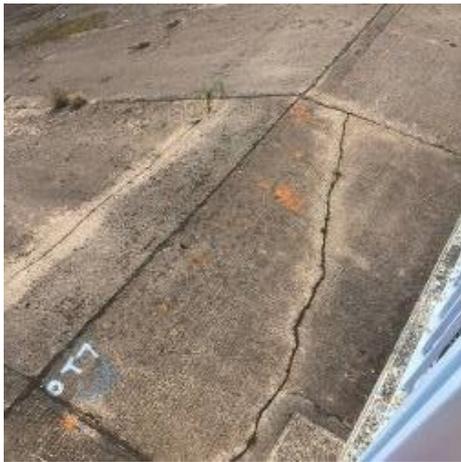
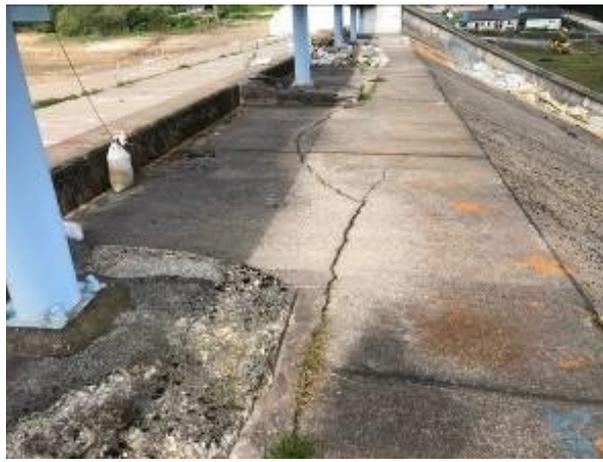
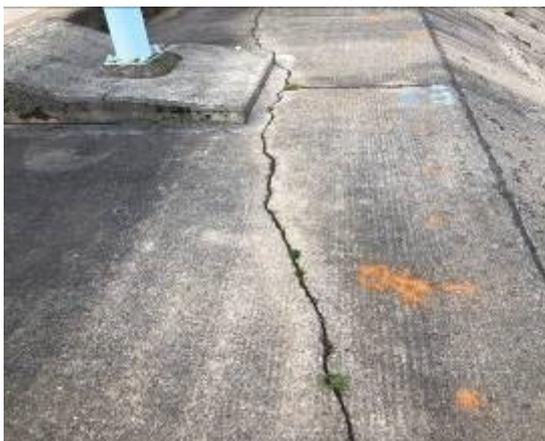
Longitudinal crack

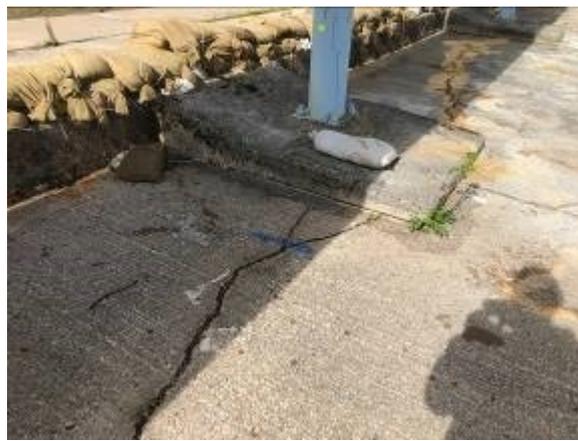
Cracking to crest

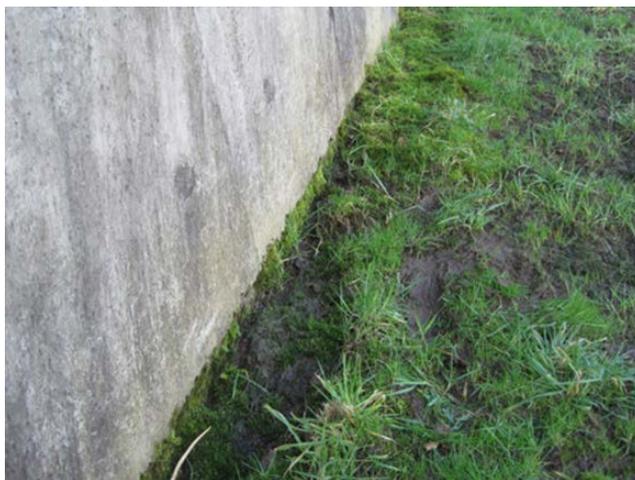
The photograph below, taken in February 2014, with the water level at +0.1m, shows the damp patches adjacent to the left side wall of the auxiliary spillway at the fourth joint down the spillway which is evidence of water getting under the slab and also passing under the wall where there is no foundation.

The damp patches pictured were located in the area of the hole that formed under the wall and the scour channel that formed during the 1st August event when water escaped from the side of the spillway.

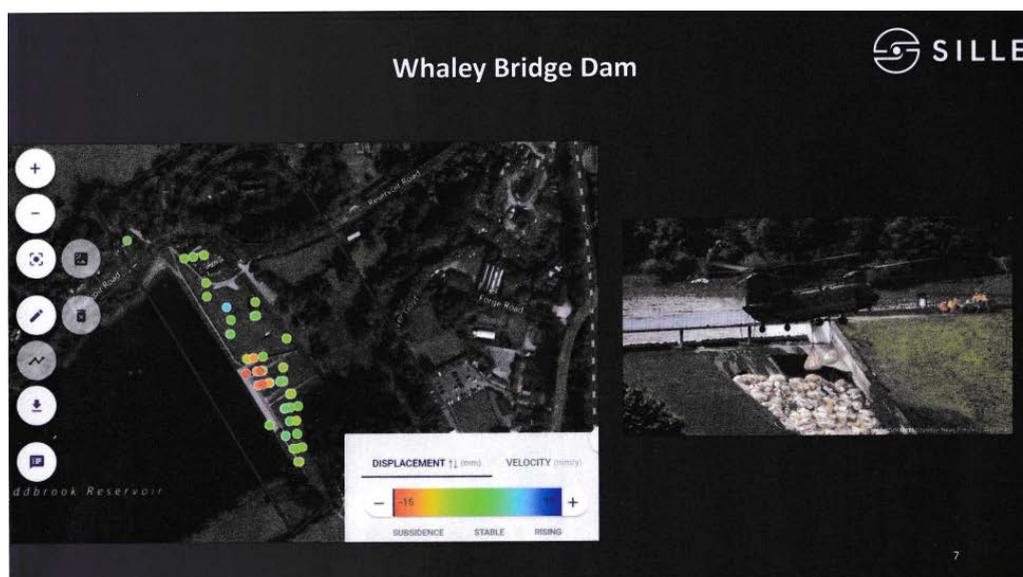
Survey points

In addition to the above, other evidence supporting a progressive failure has come to light from satellites of the Copernicus Project which is said to be able to detect movements of 1mm. The satellites called Sentinel 1A and IB provided information on a number of points on the auxiliary spillway over the last 18 months. The data shows, in the graph below, that there appears to have been a 30mm drop immediately downstream of the left-hand end of the spillway in mid/late July 2018 and also at a slab lower down on the left-hand side in January 2019. This would again suggest loss of support under the spillway long before the incident indicating that some fill had already been removed from beneath the slabs.

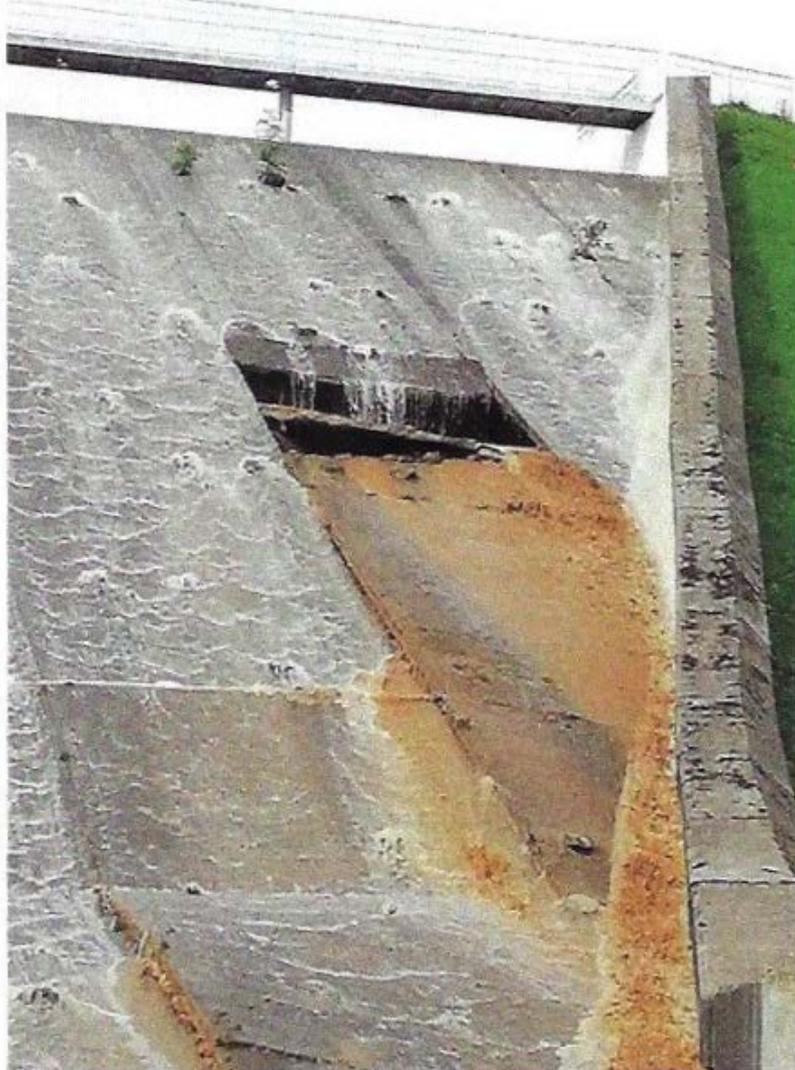
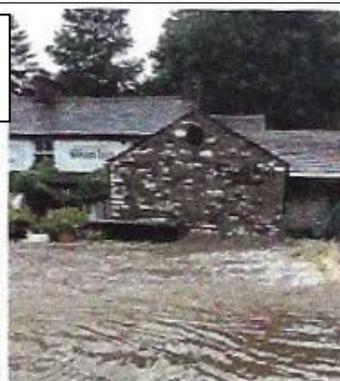
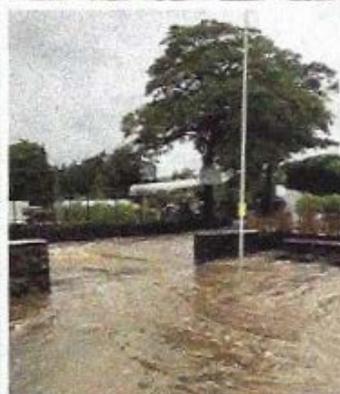
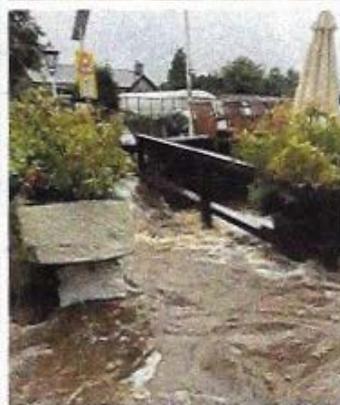
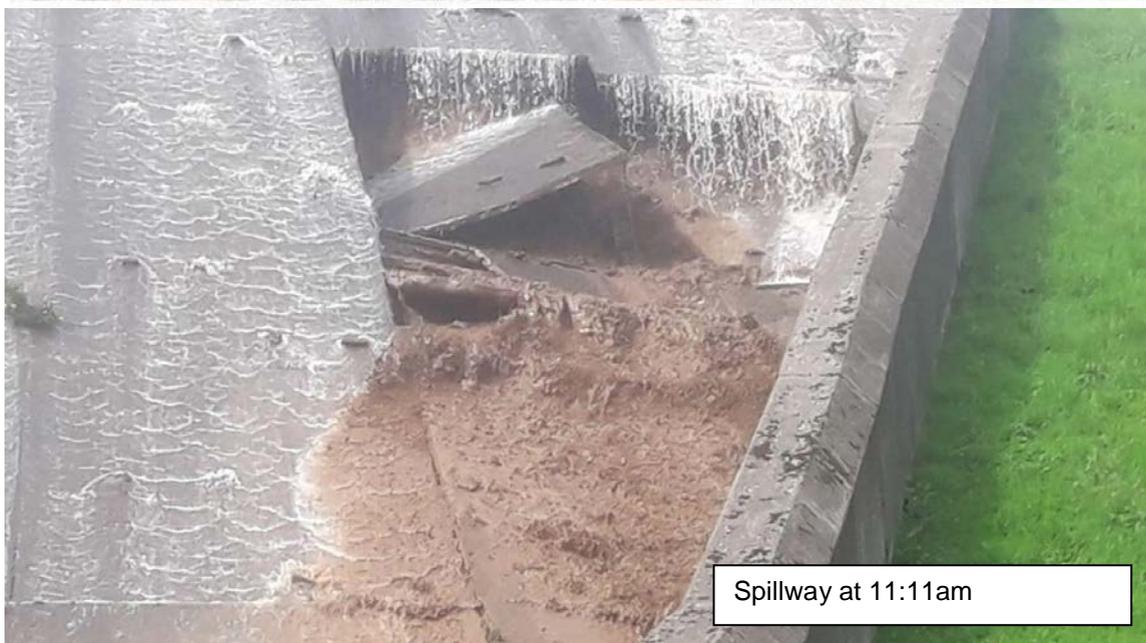
4

Pictures of flooding and Toddbrook Reservoir in Whaley Bridge
Initial lifting of lower slabs and failure of upper slab before 11am

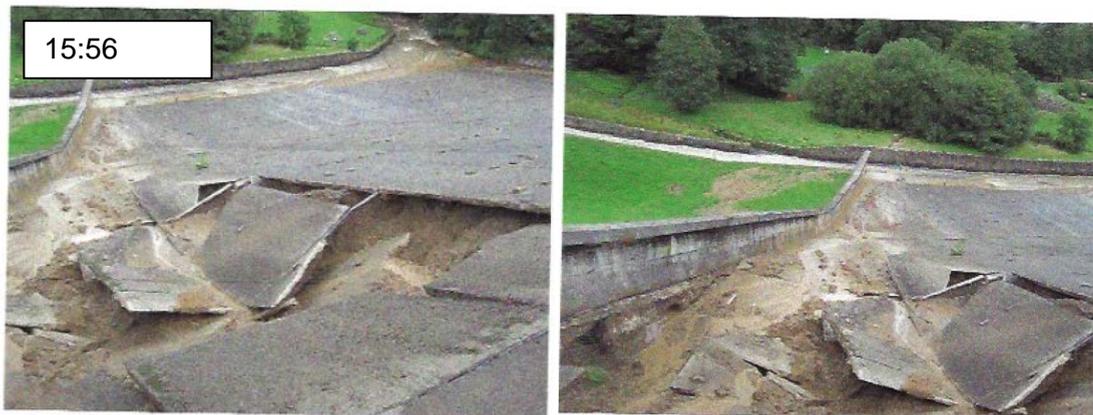
Slabs collapsed into enlarged void
