**Wern Reserve,
Coppice Lane – BS 5837:2012
Arboricultural Report, Impact
Assessment and Method
Statement**

Canal & River Trust

June 2023

Version: V4.0
Issue Date: June 2023
Report Ref: 21251

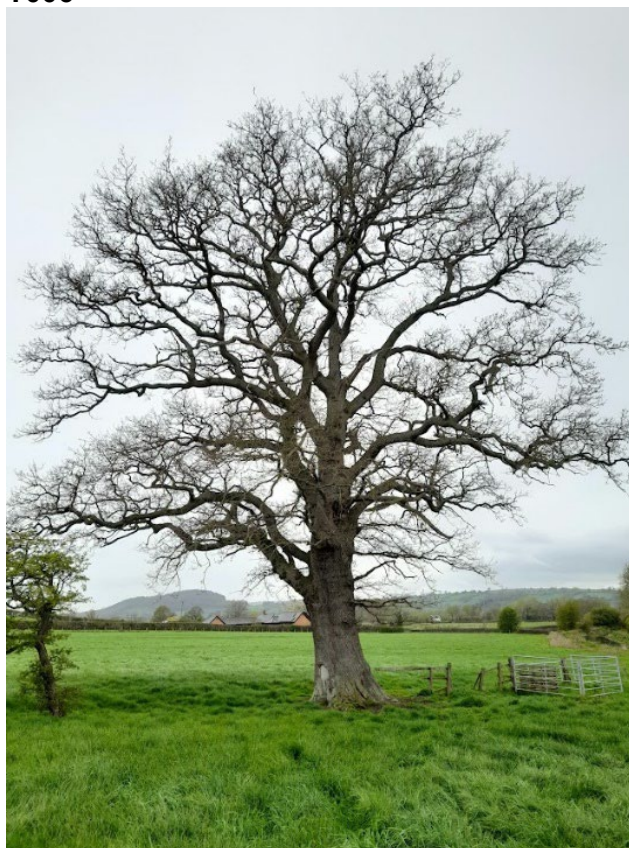
Plate 4: Looking west towards T012

| Tree No. | Species | Height (m) | No. of Stems | Stem Dia. @ 1.5m (mm) | Crown Spreads (m) | | | | Height of Crown Clearance (m) | Age Class | SLE | Overall Condition | Comments | Management | Category | RPA Radius (m) | RPA Area (m ²) |
|---|---|---|---|---|---|---|---|---|---|---|---|---|---|---|---|---|---|
| T012 | Pedunculate Oak (<i>Quercus robur</i>) | 27 | 1 | 1400 | 11 | 11 | 11 | 11 | 2 | Over Mature | 40+ Years | Good | Field boundary tree. Large deadwood in excess of 50mm in diameter. Provides excellent visual amenity / habitat, a notable specimen. Minor lower stem and exposed root surface damage. | No action required | A1 | 15 | 707 |

4.5.1 It is recommended that T012 and T009 remain fully protected by fence protection until the ground excavations are required around the periphery edge of the RPA. The works must be fully supervised by the project arboriculturalist. This approach will have minimum impact around the outer edges of the trees potential RPA, which overall is deemed to contain sufficient roots and rooting volume, therefore preserving the tree's long-term viability.

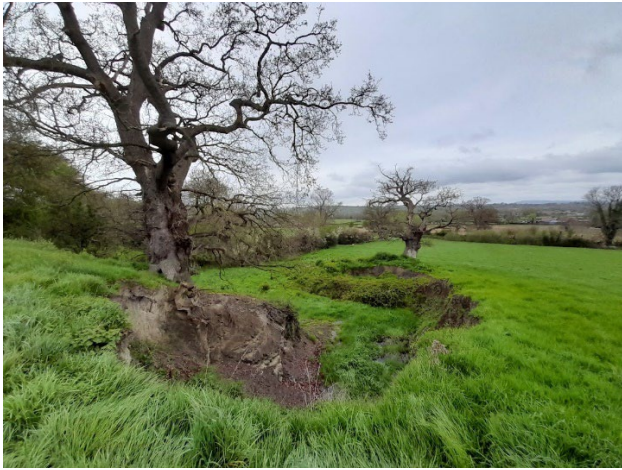
Plate 7: Historic ground excavations near T014.
