## Part 3: Managing, maintaining and restoring canals and rivers

## 3A: The cost of keeping canals in working condition

## Case study: Toddbrook Reservoir

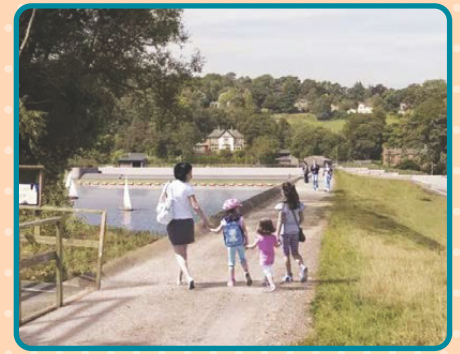
### Dams and spillways

- A dam controls the amount of water that flows out of a reservoir and protects the surrounding areas.
- A spillway is the part of a dam that releases water to prevent flooding.

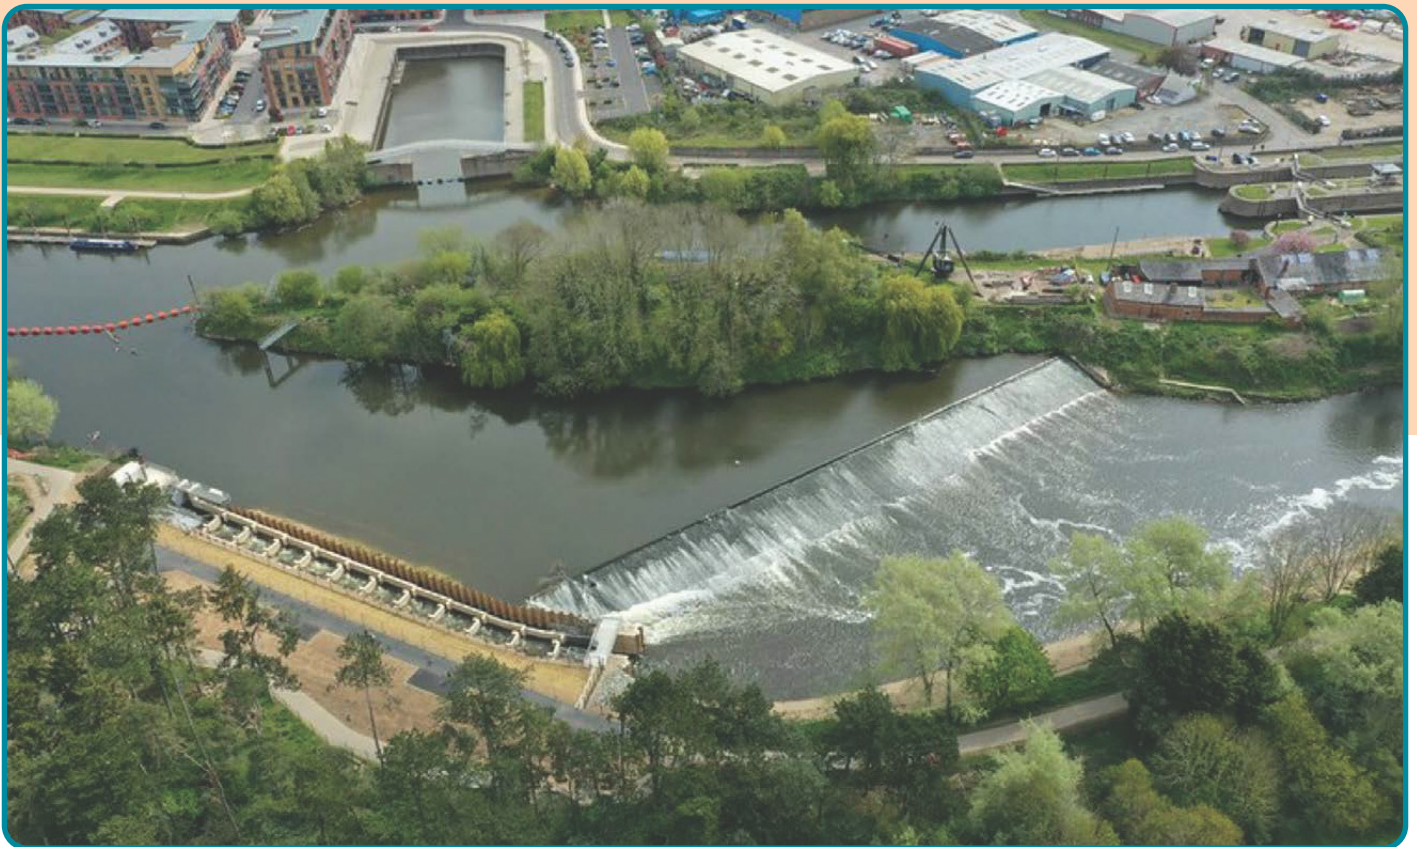
The weir at Diglis on the River Severn creates a barrier for fish. It is 2m high with a very steep surface, and the water flowing over the top moves very quickly, making it extremely difficult for fish to swim or jump over it. Fish species such as Shad need to migrate upstream, for spawning. If they are unable to reach breeding grounds this can lead to population decline.

A fish pass is a deep trench that is 100m long – the same length as a football pitch. It contains a series of pools. Each pool is slightly higher than the last, allowing the fish to gradually make their way up the height of the weir and swim off into the river upstream. The fish pass at Diglis has allowed thousands of Shad and other species of fish pass over the weir and helped to bring back natural ecology.
