Archaeological Desk-Based Assessment

**The Montgomery Canal:
Vyrnwy Reserve
Land Adjacent to the Montgomery Canal
Near Williams Bridge, Llandysilio, Powys**

February 2024 (Updated November 2024)

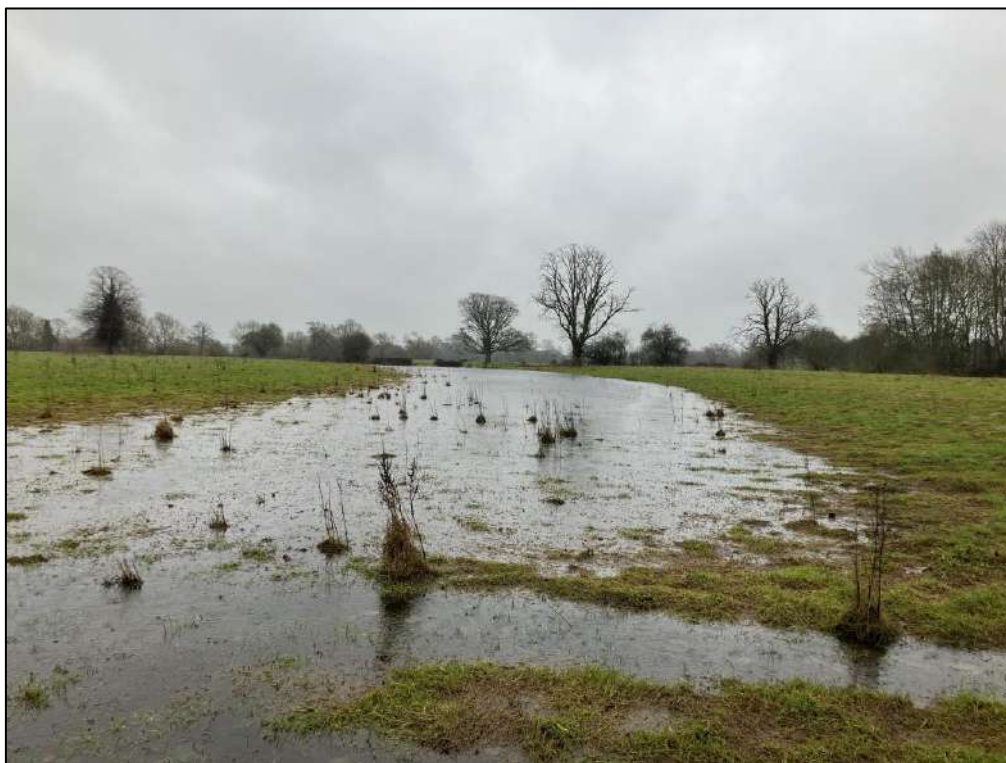
Plate 6: View looking NE at the flooded curved linear feature (2024)

During the 2024 site visit the potential ridge and furrow feature was much more visible, due to the short grass and flooding (*Plates 6-9*). It consists of a large reverse S shaped linear depression which cuts across the parkland in a SW/NE direction, before turning N towards the river. This feature was full of water due to the weather conditions, although it does not appear to reach the river, joining the hedgerow on the NE side of the site. It was not possible to ascertain the nature of this feature from the ground, and further work may be required in order to fully determine its origins.

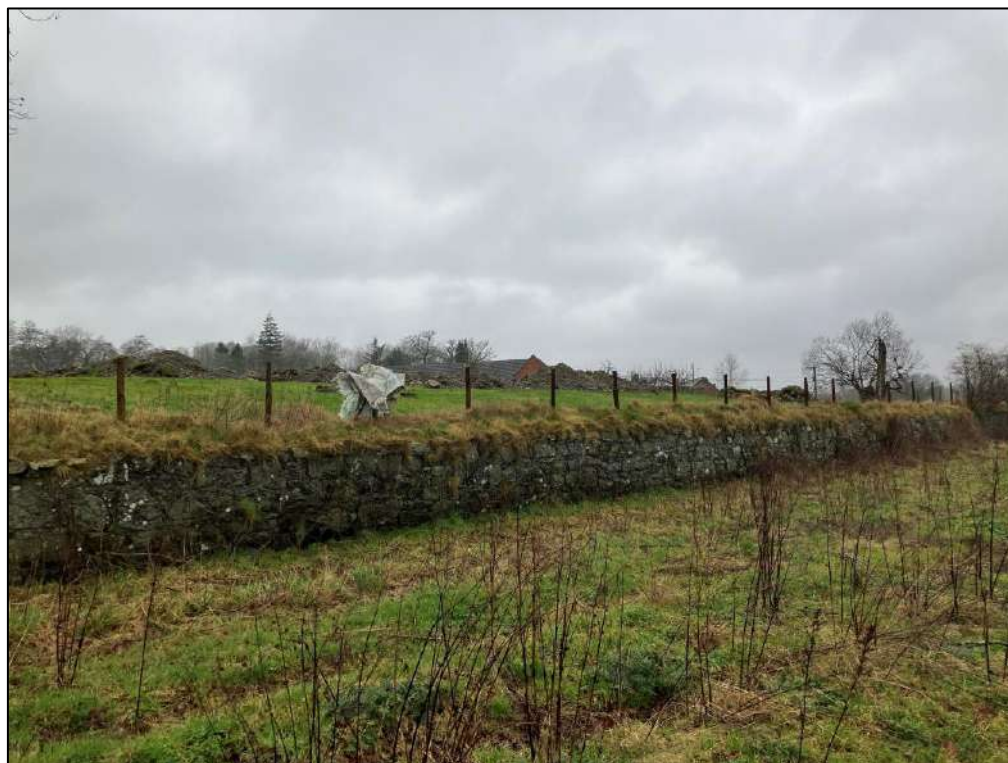
Plate 10: View looking SW at the wall feature on the S boundary of the site (2024)

The wall separating the lower parkland from the site of Pentreheylin Hall and its associated gardens was noted during the site visit (*Plates 10 & 11*). The wall appears to be a roughly coursed drystone wall, and may represent a revetment wall possibly associated with the raised lawned garden above. It appears to be of a 18th or 19th century date, and may form a surviving piece of the landscape of the Pentreheylin Hall parkland. A modern farm building was also noted on the E boundary of the site (*Plate 12*).

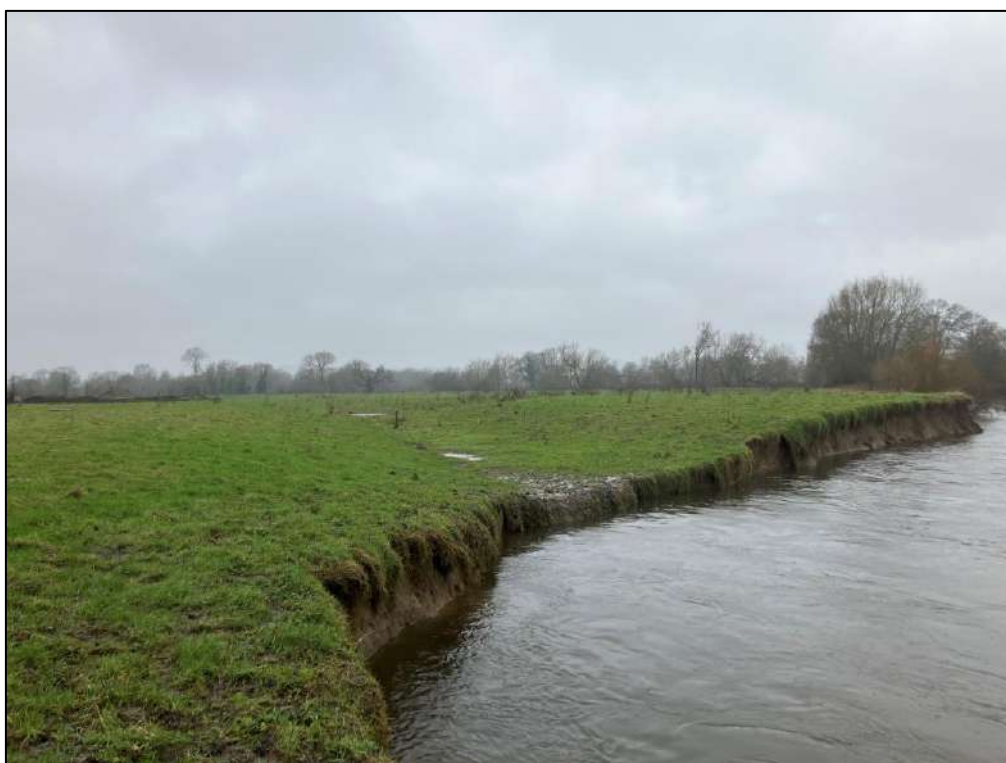
Plate 13: View looking WSW at the point where the leat/palaeochannel feature rejoins the river (2024)

On the N side of the site, the possible mill leat/palaeochannel feature was noted (*Plates 13-16*). This consisted of a shallow linear u-shaped depression running across the N portion of the site, cutting across a bend in the river. It was much more noticeable on its E edge, and is barely visible on its W edge. There is a clear point where it 'flows' back into the river, from a greater height on the river bank. No other features associated with a possible mill site were visible on the ground.

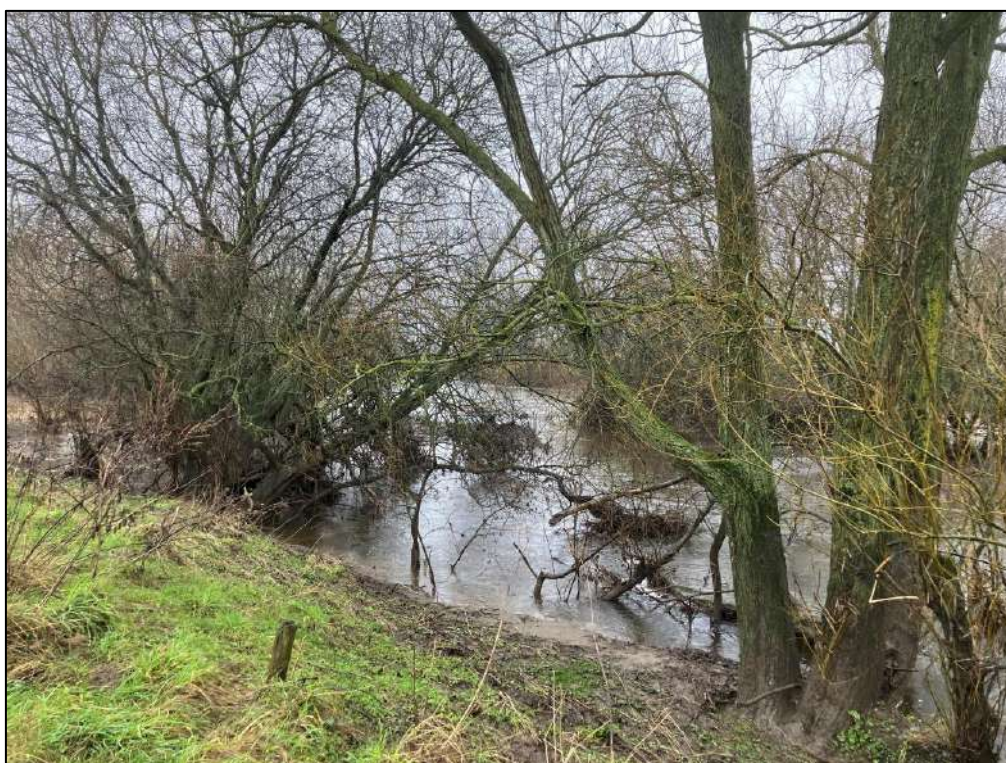
Plate 17: View looking N at an overgrown section of riverbank (2024)

The riverbank itself (*Plates 17 & 18*) is largely heavily overgrown, with small areas of shallows and trees dominating and masking the edge of the river. The exception to this is the area where the leat/palaeochannel rejoins the river, where the bank is cleared and considerably higher than the height of the river itself (which was relatively high on the day of the site visit due to the heavy rain).

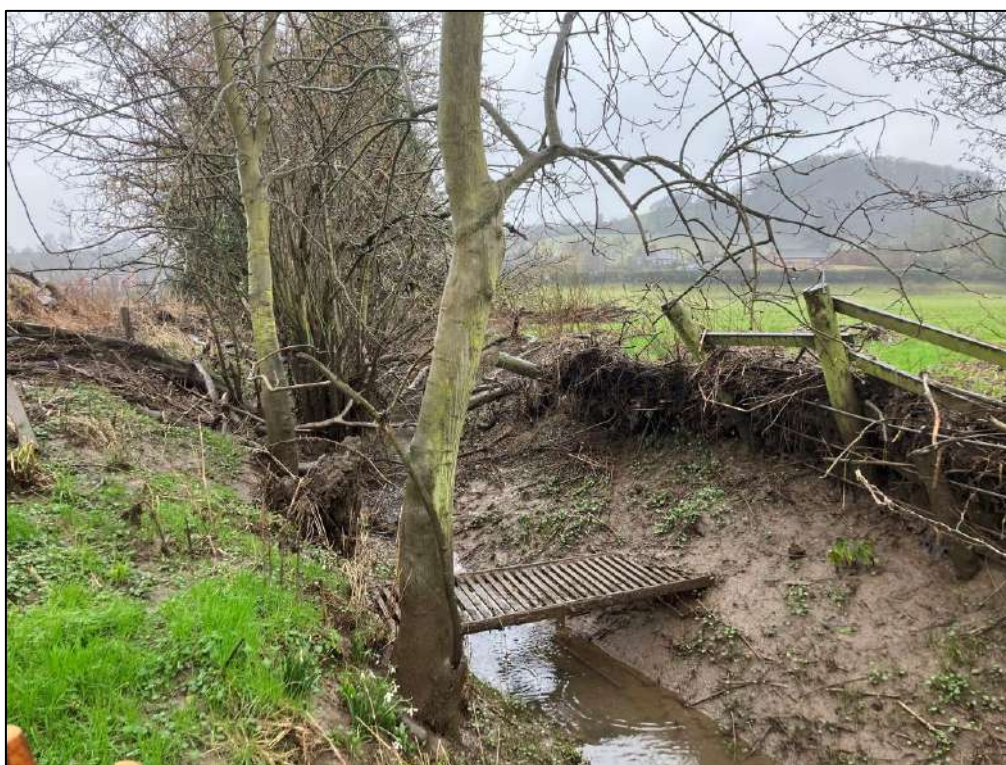
Plate 19: View looking SW at the drain running along the W boundary of the site (2024)

The site is separated on its S boundary from the line of the Montgomery Canal by a substantial mature hedge, and a well-established towpath. The post-medieval drain (*Plates 19 & 20*) on the W boundary of the site was also noted, and appeared to be actively draining excess water from the canal towards the river. Pentreheylin Farm itself consists of a collection of post-medieval farm buildings in varying states of repair. No trace of the former large house survives, within the area of garden to the E of the extant farm.

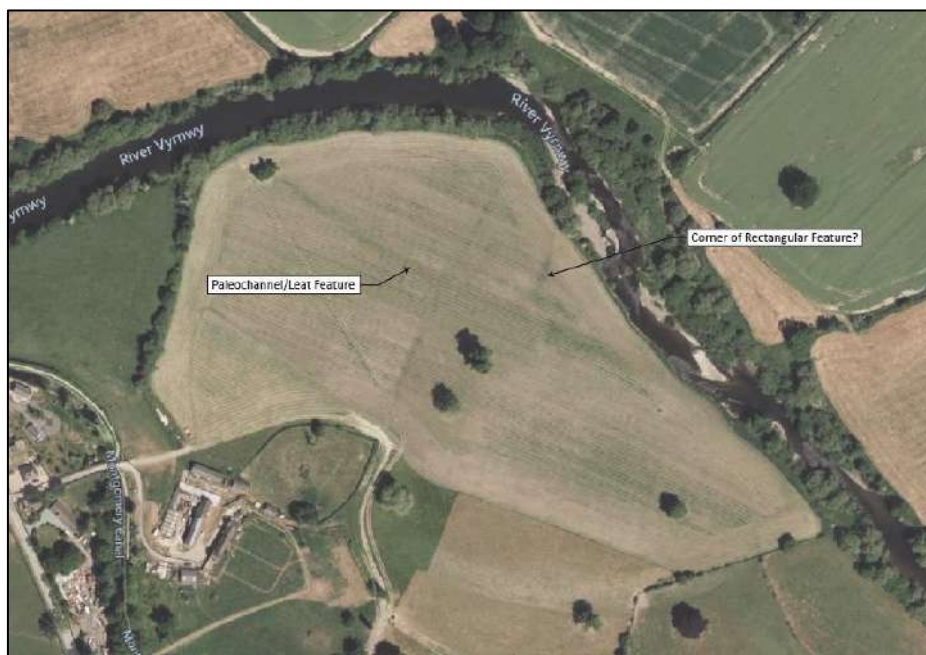
This potential palaeochannel/leat feature is also shown on available online aerial survey imagery, which record the site when conditions are conducive to the visibility of cropmarks (see *Fig. 11* as an example). On these images the line of the linear palaeochannel/leat feature is clearly visible running E/W across the northern portion of the site. Of note on these images as well is the corner of a possible small rectangular enclosure to the immediate N of the linear feature, which may provide an indication for a potential location for a mill structure, or possible associated enclosure.

*Fig. 11: Extract from available online aerial imagery, showing potential linear and rectangular features in the vicinity of the potential mill site
(Reproduced from Bing.com)*
