MONTGOMERY CANAL BUILT HERITAGE ASSESSMENT

RECOMMENDATIONS FOR HERITAGE REGISTER

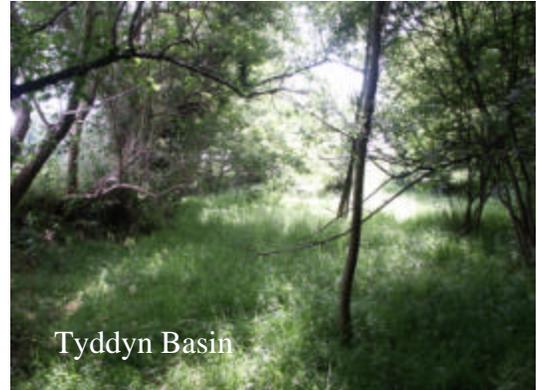
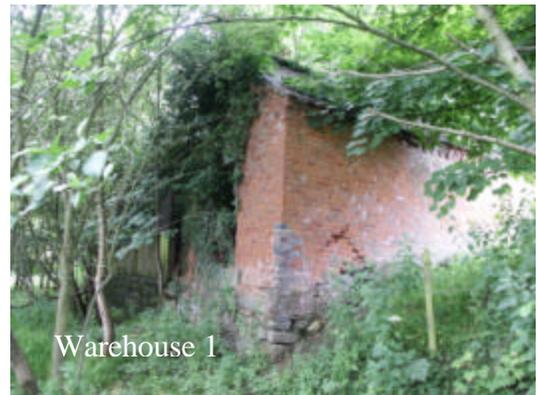
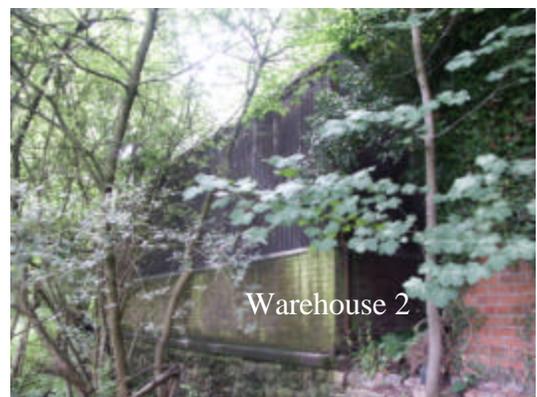
1 Tyddyn Basin and warehouses.

At the end of the Guilsfield arm. These items may not be BW property, but they are an intrinsic part of the canal. Tyddyn Basin was intended largely for the timber trade, which was a very significant element of the canal's business. No buildings or handling devices seem to have been provided at timber wharves. The sides of the basin are pitched with dry stone.

Warehouse 1, red brick with a slate roof, probably dates from the time of construction, c1797. There is a loading door at water level in the gable end.

Warehouse 2 has a blue brick base with corrugated iron cladding above. The roof is segmental arched, not pitched, the one of two examples of this amongst the surviving warehouses. Warehouse 2 is very similar to others built by the canal management in rural locations in the late C19.

The basin and warehouses are substantially intact, and are good examples of the canal's buildings and character.

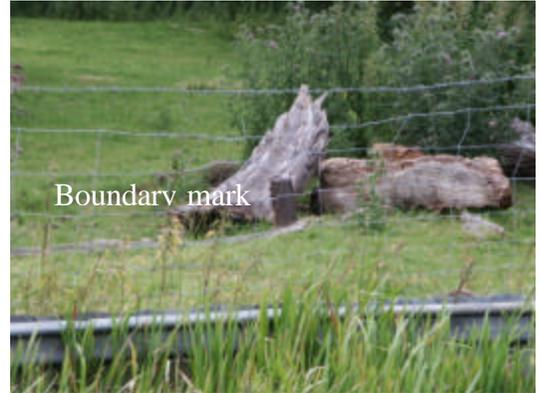
2 Boundary mark south of Brithdir aqueduct. Late C19 cast iron post marker, similar to the listed example at Wern. Should be included for the sake of completeness.

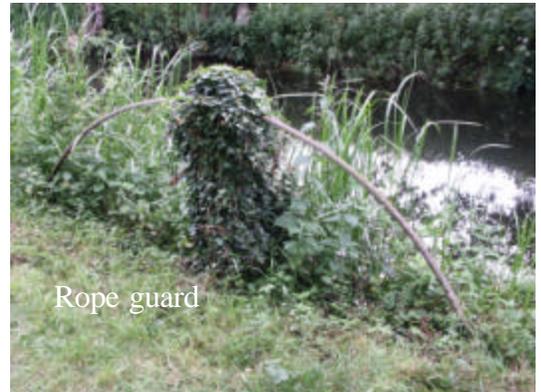
3 Rope guard near Abbey Lift Bridge. Wrought iron half-hoop, presumable intended to support the post and prevent ropes snagging on it. Similar to the device on the steps near the former inn at Frankton. Small working details of this kind are most valuable for maintaining the character of the canal.

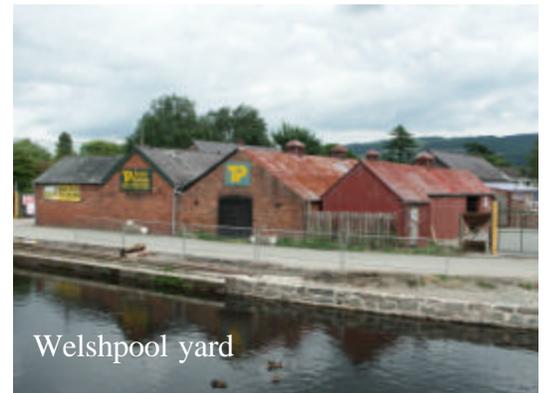
4 Welshpool maintenance yard. This complex is particularly important because so much of it survives, and it would be a key feature if a conservation area were designated around Welshpool wharf.

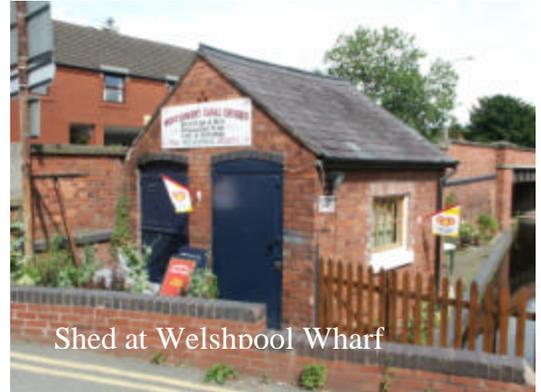
5 Office/stable at Welshpool wharf. This building at the wharf entrance from Severn Street, first appears on the 1885 edition of the OS map. Its style and materials suggest a date in the last quarter of the C19. It may have served a number of purposes, but the left door is certainly a stable type. As so many buildings around the wharf have been demolished, it is important even minor ones should now be retained.

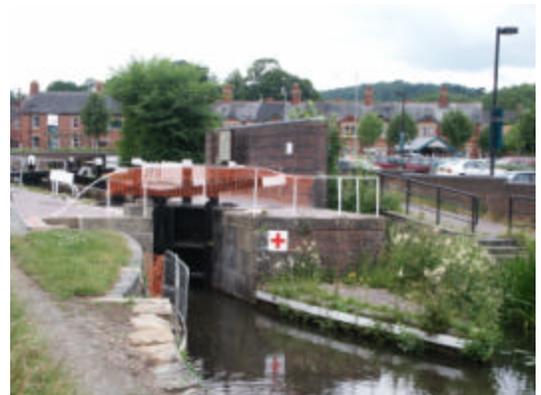
6 Welshpool mill remains. Although the mill remains are treated as one with the lock, the mill remains are of particular interest. The Montgomery canal was very unusual in supplying power water to several industrial sites, of which this is one. Its importance should be recognized.

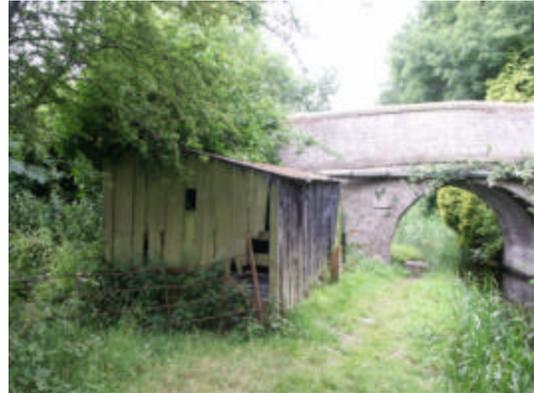
8 Shed north of bridge 137. This timber shed with corrugated iron roof is very similar to the recently restored example at Brithdir, and no doubt dates from the same period in the late C19. These minor buildings represent a particular phase in the canal's operation, and they should be recognized, particularly in view of their small numbers.

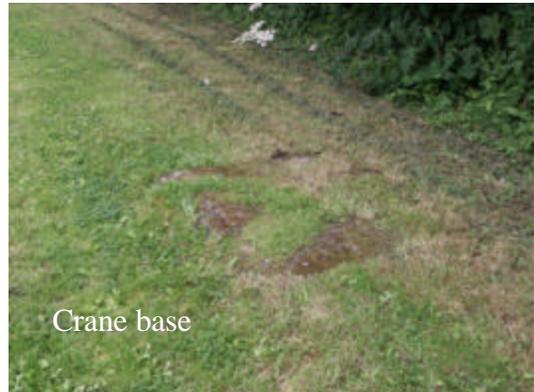
9 Crane base at Brithdir Lock. Stone block, recessed to fit cruciform cast iron base. Several crane bases remain along the canal, but this one is unusual in being sited alongside the lock chamber. This implies a very swift turnaround, or that there wasn't much traffic. It may date from the same time as the shed alongside it. Minor working details like this are important in preserving the canal's character as a working waterway.

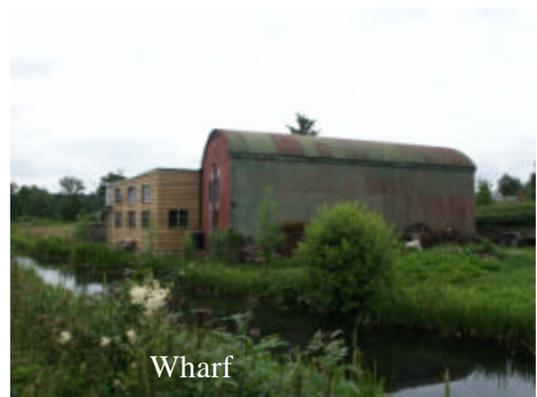
10 Wharf buildings south of bridge 128.

Without more research, it is not clear whether the corrugated iron building is part of the canal's own buildings, but it is likely that it is. This is a coal wharf with a few extra facilities. The canal had many minor wharves, and most of them have left little trace, so this example near Berriew is more important.

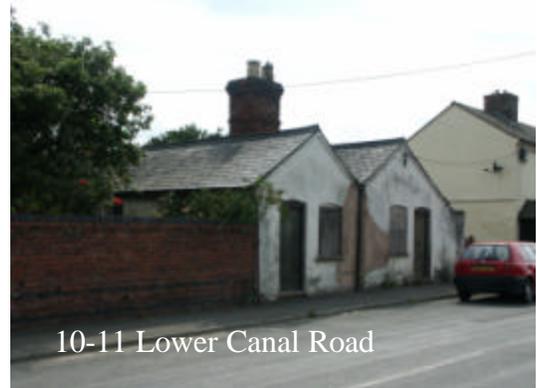
10-11 Lower Canal Road

11 Cottages and pumphouse at Newtown
These buildings are outside the area covered by the Built Heritage Survey. However, their importance in the history of the canal, and of Newtown itself, is

so great that they should at least be cross-referenced. They are a major remnant of built heritage, and should be considered as part of a comprehensive conservation masterplan. If this is not done, their isolation may lead to their significance being lost.
