Pocklington Canal

Conservation Management Plan

Report Title: Pocklington Canal – Conservation Management Plan

Revision: v1.1
Issue Date: 02/12/15
Report Ref: 5481_PCCMP_v1.1

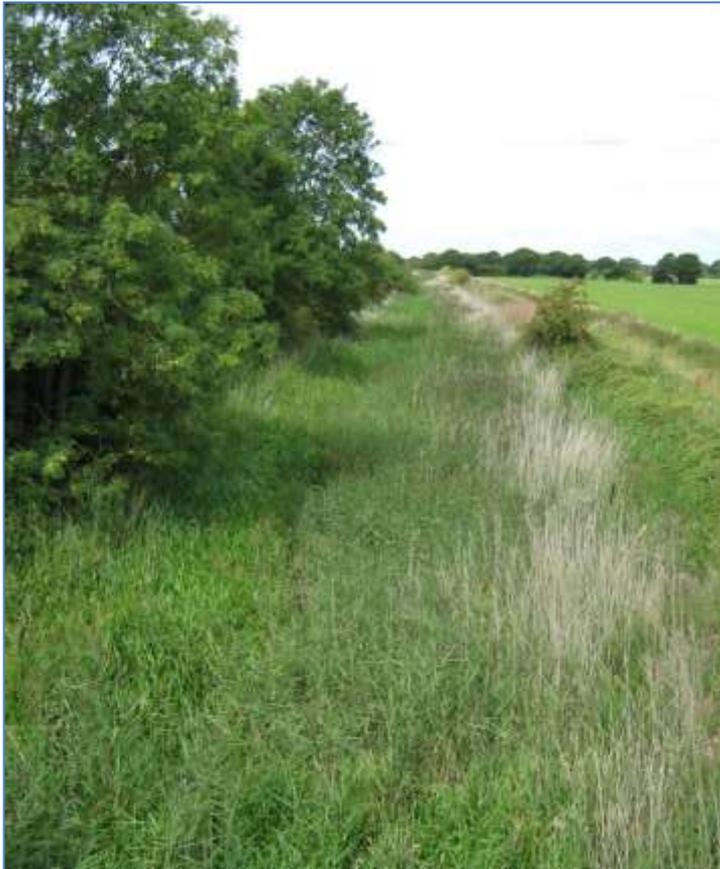
- 2.8.15 In addition to shading, Goulder (2014) also drew attention to trends in succession taking place within the Canal, with areas of previously open water now becoming colonised by emergent species. Although a valuable component of the community, if left unchecked emergent species can outcompete the truly aquatic plants. This is particularly apparent in stretches of the Canal downstream of Walbut Lock (**Plate 52**).

Plate 52: Emergent vegetation (Common Reed) dominating channel in Walbut Lock to Thornton Lock section.

- 2.8.16 This section has historically supported some of the most diverse plant communities on the Canal, however in recent years this stretch of the Canal has become dominated by common reed (*Phragmites australis*). These observations are illustrated by **Plate 50**. This is not the only section of canal experiencing this problem and it is considered that successional trends are a significant threat to plant diversity in the non-navigable section.

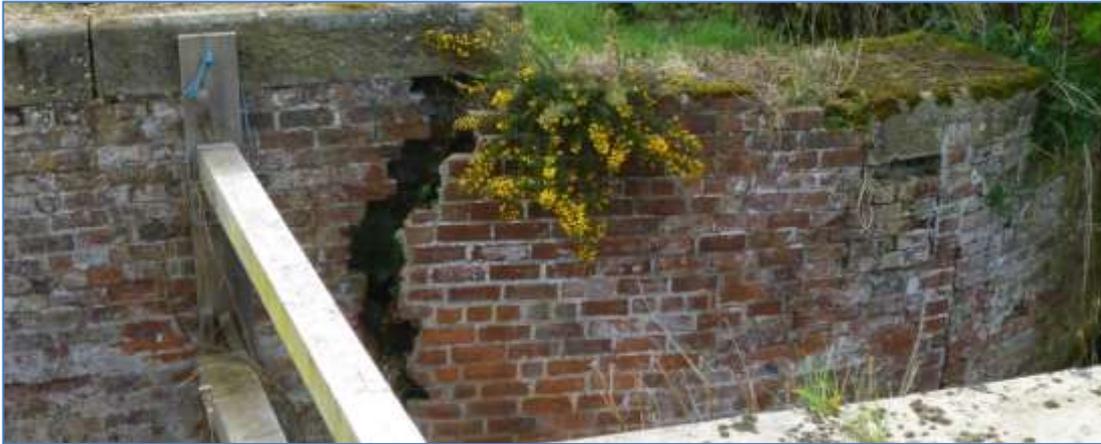
Plate 60: Collapse occurring at Sandhill Lock (HA 8)

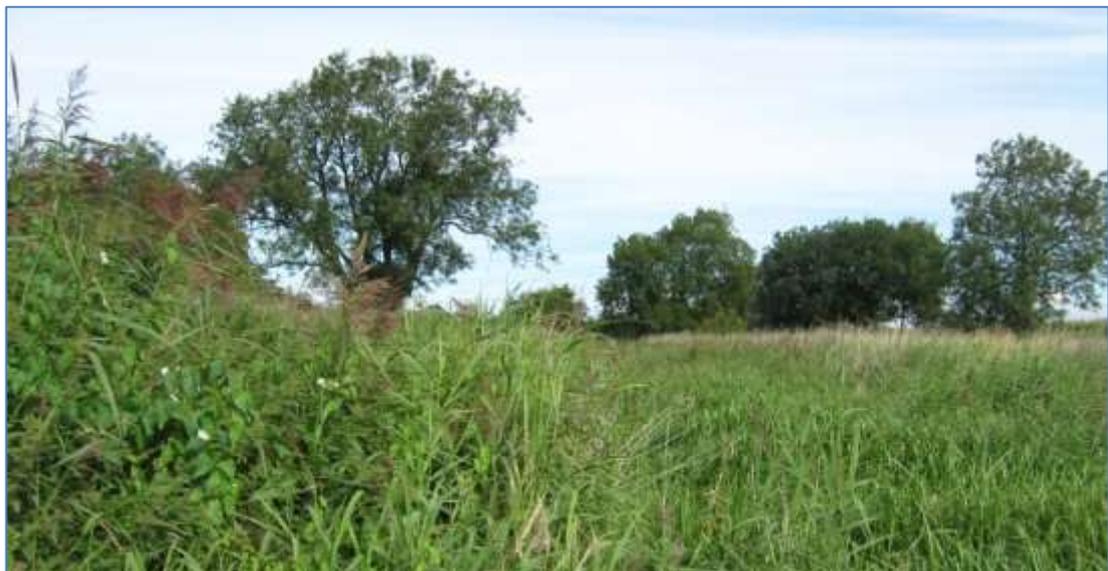
- 4.2.15 Goulder (2014) identified the significant impact succession was having on the aquatic plant communities within the non-navigable section of the Canal. As stated previously an increasing dominance of emergent species is leading to the loss of many of the less robust and truly aquatic plant species and a decline in aquatic plant diversity overall.
- 4.2.16 Loss of open water and habitat diversity may also be impacting the abundance of dragonflies and other aquatic invertebrates.
- 4.2.17 If left unchecked reeds and rushes and then trees would eventually extend over the whole area of the Canal (**Plate 62**). In extreme situations silt and decaying vegetation would build up resulting in the loss of open water and the Canal eventually drying up.

Plate 62: Common reed completely dominating the Canal channel (Natural England)

- 4.2.18 It is important active management occurs to maintain the biodiversity of the Canal and retain open water and habitat diversity. Limited works to reverse succession have been undertaken in 2014 with the removal of in-channel vegetation between Canal Head and Silburn Lock and upstream of Thornton Lock. However, further management works are urgently required in order to maintain the Canals status as one of the most important in the Country for the plant and invertebrate communities it supports.

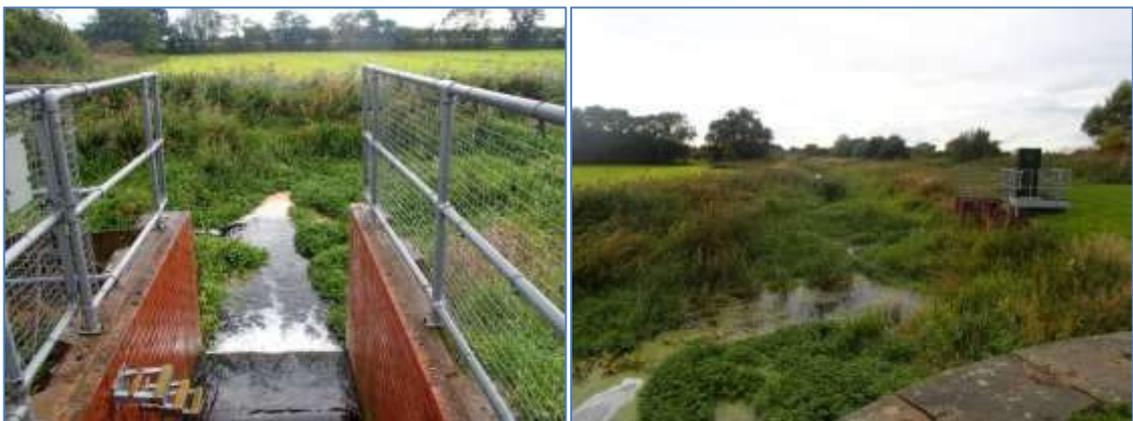
Plates 63-64: The Thornton Feeder

- 4.2.25 There are two main feeders of the Canal, one at Canal Head and one at Thornton Lock (**Plates 63 & 64**). The Jacobs report highlighted sedimentation and diffuse pollution to the Pocklington & Bielby Beck which provides water for the Canal from agricultural land both upstream of Canal Head and in the fields surrounding the upper reaches of the Canal as probable causes of water quality problems. This has also been identified in the Diffuse Water Pollution Plan for the River Derwent SSSI and Pocklington Canal SSSI (Environment Agency/Natural England 2013).

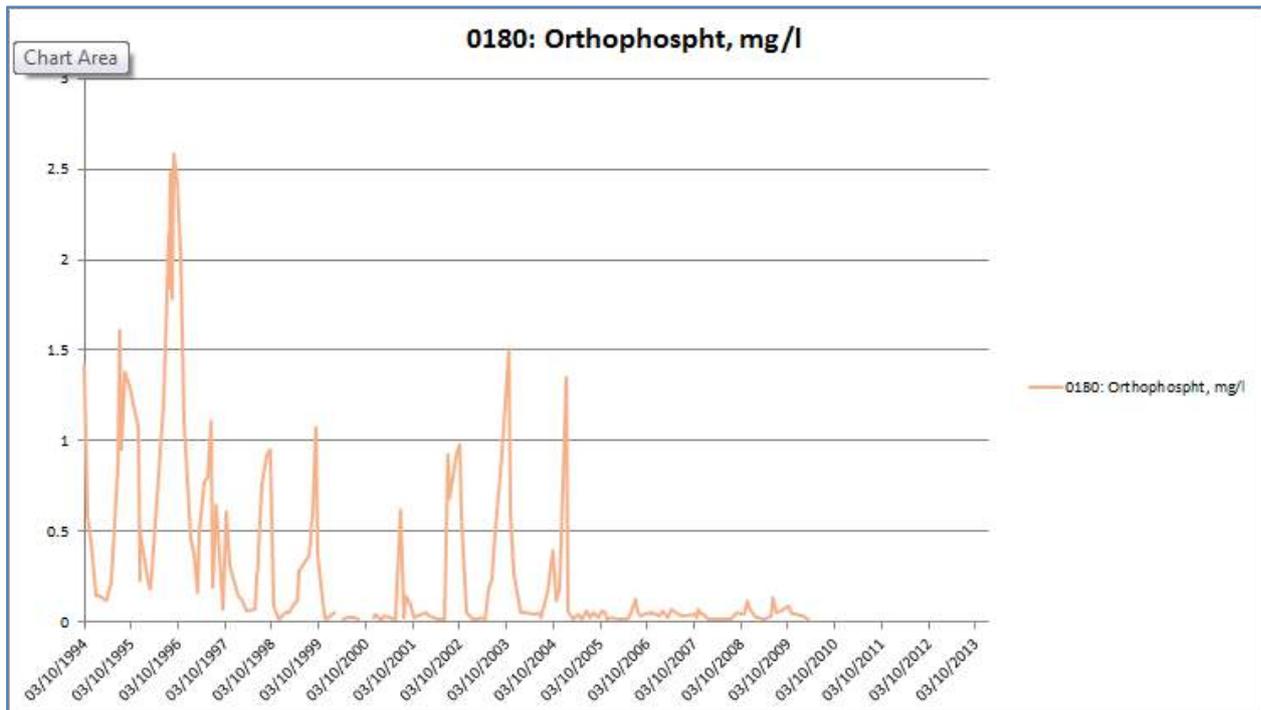
Plate 65: Environment Agency water quality monitoring data from Hagg Bridge

4.2.28 The Thornton Lock feeder receives water from the Pocklington/Bielby Beck. The Pocklington Sewage Treatment works discharges into the Pocklington/Bielby Beck and although downstream of the Canal Head feeder, this discharge historically resulted in elevated levels of phosphates entering the Canal at Thornton. The introduction of Phosphate stripping through a tertiary treatment process at the Works in 2005 however resulted in a significant reduction in phosphates entering the Canal. This is clearly demonstrated by Environment Agency water quality monitoring data from Hagg Bridge (**Plate 65**).

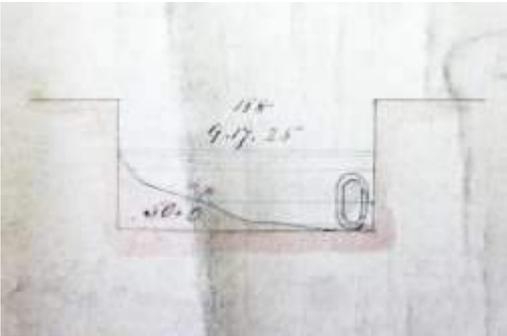
Pocklington Canal: Pocklington Beck Feeder Culvert		Heritage Asset	1

Statutory Designations:	Grade II Listed Building (part)	
	Monument Type:	Culvert	
	NGR:	480025 447359	
	Location:	Canal Head, near Pocklington	
Description:	<p>A culvert which feeds the Canal from Pocklington Beck. The culvert is documented in 1859 (see picture) as comprising an elliptical, likely brick built, structure. The route of the culvert historically led off of the tail race of the water management system associated with a former bone mill situated to the north of the York to Hull road.</p> <p>The culvert forms joins the Grade II Listed Building of Pocklington Canal Top Lock and Canal Head.</p>		
Heritage Value:	The culvert has local to regional evidential and historic value.		
Survival:	Unknown		
Condition:	Unknown		
Vulnerability:	Deterioration, water damage, vegetation, blockage.		
Trend:	Unknown

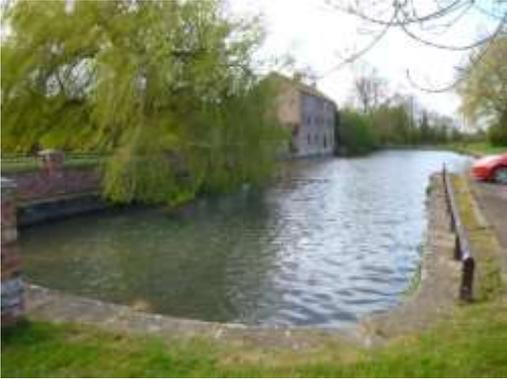
Statutory Designations:	Grade II Listed Building	
	Monument Type:	Canal Head	
	NGR:	479971 447294	
	Location:	South of Canal Head, near Pocklington.	
Description:	<p>The head of Pocklington Canal, constructed in red brick with ashlar coping stones and slots for vertically set timber bumping pieces. The structure of the Canal head comprises recessed bays on the eastern and western side and a narrowed bay at the northern terminus which likely functioned as winding hole. The wharf to the west was likely let for use by private companies, whilst that to the east was a public wharf operated initially by the wharfinger Thomas Johnson.</p> <p>The culvert joins the Grade II Listed Building of Pocklington Canal Top Lock and Canal Head.</p> <p><i>Element 1.1</i> Cast iron ring cleats (three in total) are located along the northern side of the Canal basin.</p> <p><i>Element 1.2</i> The PCAS Information Centre comprises a small red brick built structure with pitched tiled roof. The building has a door and shuttered window situated in its southern elevation. The building appears to be of nineteenth century origin, but is not depicted on historic Ordnance Survey maps. It is, however, situated in the vicinity of Denison’s warehouse and granary and may represent a surviving fragment of this complex.</p> <p>Further archaeological remains associated with the early wharf buildings may survive to its southwest.</p> <p><i>Element 1.3</i> The site of a former wharf warehouse built for Robert Dennison in 1834 lies within the vicinity of the current picnic area. Slight undulations in ground levels in this area indicate that there may be archaeological remains relating to this structure.</p> <p><i>Element 1.4</i> To the east of the Canal is a three storey brick built warehouse with pitched pantiled roof. The building has been renovated as a dwelling and is believed to comprise the first warehouse constructed in 1818 by Thomas Johnson. There are numerous irregularly spaced windows across the west elevation including one larger opening which may represent an original loading door.</p>

Pocklington Canal: Canal Head		Heritage Asset	2
	wharf buildings which would be of local archaeological value.		
Survival:	Good.		
Condition:	Good.		
Vulnerability:	Deterioration, plant growth and water damage.		
Trend:	Stable.

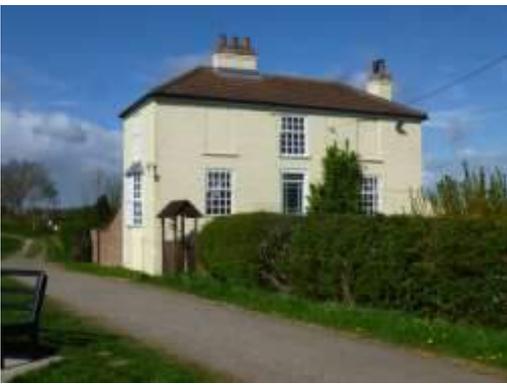
Pocklington Canal: Lock Keeper's Cottage		Heritage Asset	3

Statutory Designations:	No statutory designations.	
	Monument Type:	Building	
	NGR:	479849 447199	
	Location:	Canal Head.	
Description:	Brick built, two-storey cottage, rendered and painted. The building has a hipped red clay, pantile roof and small paned sash windows. The building is situated in a small garden the gate post to which is possibly made from a reused lock balance beam or paddle gear stanchion. A canted bay window overlooks the Canal. The Lock House is currently in private ownership.		
Heritage Value:	The building is of local-regional aesthetic and historic value.		
Survival:	Good.		
Condition:	Good.		
Vulnerability:	Removal of historic material, plant growth.		
Trend:	Stable

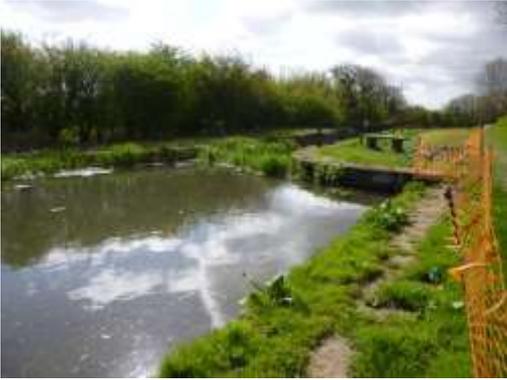
Statutory Designations:	Grade II Listed Building.	
	Monument Type:	Lock	
	NGR:	479733 446815	
	Location:	South of Top Lock (HA 38).	
Description:	<p>Constructed in 1817-1818. In very bad condition. The lock gates have been removed and there is significant damage to the brick and stone work. There is general erosion of the stonework and ashlar is missing from the side walls. There are no lock gates or other operational features left in-situ.</p> <p><i>Element 5.1</i> The top lock no longer has its lock gates. Reeds and vegetation has become established and this is loosening the stone work. The anchor collar and wrought iron brace from the former ground paddle gear survive on the south side.</p> <p><i>Element 5.2</i> There lock chamber and splayed wing walls are constructed of red brick with ashlar stone coping stepped where the lower wing walls slope down. The brick work is suffering from substantial water damage. Ivy growth is causing damage to the top edge of the chamber.</p> <p><i>Element 5.3</i> The lock gates and associated infrastructure of the bottom lock has been removed. Vegetation has become established.</p> <p><i>Element 5.4</i> The bywash remains, however the condition is unknown but water no longer flows through it due to the absence of the lock gates. The upper weir comprises low rectangular openings, whilst the lower outfall is from a brick arched opening.</p>

Pocklington Canal: Silburn Lock No.8		Heritage Asset	5
Condition:	Poor – There is vegetation becoming established in the cill, elevations of the canal chamber and wing walls of the lock. This vegetation is loosening the stone and brick work which will eventually result in structural damage. Due to the retention of the lock chamber out of water, damage from freezing and general water penetration is occurring at a low level within the chamber leading to significant risks of collapse of the above structure.		
Vulnerability:	Deterioration, plant growth, water damage, erosion		
Trend:	Decline.

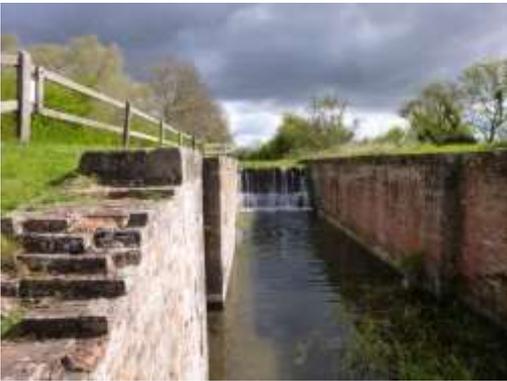
Statutory Designations:	Grade II Listed Building.	
	Monument Type:	Lock	
	NGR:	479515 446348	
	Location:	North of Toft Farmhouse.	
Description:	A brick and ashlar constructed lock. The lock chamber has been previously partially rebuilt and the majority of operational workings have been removed.		
<i>Element 6.1</i>	The top lock no longer has its lock gates. Reeds and vegetation has become established and this is loosening the stone work. The anchor collar and rising lever from the ground paddle survive to the south.		
<i>Element 6.2</i>	There lock chamber and splayed wing walls are constructed of red brick with ashlar stone coping stepped where the lower wing walls slope down. A number of the ashlar coping stones are missing. The interior of the chamber has largely been altered. In some locations leaded staples hold the ashlar stone coping together. There are partially blocked full height slots built into the chamber wall which would have held bumping pieces. The brick work is in very poor condition, suffering from substantial water damage, is missing in a number of locations and vegetation has become well established.

<i>Element 6.3</i>	The lock gates and associated infrastructure of the bottom lock has been removed. Vegetation has become established.

Pocklington Canal: Giles Lock No.7		Heritage Asset	6
<i>Element 6.4</i>	The bywash remains, however the condition is unknown but water no longer flows through it due to the absence of the lock gates. The upper weir comprises low rectangular openings, whilst the lower outfall is from a brick arched opening.		
Heritage Value:	The lock is of national aesthetic and historic value.		
Survival:	Poor.		
Condition:	Poor –Vegetation growth is loosening stone and brick work. The brick work of the canal chamber is in very poor condition and suffering from water damage similar to at Silburn Lock. This and the damage caused to the structural integrity by the loss of masonry and brick has resulted in some structural instability.		
Vulnerability:	Deterioration, plant growth, water damage, erosion, collapse		
Trend:	Decline.

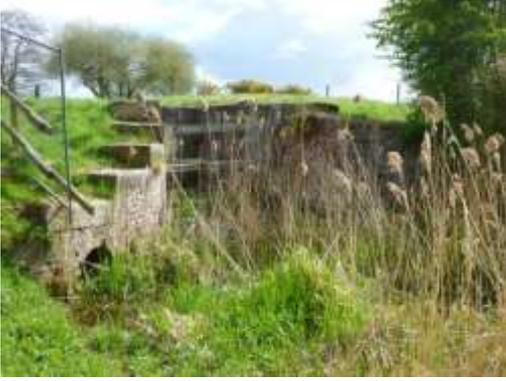
Statutory Designations:	Grade II Listed Building.	
	Monument Type:	Lock	
	NGR:	478777 445689	
	Location:	North of Marketbridge Farm.	
Description:	<p>Constructed 1817-1818. A brick and ashlar constructed lock. The majority of operational workings have been removed. The lock chamber walls are currently braced with a series of timber frames. Much of the ashlar coping is loose and the walls where the bottom lock originally sat are beginning to collapse. There are partial remains of the paddle gears situated at the former location of the top lock refaced.</p> <p><i>Element 8.1</i> The top lock no longer retains its lock gates and is in poor condition. Timber posts and rack and pinion mechanism of the ground paddle gear survive, as do the original anchor collars. Vegetation is causing the stonework of the cill to loosen and some of the stones are missing.</p> <p><i>Element 8.2</i> There lock chamber and splayed wing walls are constructed of red brick with ashlar stone coping stepped where the lower wing walls slope down. The interior of the chamber has largely been rebuilt or refaced. In some locations leaded staples hold the ashlar stone coping together. There are blocked full height slots built into the chamber wall which would have held bumping pieces. The Canal chamber is currently braced with timber supports and is at risk of collapse. Vegetation and water damage means a number of the brick faces are blown.</p> <p><i>Element 8.3</i> The bottom lock gates have also been removed. The brickwork and ashlar is unstable and at significant risk of complete collapse.</p> <p><i>Element 8.4</i> The bywash is also in poor condition and is missing brick, mortar and stonework at both the entrance and exit points. Water no longer runs through the bywash due to the removal of the lock gates from the lock. The upper weir comprises low rectangular openings, whilst the lower outfall is from a brick arched opening.</p>

Pocklington Canal: Sandhill Lock No.6		Heritage Asset	8
Condition:	Very bad - The lock is suffering significant structural problems with the canal chamber currently braced with timber supports and the wing walls being at significant risk of collapse. Vegetation growth is further exasperating the problems and a number of stones are now missing from the cill.		
Vulnerability:	Deterioration, plant growth, water damage, erosion, collapse		
Trend:	Decline.

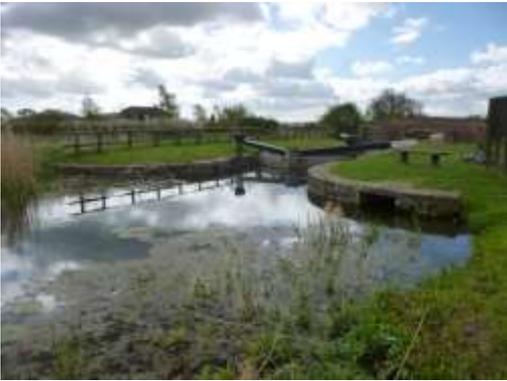
Pocklington Canal: Coates Lock No.5		Heritage Asset	10

Statutory Designations:	Grade II Listed Building.	
	Monument Type:	Lock	
	NGR:	478541 445235	
	Location:	North of Coates Bridge.	
Description:	Constructed in 1817-18 now restored and partially rebuilt.		
<i>Element 10.1</i>	The top lock is fitted with a lock gate inserted in 2000. The lock gate has iron stanchion mounted rack and pinion ground paddle gear. Vegetation has become established within the gate woodwork		
<i>Element 10.2</i>	There lock chamber and splayed wing walls are constructed of red brick with ashlar stone coping stepped where the lower wing walls slope down. The interior of the chamber has largely been rebuilt or refaced and incorporates sections of ashlar. There are full height slots built into the chamber wall before each gate to facilitate the temporary damming of the lock for maintenance. A modern steel ladder is set into the Canal chamber wall.

<i>Element 10.3</i>	The bottom lock is also a later replacement with square section balance beams and six-spoke wheel turned rack and pinion gate paddle gear. Vegetation has become established in the woodwork of the north facing side of the gate.		
<i>Element 10.4</i>	The bywash appears to be in good condition but has been bypassed by a modern ribbed plastic pipe. The upper weir comprises low rectangular openings, whilst the lower outfall is from a brick arched opening.		
Heritage Value:	The lock is considered to be of national historic and architectural value.		
Survival:	Poor. Much of the lock has been replaced or reconstructed.		
Condition:	Fair - The lock was restored and fitted with new gates in 2000. Vegetation has become established in the woodwork of these gates and will require removing before causing further damage.		
Vulnerability:	Vegetation and plant growth, water damage.		
Trend:	Declining.

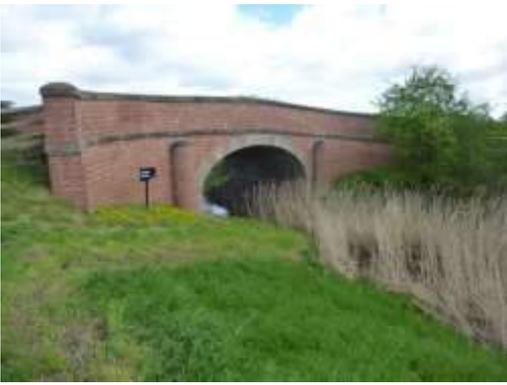
Pocklington Canal: Coates Bridge		Heritage Asset	11

Statutory Designations:	Grade II Listed Building.	
	Monument Type:	Bridge	
	NGR:	478540 445204	
	Location:	Near Marketbridge Lane.	
Description:	<p>Bridge designed by George Leather and Constructed in 1817-1818.</p> <p>Built of brick with broad ashlar basket skewed arch, rounded ashlar coping and plain ashlar string course at parapet level. Brickwork is of handmade red bricks laid in English Wall bond (alternating rows of headers and stretchers) with lime mortar bed. In addition to these architectural features the bridges also feature segmental brick buttresses with rounded stone caps either side of the arch, and square newel posts at the end of each parapet. Shows some evidence of having been rebuilt in part. The north east buttress has some damaged bricks which have been patched.. The stone coping has been removed from the tow path. There is some minor vegetation growth.</p>

Heritage Value:	The bridge is of national aesthetic and historic value.		
Survival:	Moderate.		
Condition:	Good - Some vegetation is beginning to become established within the bridge elevations.		
Vulnerability:	Deterioration, plant growth, water damage.		
Trend:	Stable

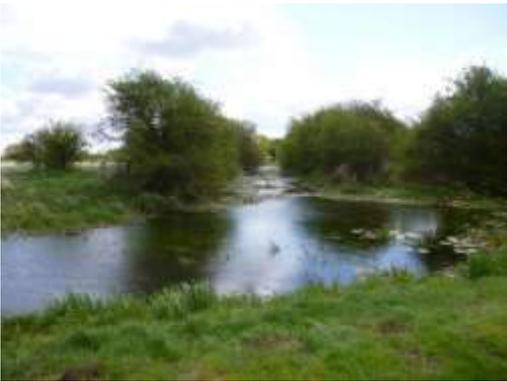
Statutory Designations:	No statutory designations.	
	Monument Type:	Canal Branch	
	NGR:	478605 444040	
	Location:	Northwest of Bielby.	
Description:	Extension of the Canal towards Bielby originally named Bielby Creek on historic maps. The arm does not retain any evidence of timber wharfs, masonry walls or associated structures. In plan the arm widens to the south to incorporate a winding hole.		
Heritage Value:	The Bielby Arm is of regional historic value.		
Survival:	Good

Pocklington Canal: Bielby Arm		Heritage Asset	13
Condition:	Good - Tree growth on the edge of the canal is likely loosening the bank and may be damaging the puddling, otherwise the arm appears to be in a good and stable condition.		
Vulnerability:	Deterioration, erosion.		
Trend:	Stable.

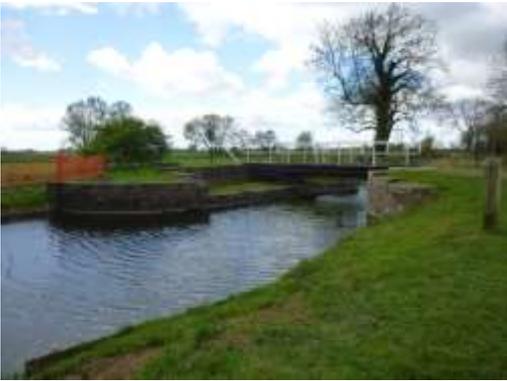
Pocklington Canal: Bielby Bridge (Swing Bridge No.8)		Heritage Asset	14

Statutory Designations:	No statutory designations.	
	Monument Type:	Bridge	
	NGR:	478165 444006	
	Location:	West of Bielby.	
Description:	<p>Originally constructed in 1815, likely replaced in the 1930s with a new swing bridge, and replaced with a fixed bridge in the 1960s. The present bridge was installed post-1970. Formerly named Chaplin Bridge (ERYA ref: DDGD/39).</p> <p>The present bridge is of steel construction and sits on top of curved brick built abutment wall which appears to predate the current bridge structure and has original ashlar coping stones. Concrete and modern brickwork is used extensively to form the foundations and superstructure.</p> <p>There are some substantial cracks in the brickwork of the supporting piers.</p>		
Heritage Value:	The bridge is of high historic value.		
Survival:	Moderate		
Condition:	Good

Vulnerability:	Deterioration, water damage, plant growth		
Trend:	Stable.

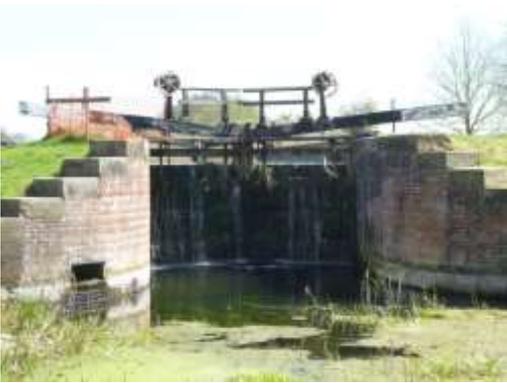
Statutory Designations:	Grade II Listed Building.	
	Monument Type:	Lock	
	NGR:	477159 444173	
	Location:	North of Walbut Mill Farm.	
Description:	<p>Constructed in 1816-1817, and refurbished post-1970 by PCAS. The lock chamber has some minor areas of mortar loss. The lock was over flowing at time of survey and the bywash did not appear to be functioning.</p> <p><i>Element 15.1</i> The top lock gate is a later replacement with square section balance beams and iron stanchion mounted rack and pinion ground paddle gears and replacement anchor collars. Due to the bywash not functioning this lock gate is currently overflowing.</p> <p><i>Element 15.2</i> The lock chamber and splayed wing walls are constructed of red brick with ashlar stone coping stepped where the lower wing walls slope down. The interior of the chamber was not inspected due to the high water level. In some locations leaded staples hold the ashlar stone coping together. There are full height slots built into the chamber wall before each gate to facilitate the temporary damming of the lock for maintenance. A modern steel ladder is set into the Canal chamber wall.</p> <p><i>Element 15.3</i> The bottom lock is also a later replacement with square section balance beams, six spoke wheel turned gate paddle gear and replaced anchor collars. The gate is currently being overflowed which is resulting in vegetation and debris collecting around the gate.</p> <p><i>Element 15.4</i> The bywash appears in fair condition but is currently not function suggesting it has become blocked. This has resulted in the high water level of the lock chamber and the overflow of the lock gates. Both the upper weir and lower outfall comprise low rectangular openings.</p>

Heritage Value:	The lock has national architectural and historic value.		
Survival:	Moderate		
Condition:	<p>Poor - The bywash currently appears to be blocked, as a result water is overflowing the lock gates and debris is collecting on the eastern side of either gate. This will be causing excessive wear and tear of the lock gates and increased potential for water damage. The balance beam</p>

Pocklington Canal: Walbut Lock No.4		Heritage Asset	15
	of the northern gate of the bottom lock has failed and needs replacing.		
Vulnerability:	Deterioration, plant growth, water damage.		
Trend:	Decline.

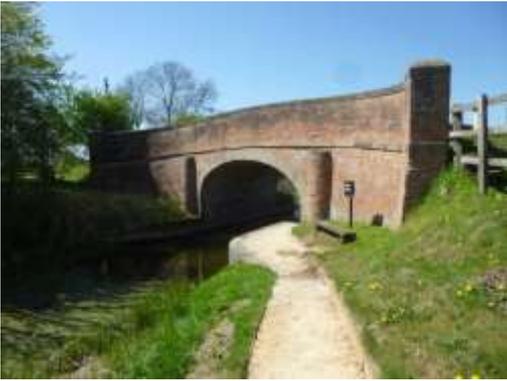
Pocklington Canal: Walbut Bridge		Heritage Asset	16

Statutory Designations:	Grade II Listed Building.	
	Monument Type:	Bridge	
	NGR:	477114 444192	
	Location:	Northwest of Walbut Mill Farm.	
Description:	<p>Bridge designed by George Leather and constructed in 1815-1816.</p> <p>Built of brick with broad ashlar basket skewed arch, rounded ashlar coping and plain ashlar string course at parapet level. Brickwork is of handmade red bricks laid in English Wall bond (alternating rows of headers and stretchers) with lime mortar bed. In addition to these architectural features the bridges also feature segmental brick buttresses with rounded stone caps either side of the arch, and square newel posts at the end of each parapet. Shows some evidence of having been rebuilt in part. The north east buttress has some damaged bricks which have been patched.</p>		
Heritage Value:	The bridge is of national architectural and historic value.

Survival:	Moderate.		
Condition:	Good - Patching and partial repointing of the bridge in cement has caused some damage to the brick work and replacement with appropriate materials such as a lime mortar should be considered.		
Vulnerability:	Deterioration, plant growth and water damage.		
Trend:	Stable.

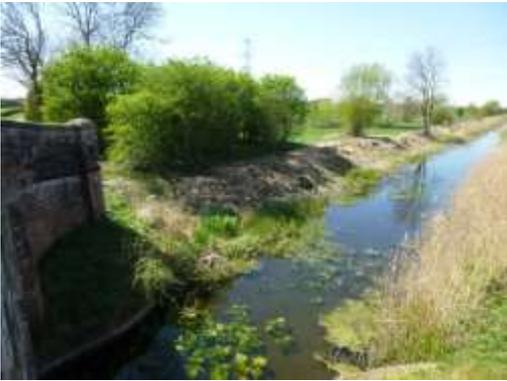
Pocklington Canal: Walbut Mill Wharf		Heritage Asset	17

Statutory Designations:	No statutory designations.	
	Monument Type:	Wharf	
	NGR:	477085 444180	
	Location:	West of Walbut Mill Farm.	
Description:	A wharf visible as an area of flat grassland. The location of this wharf appears on historic mapping dated 1815-1847 (CRT archive ref 55530). The wharf was likely associated with Walbut Mill which lay to the southwest of the wharf. The wharf itself is not known to have had any structures.		
Heritage Value:	The wharf has local historic value.		
Survival:	Moderate		
Condition:	Fair.		
Vulnerability:	Ploughing, vegetation, flooding.		
Trend:	Stable.

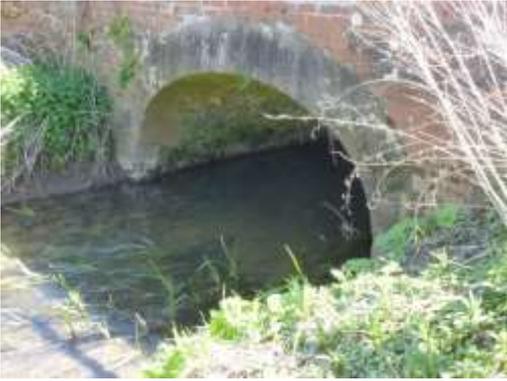
Statutory Designations:	No statutory designations.	
	Monument Type:	Culvert	
	NGR:	476570 444397	
	Location:	South of Mill House.	
Description:	Culvert built in 1815-17 to carry the Canal over The Beck. A basket arched culvert with ashlar voussoirs and skewed brick soffit contained within substantial sweeping brick built wing walls with ashlar coping. There are several phases of brick work with the upper levels of the culvert having been rebuilt.		
Heritage Value:	The culvert is of moderate architectural and historic value.

Pocklington Canal: Culvert No.6 (The Beck or Nelly Hole Culvert)		Heritage Asset	18
Survival:	Moderate		
Condition:	Fair. - The upper levels of the culvert have been previously rebuilt however the brickwork at the current water level has been partially eroded.		
Vulnerability:	Deterioration, plant growth, water damage.		
Trend:	Stable.

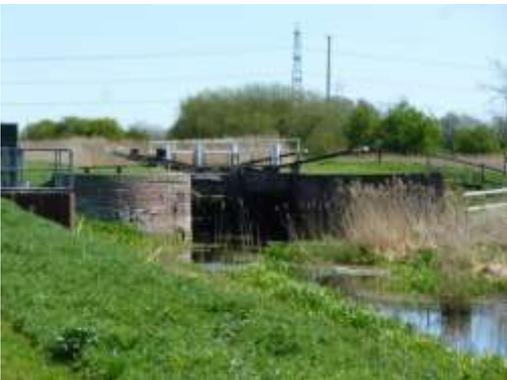
Pocklington Canal: Thornton Lock No.3		Heritage Asset	19

Statutory Designations:	Grade II Listed Building.	
	Monument Type:	Lock	
	NGR:	476095 444396	
	Location:	North of bridge farm.	
Description:	<p>Constructed in 1815-17, and refurbished post-1970 by PCAS. Lock partially rebuilt. The wing wall is missing some bricks.</p> <p><i>Element 19.1</i> The top lock gate is a later replacement with railway lines used for balance beams. The lock gate has hydraulic paddle gear and re-uses the original anchor collars.</p> <p><i>Element 19.2</i> There lock chamber and splayed wing walls are constructed of red brick with ashlar stone coping. In some locations there is evidence of leaded staples that would have held the ashlar stone coping together. There are slots containing timber bumper pieces within the chamber, and a steel access ladder.</p> <p><i>Element 19.3</i> The bottom lock matches the top lock. Some vegetation and debris has built up on the gate.</p> <p><i>Element 19.4</i> The bywash appears to function although the brick and stone work at both the entrance and exit points is coming loose and is in poor condition. Both the upper weir and lower outfall comprise low rectangular openings.</p>

Heritage Value:	The lock is of national aesthetic and historic value.		
Survival:	Moderate		
Condition:	Fair - Some vegetation and debris has built up on the bottom lock gate and the stone and brickwork at both the entrance and exit point to the bywash has been loosened and is in poor condition. The use of railway tracks as

balance beams here is of historical significance but is unsatisfactory for its operation.
Vulnerability:	Deterioration, plant growth, water damage.
Trend:	Stable.

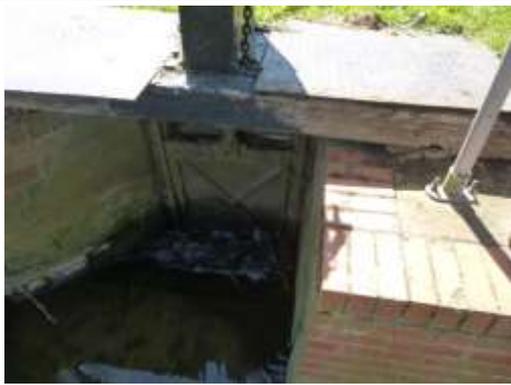
Pocklington Canal: Thornton Lock Feeder Sluice		Heritage Asset	20

Statutory Designations:	No statutory designations.	
	Monument Type:	Sluice	
	NGR:	476570 444397	
	Location:	South of Mill House	
Description:	A modern red brick sluice with steel sluice gate that allows water into the Canal from The Beck. This sluice possibly replaced an earlier system that originally joined the Canal at the edge of Thornton Lock's northwest wing wall (based on observation of historic OS maps).		
Heritage Value:	The sluice is of local historic value.		
Survival:	Poor		
Condition:	Good		
Vulnerability:	Vegetation, water damage		
Trend:	Stable

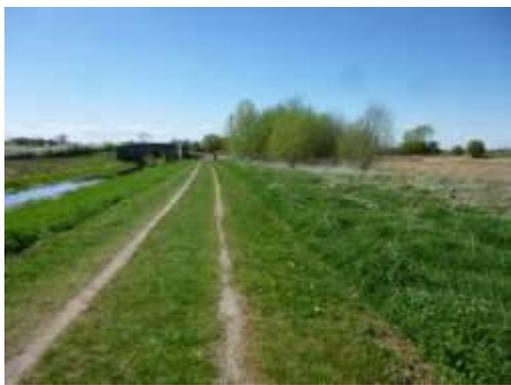
Statutory Designations:	No statutory designations.	
	Monument Type:	Wharf	
	NGR:	475929 444445	
	Location:	North east of Church Bridge, west of Thornton Lock.	
Description:	A former wharf, visible as an area of flat, grassed land. The location of this wharf appears on historic mapping dated 1815-1847 (CRT archive ref 55530). The wharf is not

Pocklington Canal: Private Wharf		Heritage Asset	21
	known to have been associated with any structures.		
Heritage Value:	The wharf has local historic value.		
Survival:	Moderate		
Condition:	Fair.		
Vulnerability:	Ploughing, vegetation growth.		
Trend:	Stable.

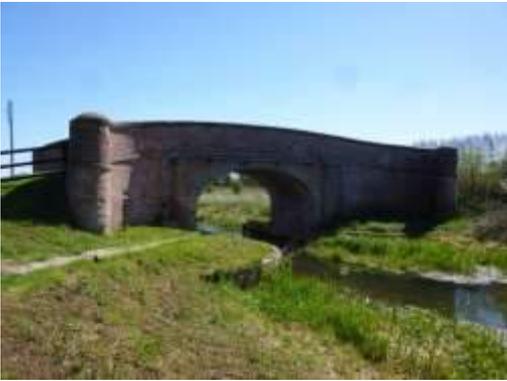
Pocklington Canal: Church Bridge		Heritage Asset	22

Statutory Designations:	Grade II Listed Building.	
	Monument Type:	Bridge	
	NGR:	475855 444410	
	Location:	North of Bridge Farm, south of Thornton.	
Description:	<p>Bridge designed by George Leather and Constructed in 1815-1816.</p> <p>Built of brick with broad ashlar basket arch, rounded ashlar coping and plain ashlar string course at parapet level. Brickwork is of handmade red bricks laid in English Wall bond (alternating rows of headers and stretchers) with lime mortar bed. In addition to these architectural features the bridges also feature segmental brick buttresses with rounded stone caps either side of the arch, and circular newel posts at the end of each parapet.</p> <p>Service pipes are located along the western face of the bridge. There is some minor vegetation growth and some damage to the brick and stone work.</p>		
Heritage Value:	The bridge is of national aesthetic and historic value.

Survival:	Good.		
Condition:	Fair - The bridge has been repointed with concrete which will damage the brickwork. Brick work has also been damaged by vegetation growth and vehicular strikes.		
Vulnerability:	Deterioration, plant growth, water damage.		
Trend:	Declining.

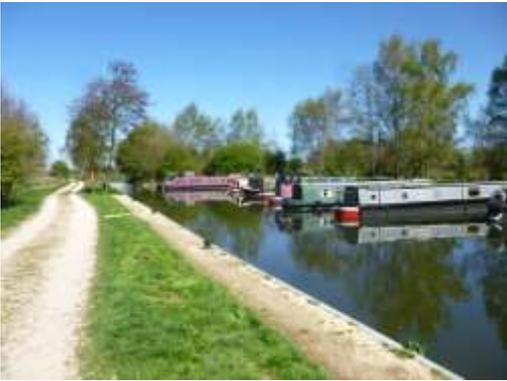
Pocklington Canal: Melbourne Arm		Heritage Asset	23

Statutory Designations:	No statutory designations.	
	Monument Type:	Canal Branch	
	NGR:	475325 444296	
	Location:	North of Melbourne.	
Description:	<p>Branch of the Canal containing a marina. Serves the town of Melbourne.</p> <p>The arm was altered in 1987 to make space for six pontoons for permanent moorings</p> <p>In 2013 a new 30m mooring was installed, replacing a timber wharf stage on the western side of the arm.</p>		
Heritage Value:	The Melbourne Arm has regional historic value.		
Survival:	Good		
Condition:	Good		
Vulnerability:	Vegetation growth.		
Trend:	Stable.

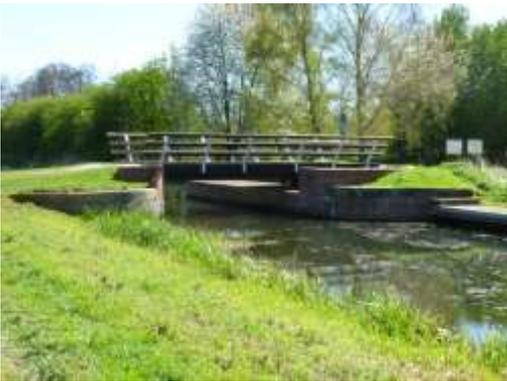
Statutory Designations:	No statutory designations.	
	Monument Type:	Bridge	
	NGR:	475310 444414	
	Location:	North of Melbourne Arm.	
Description:	<p>Originally constructed in 1815, likely replaced in the 1930s with a new swing bridge, and replaced with a fixed bridge in the 1960s. The present bridge was installed post-1970.</p> <p>The present bridge is of steel construction with timber deck. The bridge sits on top of curved brick built abutment wall which reuses original ashlar coping and incorporates some brickwork in the northern abutment that appears to</p>

Pocklington Canal: Dales Bridge (Swing Bridge No.7)		Heritage Asset	24
	predate the current bridge structure. Concrete and modern brickwork is used extensively to form the foundations and superstructure. The bridge has brick kickers set into concrete.		
Heritage Value:	The swing bridge is of local aesthetic and historic value		
Survival:	Poor		
Condition:	Good		
Vulnerability:	Deterioration, plant growth, water damage.		
Trend:	Stable

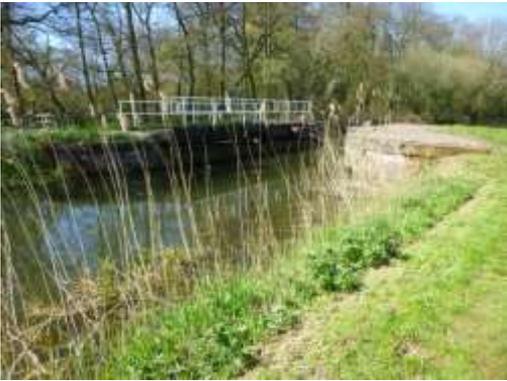
Pocklington Canal: Peacock Bridge (Swing Bridge No.4)		Heritage Asset	28

Statutory Designations:	No statutory designations.	
	Monument Type:	Bridge	
	NGR:	473013 445283	
	Location:	North of The Grange.	
Description:	<p>Originally constructed in 1815, replaced in the 1930s with a new swing bridge, replaced with a fixed bridge in the 1960s, with the present bridge post-1970.</p> <p>The present bridge is of steel construction and sits on top of curved brick abutment walls with ashlar coping stones. Makers mark on the steel joists indicates they were produced by British Steel in Shelton. Concrete is used extensively to form the foundations and superstructure. The bridge has brick kickers set into concrete.</p>		
Heritage Value:	The bridge has local historic value.		
Survival:	Poor		
Condition:	Good		
Vulnerability:	Deterioration, plant growth, water damage		
Trend:	Stable.

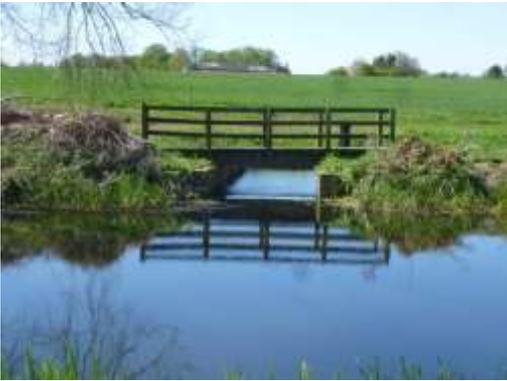
Pocklington Canal: Bywash		Heritage Asset	29

Statutory Designations:	No statutory designations.	
	Monument Type:	Bywash	
	NGR:	473442 445138	
	Location:	East of Gardham Lock.	
Description:	Bywash for Gardham Lock. Comprises a weir situated above the lock, with modern brick abutment walls and timber foot bridge (pictured). Water taken from the weir joins a drain that runs to the south of the Canal and feeds back into the Canal below Gardham Lock within an earth banked channel. The structure appears modern but likely dates originally to 1815.		
Heritage Value:	The bywash is of local evidential and historic value.		
Survival:	Good		
Condition:	Fair		
Vulnerability:	Deterioration, debris, plant growth, water damage.		
Trend:	Stable.

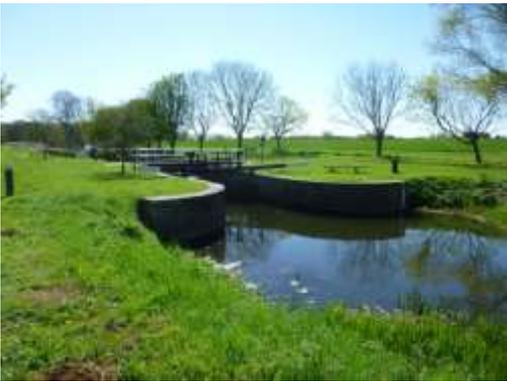
Statutory Designations:	Grade II Listed Building.	
	Monument Type:	Lock & Bridge	
	NGR:	472944 445322	
	Location:	Northeast of Rossmoor Grange.	
Description:	<p>Constructed in 1815, and refurbished post-1970 by PCAS. Refurbishment in 1994 commemorated on a small plaque located on the bottom lock.</p> <p>Historically this lock has been known by a number of names, including Nottingham Lock, Bramleys Lock (Nottingham 2015) and Thompsons in 1859 (CRT archive ref 7453). These names possible derive from local</p>

Pocklington Canal: Gardham Lock No.2 & No. 3 Swing Bridge		Heritage Asset	30
<i>Element 30.1</i>	landowners, arriving at its current name in the 1860s (Nottingham 2015). Brick work behind top and bottom lock gates in very poor condition. The top lock is a later replacement with square section balance beams and boxed rack and pinion paddle gear, and cast iron anchor collars with square bolts. The position of the cill is marked on top of the Canal chamber sides but was not examined.		
<i>Element 30.2</i>	There lock chamber and splayed wing walls are constructed of red brick with ashlar stone coping stepped where the lower wing walls slope down. The interior of the chamber has been rebuilt or refaced. There are full height slots built into the chamber wall before each gate to facilitate the temporary damming of the lock for maintenance. A modern steel ladder is set into the Canal chamber wall.

<i>Element 30.3</i>	The bottom lock is also a later replacement with six spoke wheel turned paddle gear (replicas). The top lock also has square section balance beams and one plaque commemorates the refurbishment in 1994.		
<i>Element 30.4</i>	A swing bridge crosses the centre of the Canal chamber. It is of steel construction and sits on top of concrete foundations. The steel is from British Steel in Scunthorpe. The bridge has brick kickers set into concrete.		
Heritage Value:	The lock and swing bridge have national aesthetic and historic value.		
Survival:	Moderate.		
Condition:	Fair - The brickwork behind both the top and bottom lock gates is in very poor condition.		
Vulnerability:	Deterioration, plant growth, water damage.		
Trend:	Decline

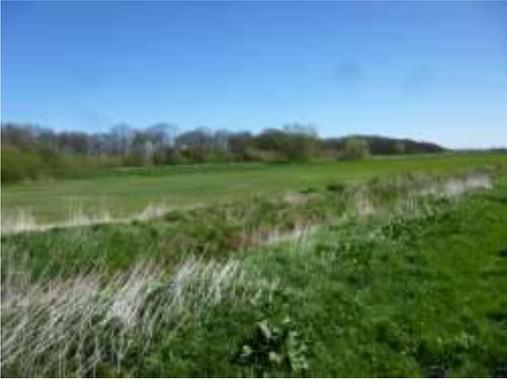
Pocklington Canal: Gardham Wharf		Heritage Asset	31

Statutory Designations:	No statutory designations.	
	Monument Type:	Wharf	
	NGR:	472512 445566	
	Location:	South of Four Beck Ends.	
Description:	An area of flat land previously used as a wharf. The location of this wharf is recorded on historic OS maps. The wharf was likely in use as a coal wharf for an Engine House (presumably a pumping station) situated at Four Beck Ends which was shown on the 1890 Ordnance Survey map but had been cleared by the 1910 map. The wharf is not known to have been associated with any structures.		
Heritage Value:	The wharf has local historic value and unknown evidential value.		
Survival:	Moderate.		
Condition:	Fair.		
Vulnerability:	Ploughing, vegetation growth.		
Trend:	Stable.

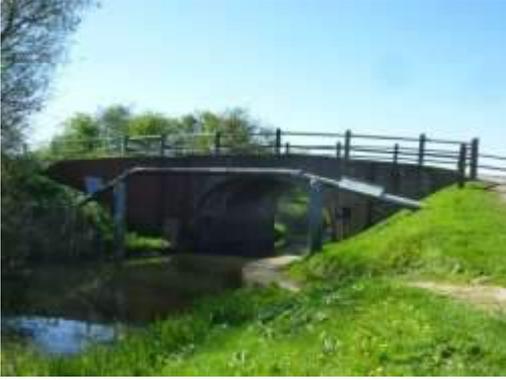
Pocklington Canal: Hagg Bridge		Heritage Asset	33

Statutory Designations:	No statutory designations.	
	Monument Type:	Bridge	
	NGR:	471703 445139	
	Location:	West of Hagg Bridge Farm.	
Description:	<p>Designed by George Leather and constructed in 1815 by William Marley, James Newton, James Nelson and John Glover. It is possible the bridge incorporates or encases an earlier bridge over The Beck that predated the construction of the Canal.</p> <p>Hagg Bridge is a two span red brick bridge of narrow-waisted, humped-back design featuring a gently curve to wing walls in both elevation and plan. The span over the Canal comprises a basket arch with stone voussoirs. The span over The Beck is principally ashlar built with a semi-circular arch and modern brick parapet supported above on a modern RSJ. The bridge has thin flat stone coping with post and rail fence. Square brick buttresses are situated either side of the Canal arch.</p> <p>The west wall has two phases of brick work with some patching. The west wall is cracked and is also suffering from some bulging. The southwest buttress is also cracked and bulging as is the northeast. The east face has also been rebuilt in two phases. Much of the brick work is blown and the parapet is lifting. The bridge has been repointed in parts in concrete and some of the coping stones have also been replaced in concrete.</p> <p>Services are attached to the west face of the bridge and a free standing gas pipe lies in proximity to the east face.</p>

Heritage Value:	The bridge has national aesthetic and historic value.		
Survival:	Moderate.		
Condition:	Poor - The bridge is suffering from some bulging and cracks within the brick work. Much of the brick work is blown and the parapet is lifting. The bridge has been partially repointed in concrete which will damage the surrounding brick and stone work and a number of the

coping stone have also been replaced in concrete.		
Vulnerability:	Deterioration, plant growth, weathering, water damage. Surface damage to bricks from concrete.		
Trend:	Decline.		
Pocklington Canal: Culvert No.3 (The Flags)			Heritage Asset 34

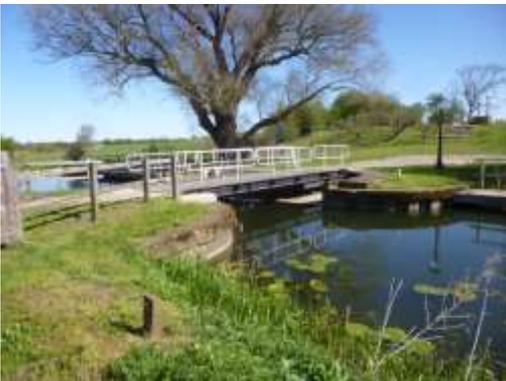
Pocklington Canal: Storhwait Top Bridge (Swing Bridge No.2)			Heritage Asset 35

Statutory Designations:	No statutory designations.	
	Monument Type:	Bridge	
	NGR:	471024 444388	
	Location:	Northwest of Storwood.	
Description:	Originally constructed in 1815, replaced in the 1930s with a new swing bridge, replaced with a fixed bridge in the 1960s, with the present bridge post-1970. The present bridge is of steel construction and sits on top

Pocklington Canal: Storthwait Top Bridge (Swing Bridge No.2)		Heritage Asset	35
	of curved concrete and steel piled abutment walls which re-use original ashlar coping stones. Concrete is used extensively to form the foundations and superstructure. The bridge has brick kickers set into concrete.		
Heritage Value:	The bridge has local historic value.		
Survival:	Poor		
Condition:	Good		
Vulnerability:	Deterioration, plant growth, water damage		
Trend:	Stable

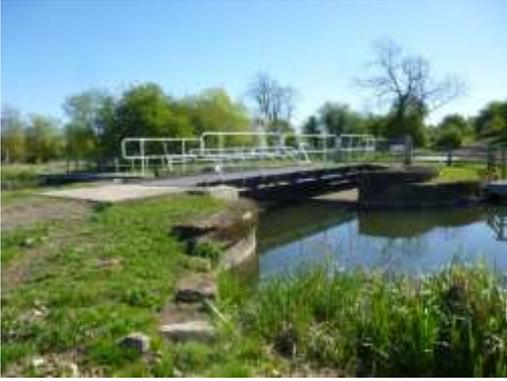
Pocklington Canal: Storwood Low Bridge (Swing Bridge No.1)		Heritage Asset	36

Statutory Designations:	No statutory designations.	
	Monument Type:	Bridge	
	NGR:	471068 443979	
	Location:	Southwest of Storwood.	
Description:	<p>Originally constructed in 1815, replaced in the 1930s with a new swing bridge, replaced with a fixed bridge in the 1960s, with the present bridge post-1970.</p> <p>The present bridge is of steel construction and sits on top of rebuilt curved brick abutment walls which re-use original ashlar coping stones. Concrete is used extensively to form the foundations and superstructure. The bridge has brick kickers set into concrete.</p>		
Heritage Value:	The bridge has local historic value.		
Survival:	Low survival of historic fabric.		
Condition:	Fair		
Vulnerability:	Deterioration, plant growth, water damage.		
Trend:	Stable

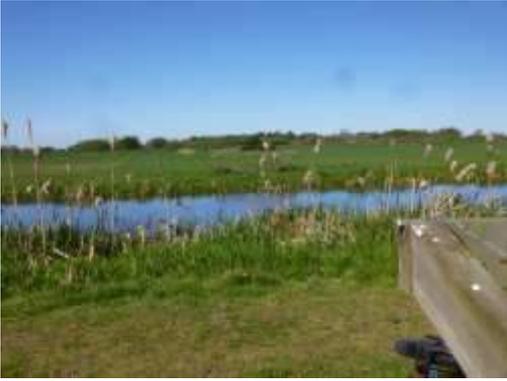
Pocklington Canal: Culvert No. 2		Heritage Asset	37

Statutory Designations:	No statutory designations.	
	Monument Type:	Culvert	
	NGR:	470947 443458	
	Location:	The culvert is located east of Wheldrake Ings.	
Description:	Constructed in 1815. Carries water out of the Ings into the Beck. The culvert is evident as a fenced off area either side of the Canal. Whilst no built structure is visible a similar brick built structure to other culverts along the line is anticipated.		
Heritage Value:	Potential local historical and evidential value.		
Survival:	Unknown		
Condition:	Unknown		
Vulnerability:	Deterioration, plant growth, water damage		
Trend:	Unknown

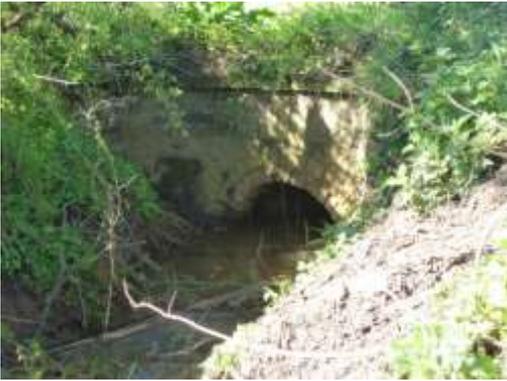
Statutory Designations:	No statutory designations.	
	Monument Type:	Culvert	
	NGR:	470962 443194	
	Location:	Situated north of East Cottingwith at the end of Canal Road. Near HA4.	
Description:	Constructed in 1815. Carries soak drain water into The Beck. Curved brick wing wall with round headed arched culverts with two ring brick soffit and ashlar coping.		
Heritage Value:	The culvert has local evidential and historic value		
Survival:	Good		
Condition:	Good - Vegetation loosening the brickwork of the elevation.		
Vulnerability:	Deterioration, plant growth, water damage

Pocklington Canal: Culvert No. 1 (Hacking Drain)		Heritage Asset	38
Trend:	Decline

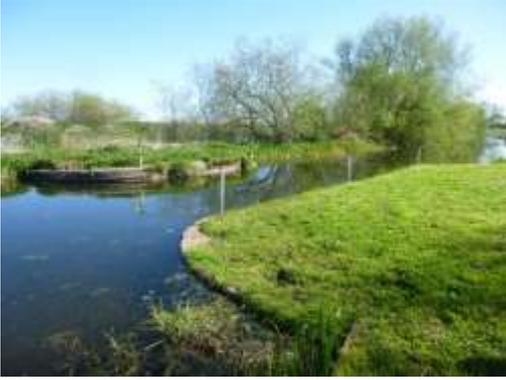
Pocklington Canal: Swing Bridge		Heritage Asset	39

Statutory Designations:	No statutory designations.	
	Monument Type:	Bridge	
	NGR:	470409 442757	
	Location:	Situated north of East Cottingwith at the end of Canal Road.	
Description:	<p>Footings for swing bridge dating to 1815, situated at the end of North Hills Lane from Cottingwith. The bridge was labelled on the 1854 OS map, but was no longer shown by the production of the 1896 OS map. Interestingly the bridge numbering system does not include this bridge indicating it post-dates this bridge falling into disuse.</p> <p>The remaining structure comprises two projecting abutments with curving profile in plan. Constructed in brick with an ashlar foundation and coping stones. These stones have a chiselled edge and pecked finish. The bridge no longer survives.</p> <p>Due to the early removal of this bridge and the lack of any subsequent replacement there is considered to be potential for archaeological remains relating to the original swing mechanism to survive below ground level.</p>

Heritage Value:	The former bridge has local aesthetic and historic value and possible regional evidential value in the potential for the remains to increase knowledge of the form and operation of the original accommodation bridges along the Canal.		
Survival:	Poor (unknown potential for archaeological remains)		
Condition:	Very bad - The remains of the bridge are at risk of being struck by passing boats and the coping stones are becoming loose through erosion of mortar.		
Vulnerability:	Deterioration, plant growth, water damage		
Trend:	Stable.

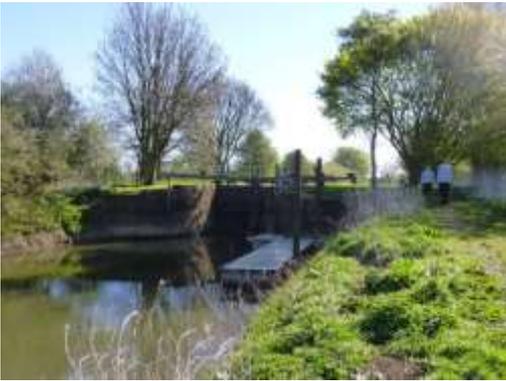
Statutory Designations:	Grade II Listed.	
	Monument Type:	Lock	
	NGR:	470078 442701	
	Location:	Northwest of East Cottingwith.	
Description:	<p>Constructed in 1815, and refurbished post-1970 by PCAS. Refurbishment in 2008 commemorated on a small plaque located on the bottom lock. The lock comprises the following elements.</p> <p><i>Element 40.1</i> The top lock is also a later replacement with six spoke wheel turned paddle gear. The position of the cill is marked on top of the Canal chamber sides but was not examined. The top lock also has square section balance beams and two plaques one to commemorate the refurbishment in 2008 and one to commemorate George Parkes.</p> <p><i>Element 40.2</i> There lock chamber and splayed wing walls are constructed of red brick with ashlar stone coping stepped where the lower wing walls slope down. The interior of the chamber has largely been rebuilt or refaced. In some locations leaded staples hold the ashlar stone coping together. There are full height slots built into the chamber wall before each gate to facilitate the temporary damming of the lock for maintenance. A modern steel ladder is set into the Canal chamber wall.</p> <p><i>Element 40.3</i> The bottom lock comprises two gates with square section timber balance beams, hydraulic gate paddle gear, and cast iron anchor collars with square bolts.</p> <p><i>Element 40.4</i> The entrance to the bywash is a low rectangular opening built into the Canal chamber walls before the top lock. The outfall from the bywash was not observed and may exit into The Beck.</p> <p><i>Element 40.5</i> A counter is situated on the south side of the Canal. The counting mechanism could not be observed.</p>

Heritage Value:	The site is considered to have national historic and aesthetic value, and local-regional evidential value.		
Survival:	Moderate. Extensive repairs to exposed structure.		
Condition:	Good.		
Vulnerability:	Deterioration, plant growth, water damage (especially during flood episodes).

Pocklington Canal: Cottingwith Lock No.1		Heritage Asset	40
Trend:	Stable

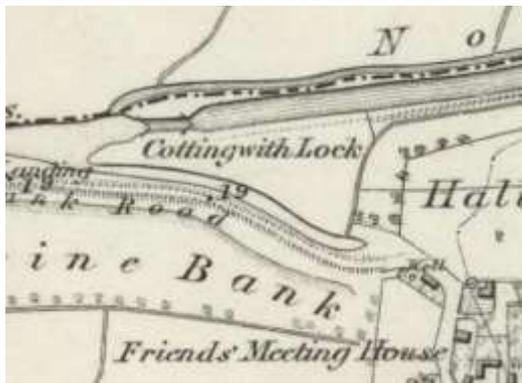
Pocklington Canal: East Cottingwith Arm		Heritage Asset	41

Statutory Designations:	No statutory designations.	
	Monument Type:	Canal Branch	
	NGR:	470097 442668	
	Location:	Northwest of East Cottingwith on the south bank of the Canal.	
Description:	<p>Canal arm serving East Cottingwith, and named on historical maps as 'The Cut'. This canal arm pre-dated the construction of Pocklington Canal and was likely formed in relation to the Derwent Navigation c.1702</p> <p>The arm was infilled in the 1960s although its course is still marked by a pathway down to the Canal.</p>		
Heritage Value:	The site is considered to have local-regional historic and evidential value.		
Survival:	Very bad. The arm has been in-filled.		
Condition:	Poor		
Vulnerability:	Deterioration of the path due to waterlogging, or agricultural activities.		
Trend:	Gradual decline.
