Canal & River Trust

Report on the Nature and Root Cause of the Toddbrook Reservoir Auxiliary Spillway Failure on 1st August 2019

Dr Andy Hughes
February 2020

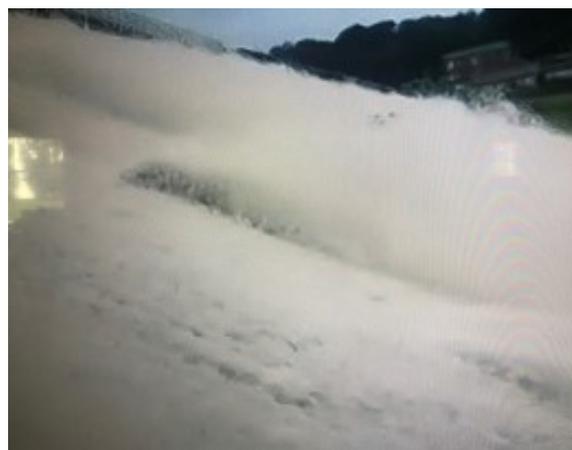
Flow on spillway channel

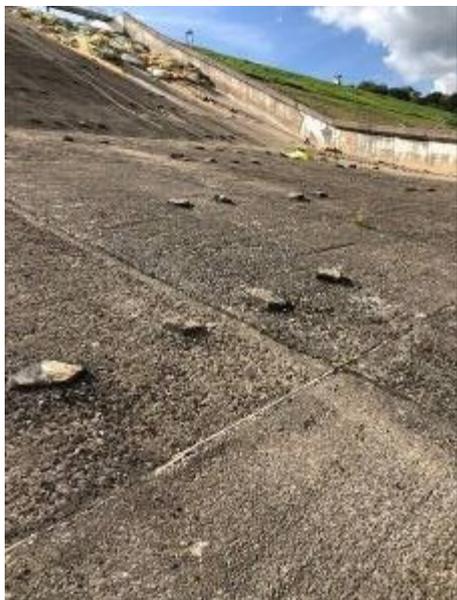
Granite chippings were poured onto the top surface of the wet concrete and tamped in. Stone 'plums' 9-inch x 9-inch x 9-inch (225 mm x 225 mm x 225 mm) were grouted into the wet concrete in a pattern which consisted of 4 No. per 25 ft x 12 ft 6-inch (7.62 x 3.8 metres) bay. The total area of inclined slab was 4,700 square yards (3,930 square metres).

Plums

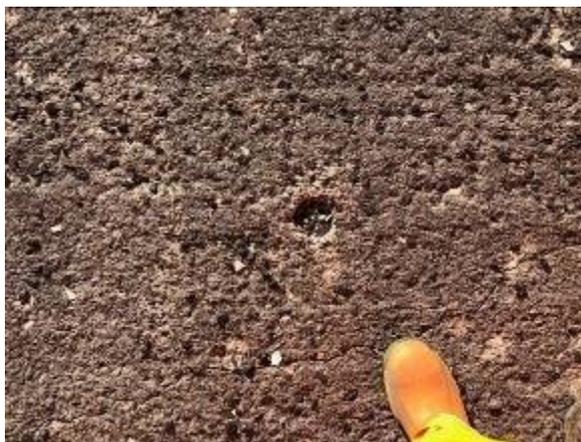
Granite chips

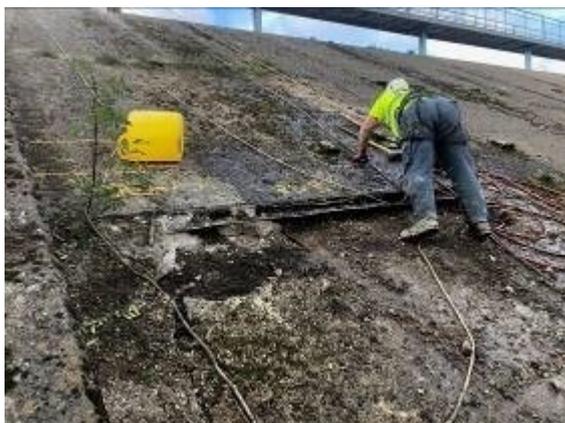
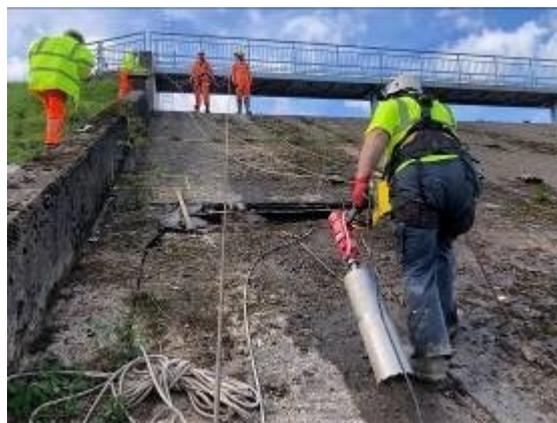
The intrusive sampling via cored holes and trial holes directed by myself in association with the last IE showed the concrete to be of what appeared to be good quality and well compacted. The thickness of concrete appeared, surprisingly (considering the steepness of the slope and the construction equipment available at the time), to be uniform up and down the slope, and across a number of panels.

Excavation on the slope

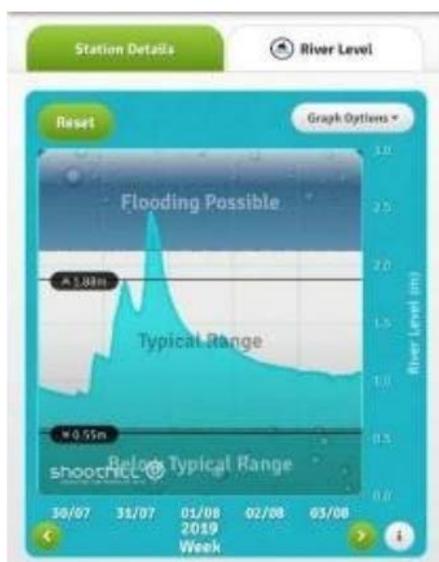
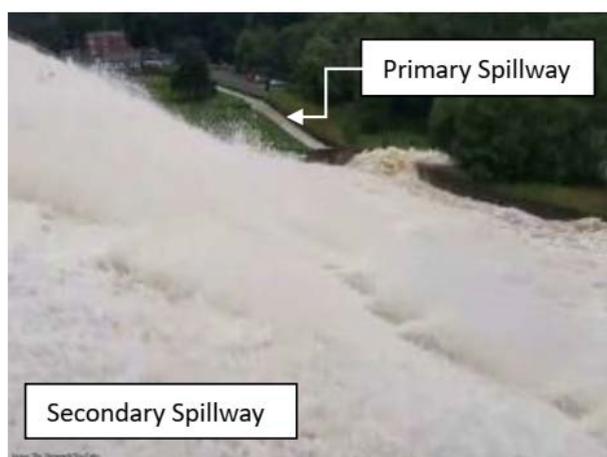
There is limited hydrological and hydraulic information available but based on data from level records and a gauging station just downstream it appears that the site was subject to two hydrological events in quick succession - a 1 in 43 year event followed by a 1 in 92 year event two days later - resulting in a significant combined event.

Flood event – 31st July 2019

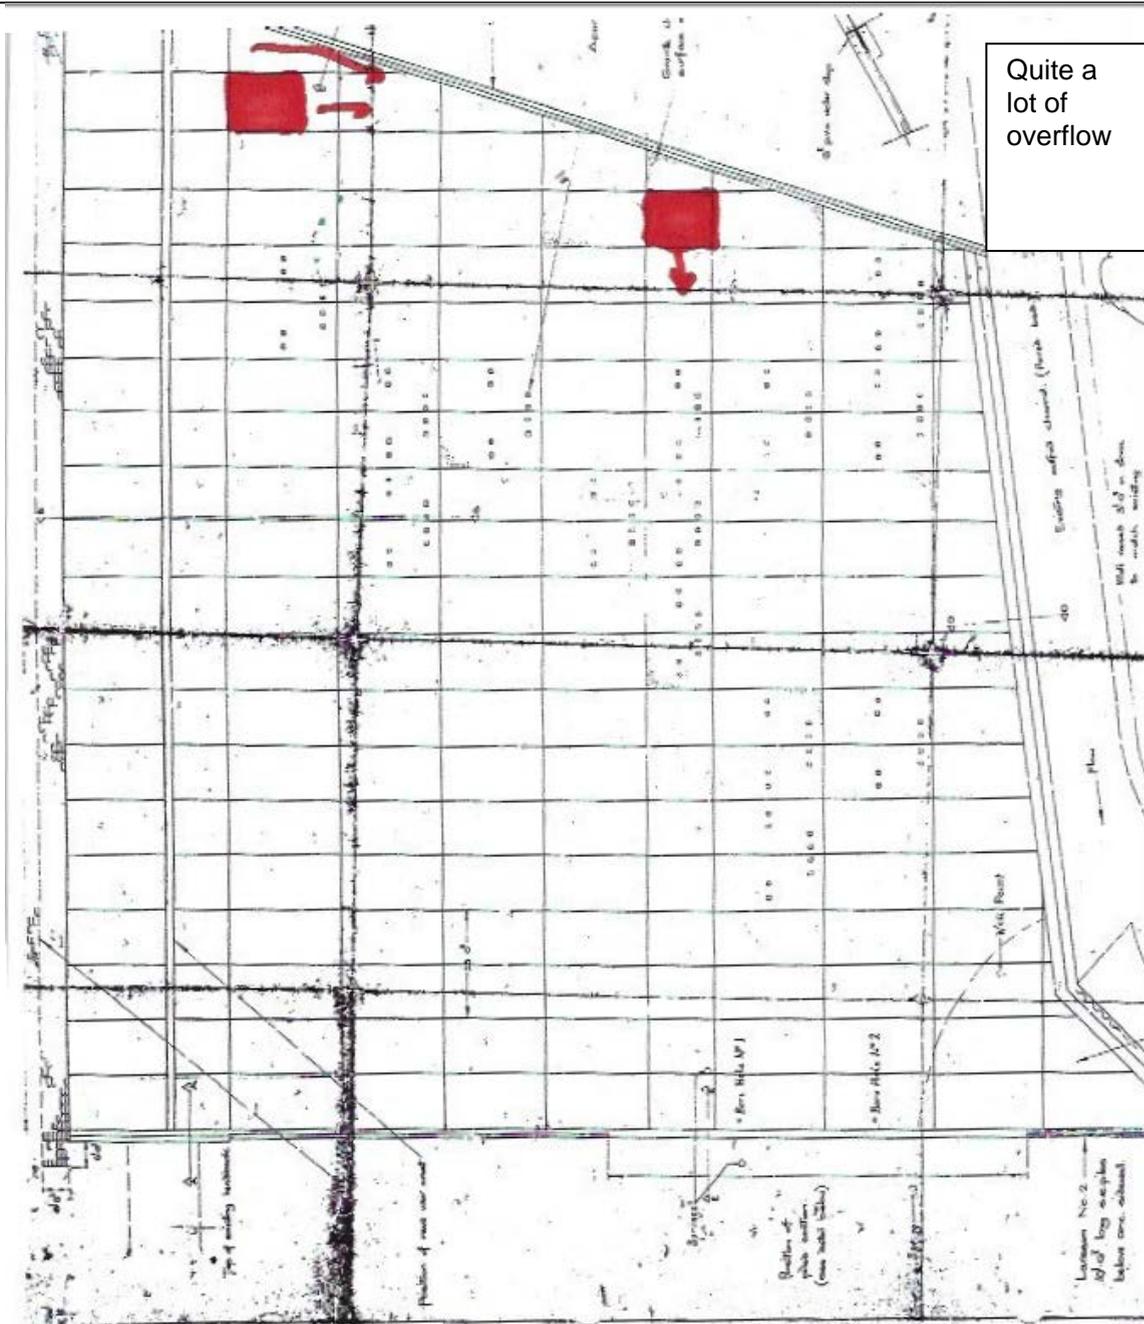
4

Pictures of flooding and Toddbrook Reservoir in Whaley Bridge
Initial lifting of lower slabs and failure of upper slab before 11am

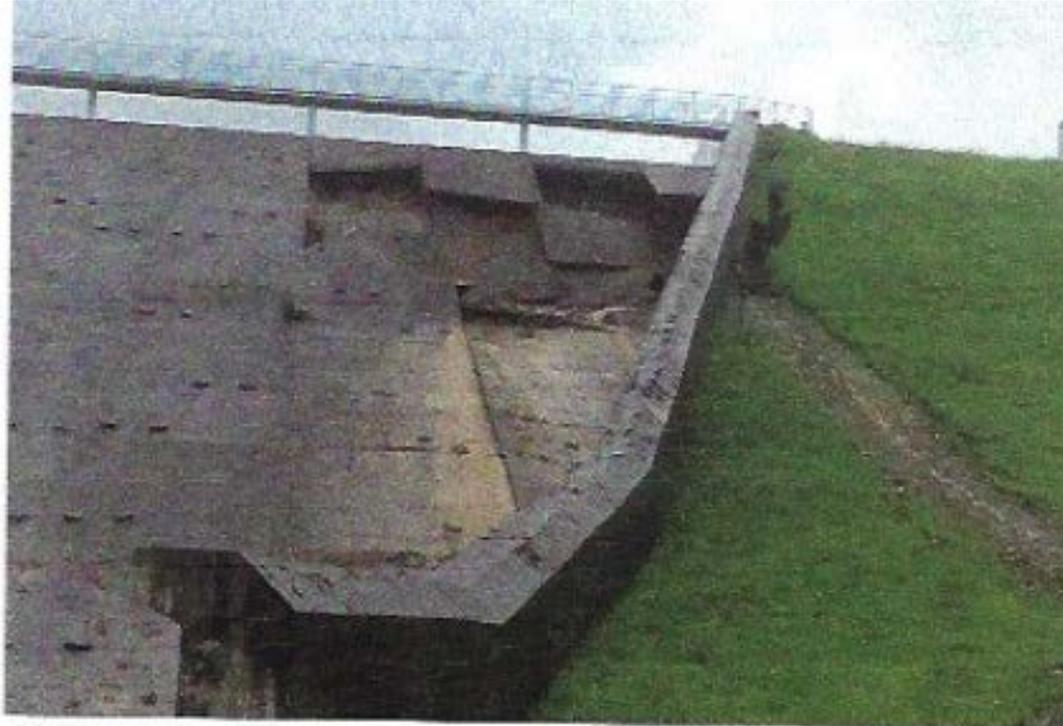
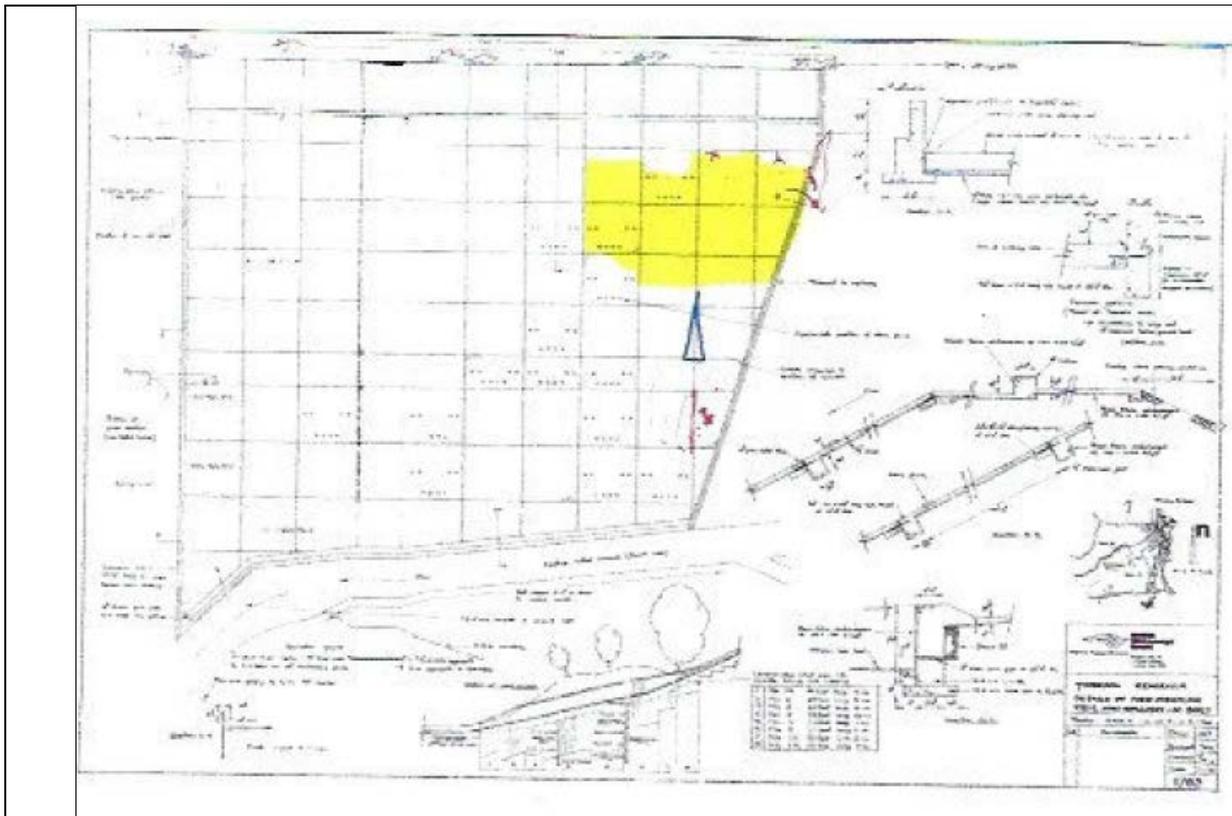
Afternoon of 1st August 2019: (valves had taken water down to the level of the auxiliary spillway crest and sandbagging had stopped any overflow across the slightly lower left-hand end of the weir). 14:29 David Brown
