Epic Engineering

**Showcasing what can be achieved
when restoring our waterways**

**Canal &
River Trust**

**The Inland
Waterways
Association**

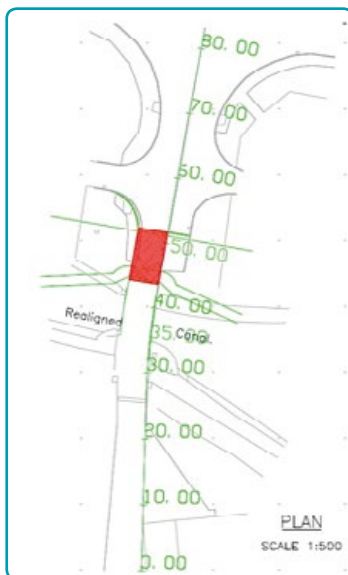
Upper Mills Bridge, Stroudwater Navigation

Upper Mills Bridge used to be a swing bridge that had, in its later life, been fixed and strengthened to accommodate increased vehicle weights, leaving not enough room for a boat to pass underneath. The crossing had been upgraded and maintained by the owners of the adjacent industrial estate under an agreement which gave them unfettered rights of access.

Various options were considered, including moving the entrance to the industrial estate, but the solution was to provide a fixed bridge located slightly (11 yards) to the north of the swing bridge.

Work commenced in the second half of 2010 to construct the new high-level fixed bridge that is seen today. The canal was also re-aligned and widened to give canal boats sufficient head room to go under the bridge. The slight change in location allowed for the provision of an acceptable gradient (1 in 9) into the estate.

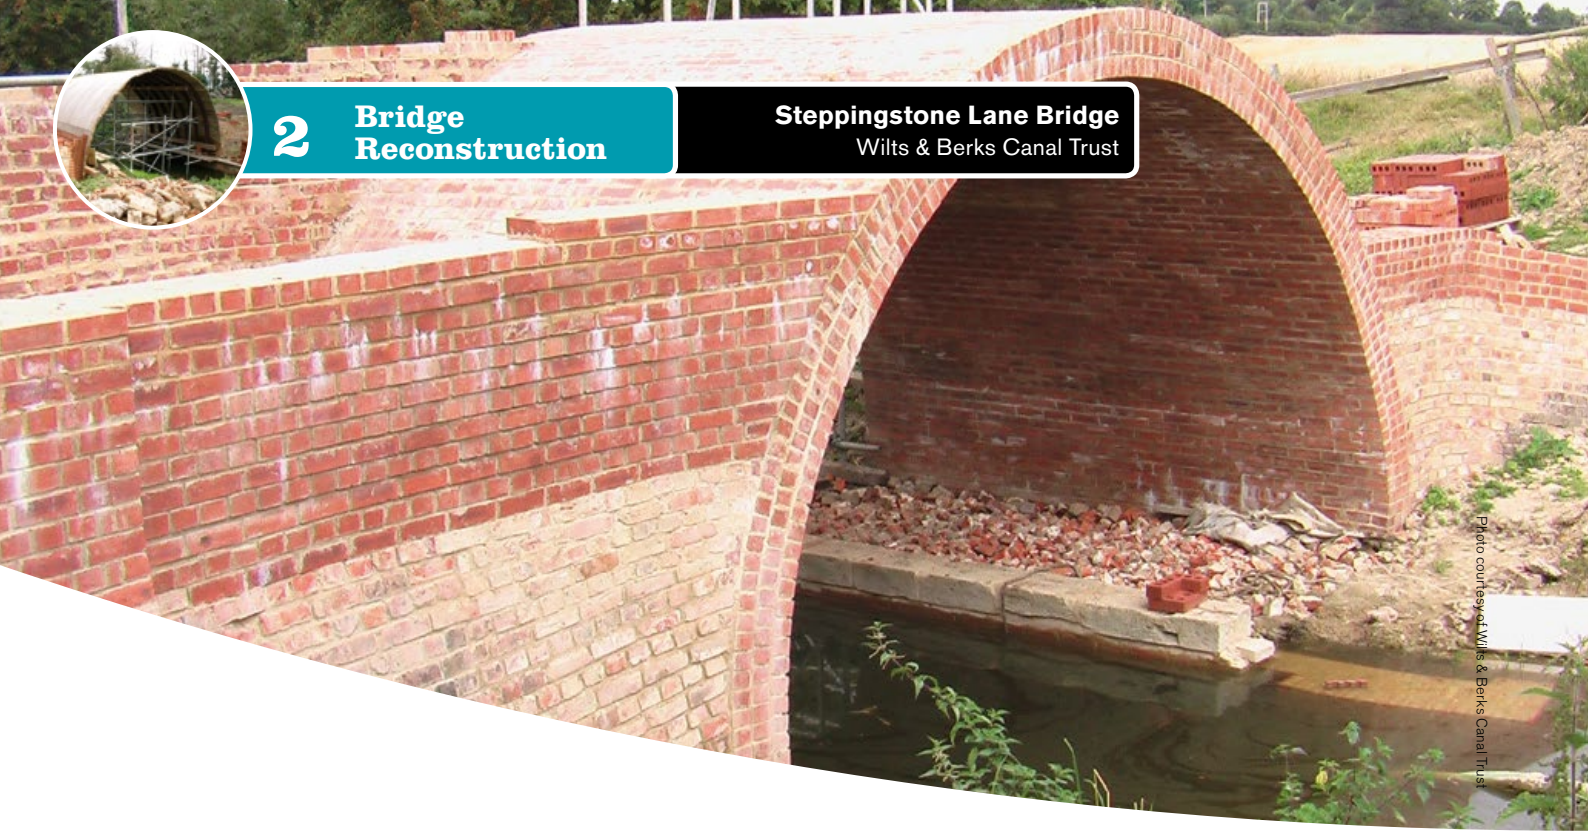
Steppingstone Lane bridge, Wilts & Berks Canal Trust

The original bridge was constructed in 1804/5 to carry the road from Shrivenham to Bourton. New access roads meant that this route became less popular and was a simple track and bridleway for many years. In the late 1940's the bridge became unsafe, it was culverted and then collapsed onto the culvert.

The rebuilding of the bridge finally commenced, in earnest, in August 2006 and continued as labour, funds and weather permitted. 10 large, curved, steel formers, 10,000 facing bricks, 3000 engineering bricks plus quantities of cement, lime and sand were obtained and moved to the site. The bridge was rebuilt entirely by volunteers.

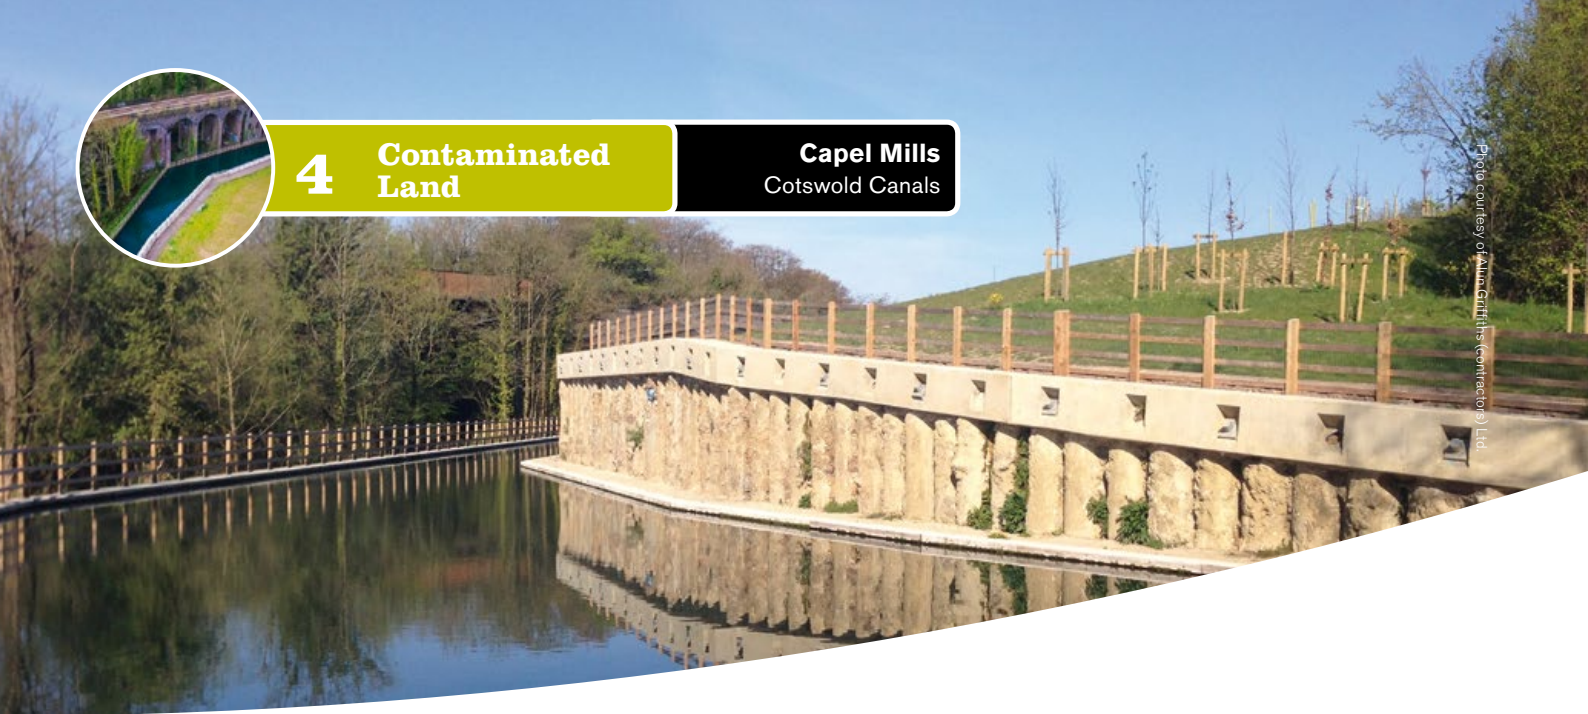
Capel Mills, diversion through landfill site

The Capel Mills site in Stroud presented a huge challenge to the project team. The land was contaminated and the aim was to cut a new 350 yard section of canal through this land. This new section would link Capel Mills in Stroud, to the existing channel north of the A419 in the west to Arundel Aqueduct in the east, one of the biggest engineering challenges on the whole 37 mile Cotswold Canals restoration.

Adding to the complexity of this already difficult site, the land was constrained by a railway viaduct, and by the River Frome running along the southern boundary and a domestic landfill site which had created variable topography and required the removal and remediation of contaminated material.

An intrusive ground investigation on the landfill slopes was undertaken in order to determine the type of retaining wall construction required and associated material remediation. A 190 yard anchored contiguous piled wall was constructed to support the landfill slope and was installed using an “up and over” drilling approach.

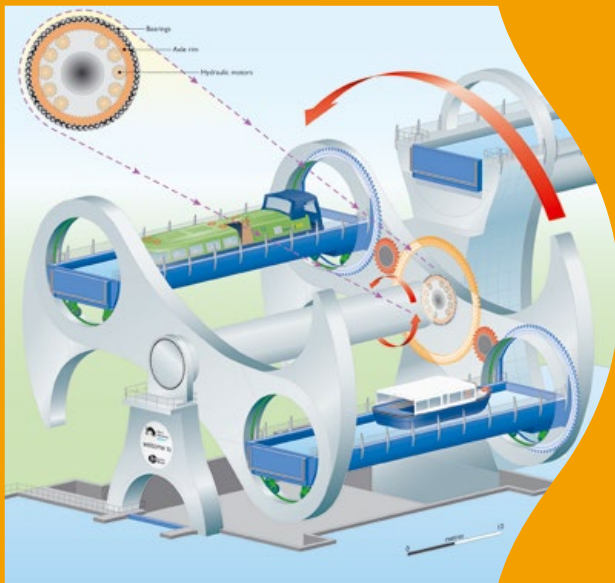
Left:
Isometric drawing
showing how the
Wheel works

The jewel in the crown of the Millennium Link project, The Falkirk Wheel is designed to raise and lower boats between the 115 feet that separate the Union and Forth & Clyde canals. Opened in 2002, the Wheel is now a major Scottish landmark enjoyed by over 500,000 visitors per year.

The Wheel replaced 11 sets of lock gates which were long lost and remain buried beneath nearby streets. The Wheel is some 2 miles from the original locks on the site of a redundant tarworks. The design of the Wheel was developed over 5 years, evolving from a design based on the Greek Noria machine to an open cylindrical drum containing rotating gondolas to carry the boats.

Computer controlled motors raise and lower boats in two large gondolas. The prime mechanisms are hydraulic motors that rotate the Wheel's two propeller-shaped arms and linked cogs that interact as the Wheel's turn. Imposing stresses on the structure due to the weight of the water filled gondolas changing completely in direction. Instead of using normal welded joints, steel sections were bolted together, making them more robust and able to resist fatigue-induced stresses. The Wheel needs only 1.5 kW hours of electricity to complete a half turn, the equivalent of boiling eight household kettles.

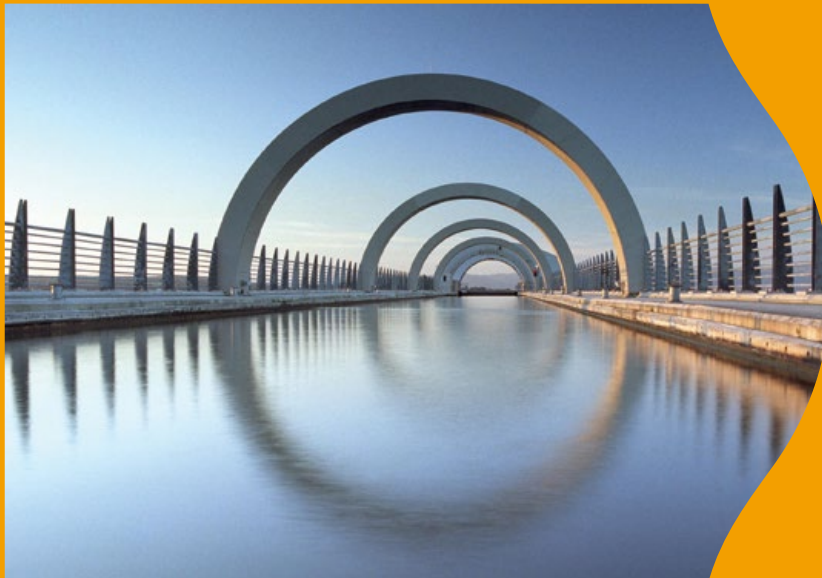
Left:
Falkirk Wheel's
top approach
and gondola

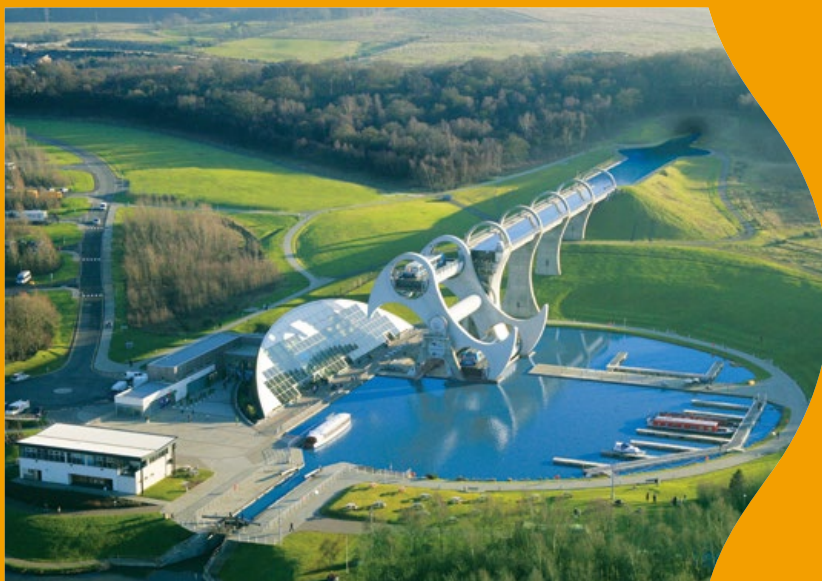
Left:
Aerial view of
the Wheel

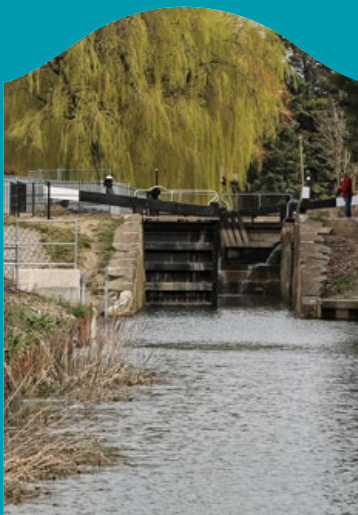
Above:
Lock featuring paddle gear

Part of the restoration of the Cotswold Canals involved developing paddle gear suitable for operation by the general public in the 21st century. The original gate paddle gear required the windlass operator to stand on the walkway across the lock gate, which is not safe. This meant that the design needed modification, whilst ensuring that the heritage was respected and that the paddle gear resembled as much as possible how the equipment looked 100 years ago.

The final design visually echoes the gate and ground paddle gear as it was at the turn of the 20th century. Changes include using spheroidal graphite iron as opposed to cast iron with variations to the windlass and gear ratios.

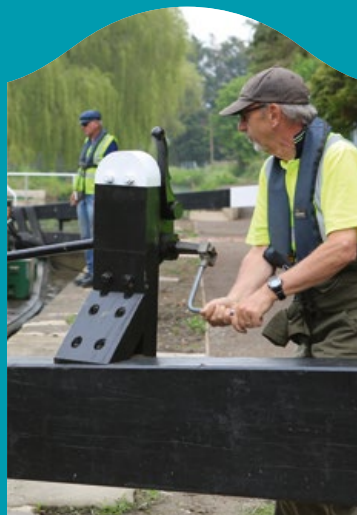
Above:
Paddle gear in action
