Towpath collapse following LPA non-consultation

Checklist Topics: Structural

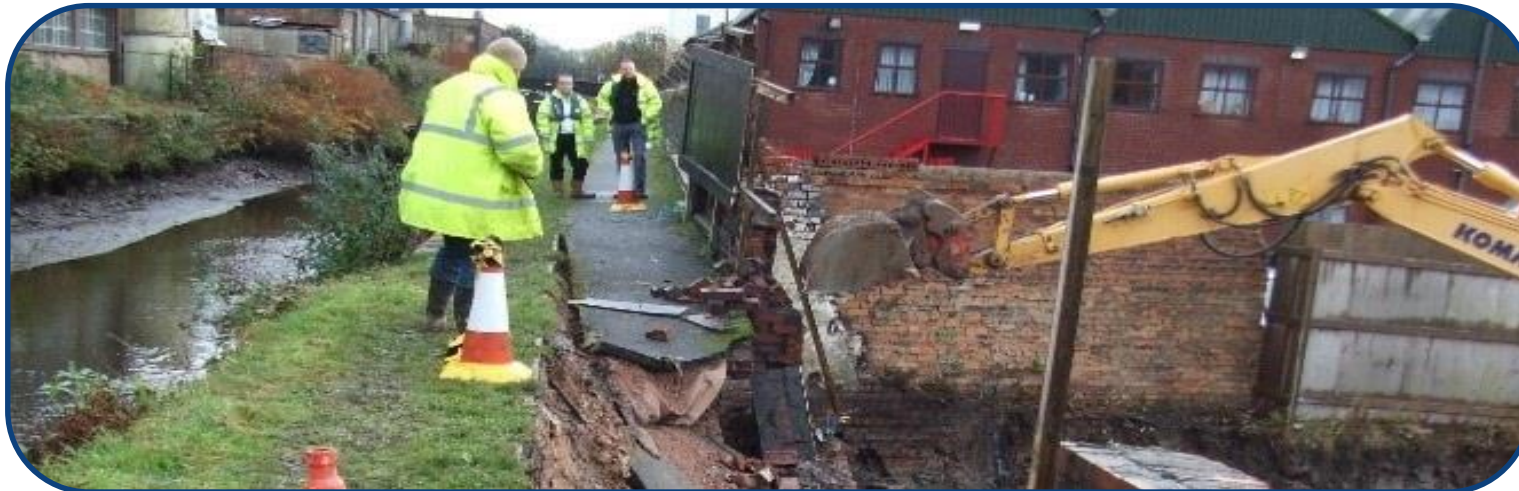
On-site excavation works associated with the redevelopment caused the towpath to collapse and the canal had to be urgently drained to reduce the risk of a canal breach occurring. The Trust is a statutory consultee where an
