***Storm Desmond*-related damage to Grade II Stainton Aqueduct**

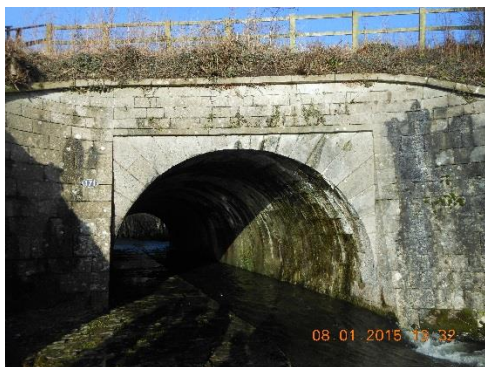
The beautiful Aqueduct that you are standing on was built almost 200 years ago, in 1819, designed by engineer Thomas Fletcher. It is constructed of limestone with a segmental-arch, flanked by curved and battered wing walls.

Stainton Aqueduct in 2015 before *Storm Desmond*

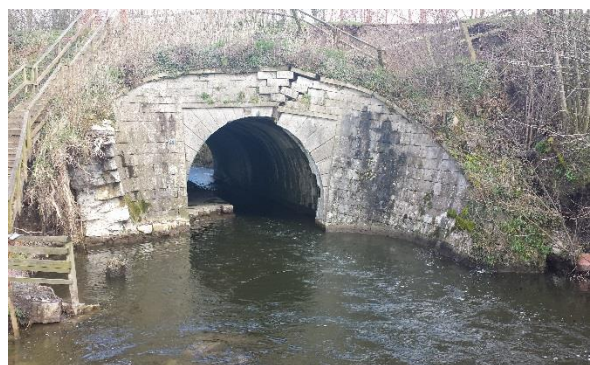
Back in December 2015 *Storm Desmond* caused water levels to rise six or seven feet higher than normal. Turbulence scoured the bed of the beck, washing away the path and part of the embankment, deepening the beck by up to one and a half metres. This undermined the foundations of the south-west wing wall leading to it subsiding and rotating, breaking the arch of the Aqueduct.

Severe damage caused by *Storm Desmond* December 2015

The Canal & River Trust has strengthened the damaged structure to prevent any further movement occurring. The water level in the canal above has also been lowered to reduce pressure on the Aqueduct.
